<b>SAFETY ALERT NOTIFICATION</b>	Safety Alert #	SA – 2017 - 2
	IMS #	75235
	OPERATION:	Safford
	INCIDENT DATE:	2/23/2017
	TIME:	10:47
	TYPE:	Near Miss
<b>Safford Boart Near Miss</b>		
Issued By: <b>FM Safford Operation</b>		Contact For Additional Details: <b>Drew Borcharding</b>

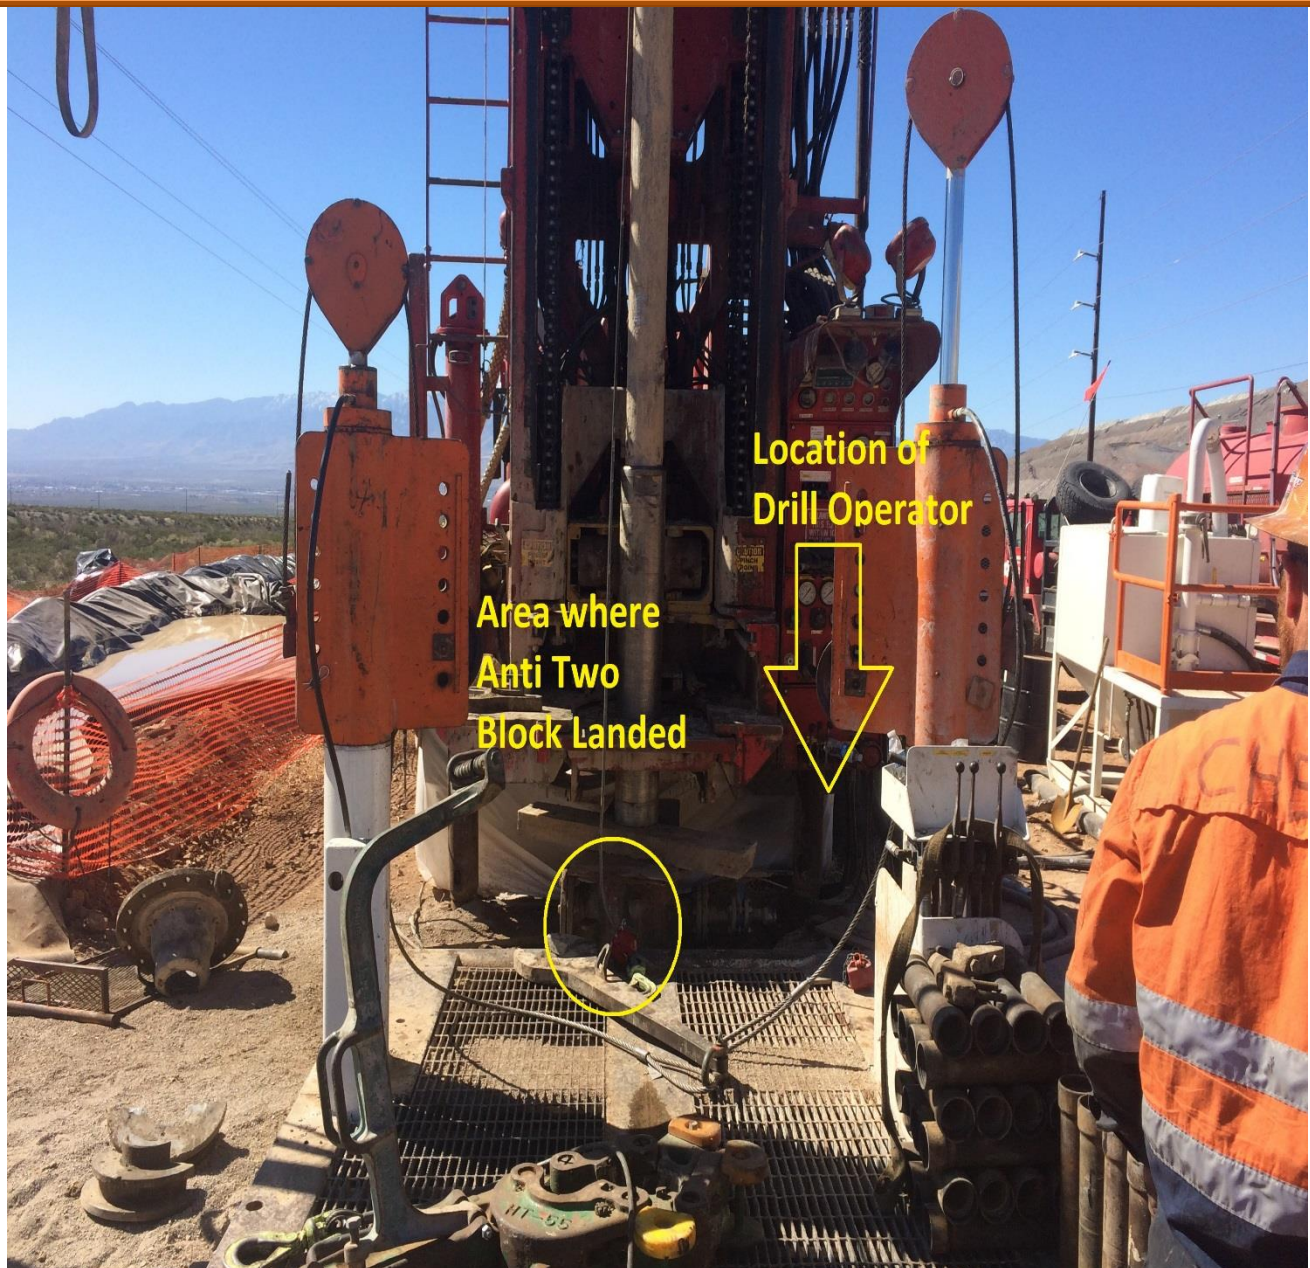
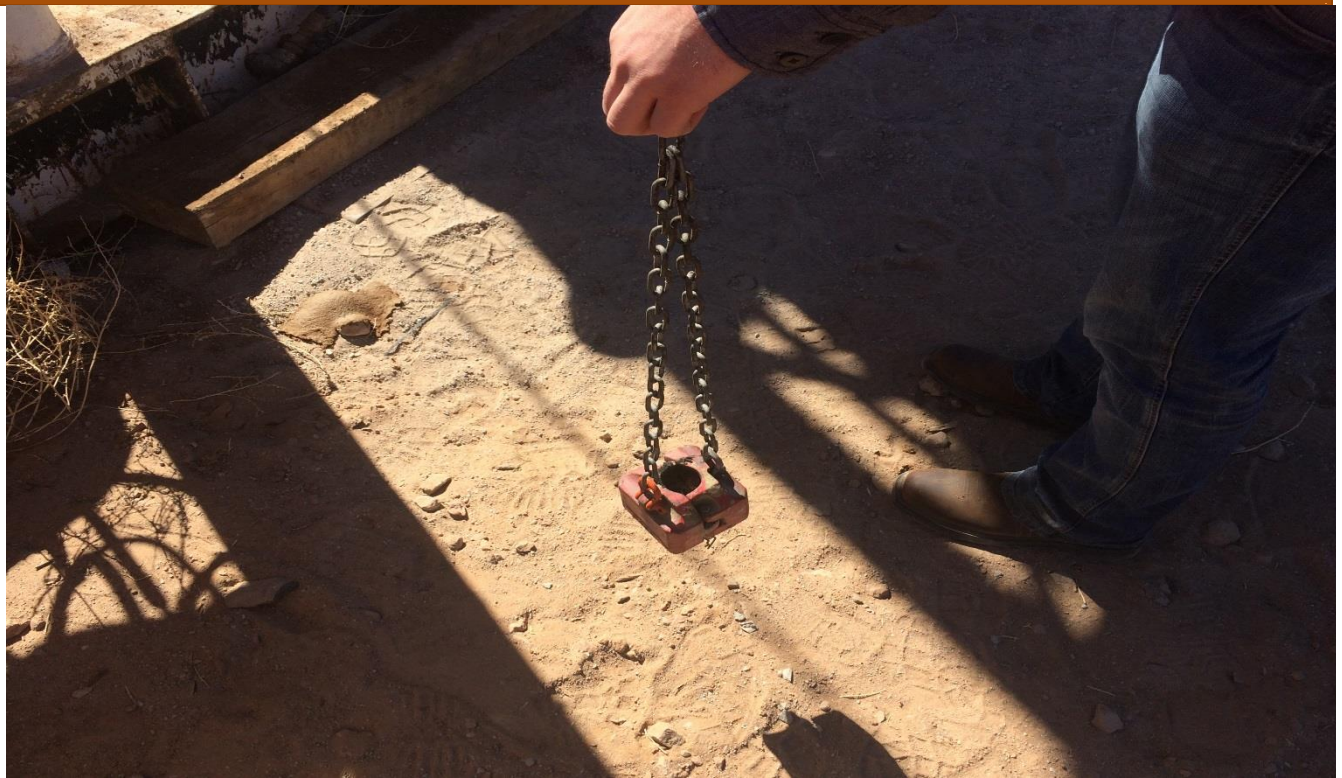
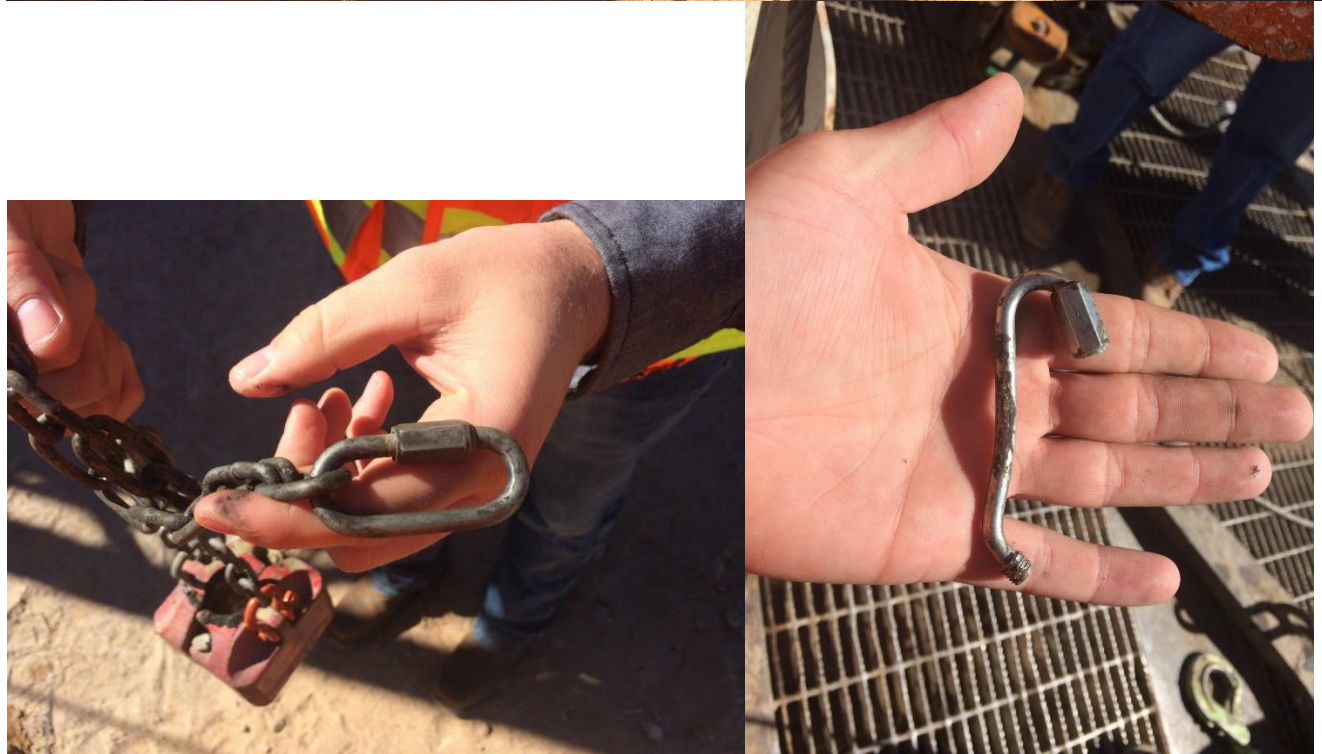
Contract drilling company Boart Longyear was adding a drill collar to the drill string at the AP 22-A well when the weight and chain component (12 lbs) of the anti two block system fell approximately 30 feet and landed on the deck. The drill operator was standing three feet from where the weight and chain component landed. It was found that the fastener provided by the manufacturer of the two block, a quick link rated at 880 pounds, had come unscrewed, caught on a mast component, and bent causing the weight component to fall. Boart Longyear typically replaces quick link with a clevis prior to usage, this drill arrived at site following a recent PM. It is unknown at this time why the quick link was reinstalled during the PM.

The anti-two block was fastened to the top of the drill mast with a chain quick link. It appears that the quick link was not properly installed and tightened down.

A larger more substantial clevis was installed in a manner which was tight/secured and could not come loose.

Boart Longyear is currently reviewing their equipment in operation at all sites and ensuring that any quick links are replaced with a more substantial clevis to prevent a reoccurrence.
