SAFETY ALERT NOTIFICATION		Safety Alert #	SA – 2017 - 5
  <h2 style="margin: 0;">Chino Motor Stand Design</h2>		IMS #	75320
		OPERATION:	Chino Mines
		INCIDENT DATE:	2/27/2017
		TIME:	3:00 PM
		TYPE:	Property Damage
Issued By: Sean Maddock		Contact For Additional Details: 575-912-5307

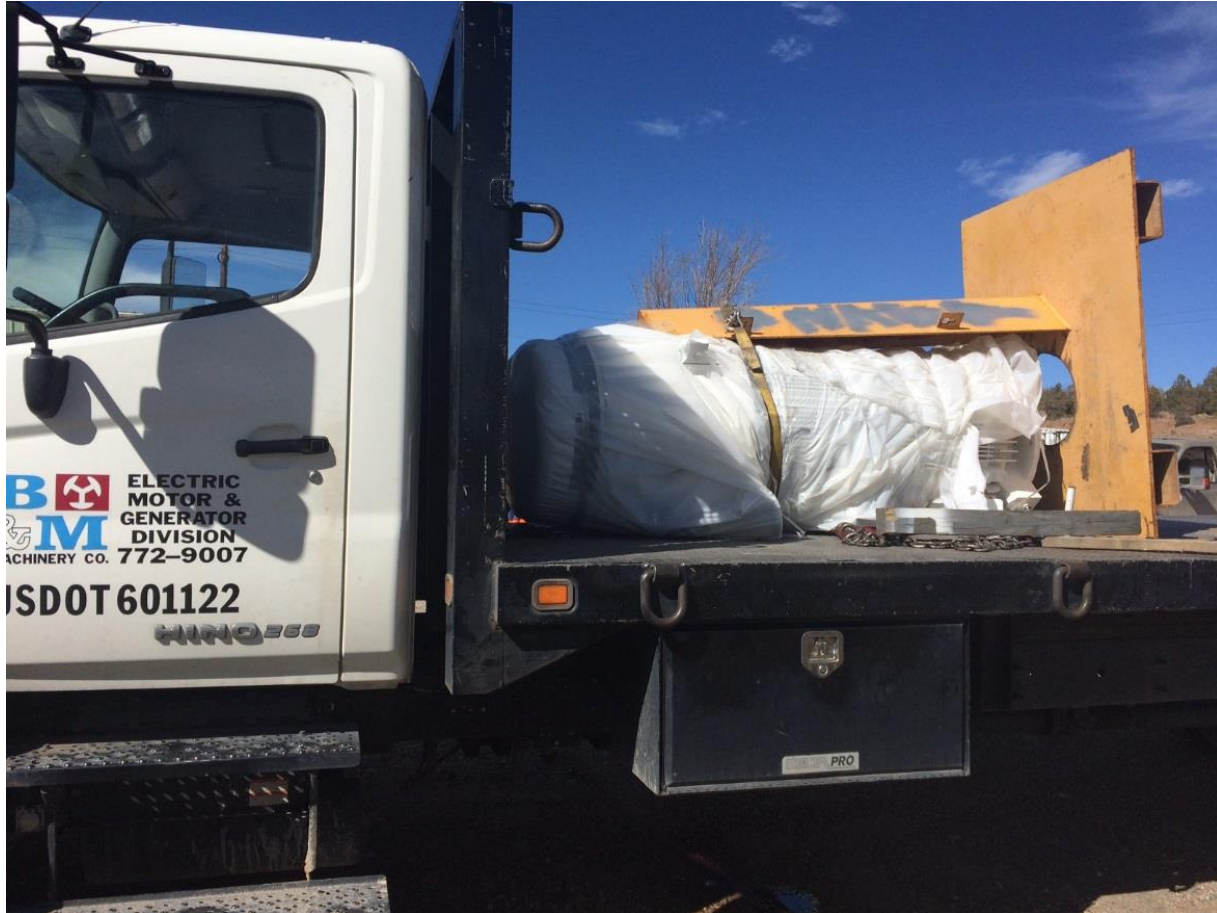
On 02/27/2017 an SX maintenance employee was tasked with unloading a 700 HP vertical pump motor off a vendor delivery truck with a Hyster forklift. They moved the forklift into place and realized the forks could not spread to the width required to utilize the pockets on the motor stand. The operator then decreased the fork width and positioned under the stand between the two fork pockets. Unfortunately, the stand that was being used was not the correct size and the motor was off center in the stand, with the bulk of the weight towards the front of the truck. As the load was lifted, it quickly went off balance and fell forward, causing damage to both the pump and the flatbed of the truck.

- Motor stand was improperly engineered to have the center of the weight focused more on one side as opposed to being centered allowing the weight to be equally distributed.
- Forklift was not large enough to allow both fork pockets to be used.
- Operator did not perform an adequate risk assessment when making the decision to not use the fork pockets.

- Require that any stands coming in have to be engineered for lifting with forklifts. Any that do not must be unloaded with a crane.
- Communicated the event and associated expectations to all employees that are involved with these activities  
Site sent CCI engineer and senior mechanical supervisor to evaluate stands and discuss solutions with the vendor.

- Continue collaboration with vendor to design and engineer stands that incorporate proper safety factors
- Ensure the vendor understands the expectations that all stands must be engineered prior to having FMI equipment placed on them and delivered to any branch.
- Communicate safety concerns with departments that unload/load motors or pumps.
- Identify all material shipment methods involving stands for similar potential hazards and verify they are properly engineered.
