SAFETY ALERT NOTIFICATION	Safety Alert #	SA – 2017 - 1
	IMS #	74657
Energized Frame on Portable Welder	OPERATION:	Henderson Mine
	INCIDENT DATE:	1/17/2017
	TIME:	12:00 PM
	TYPE:	Near Miss
Issued By: Andrew Siersma	Contact For Additional Details: David Brence

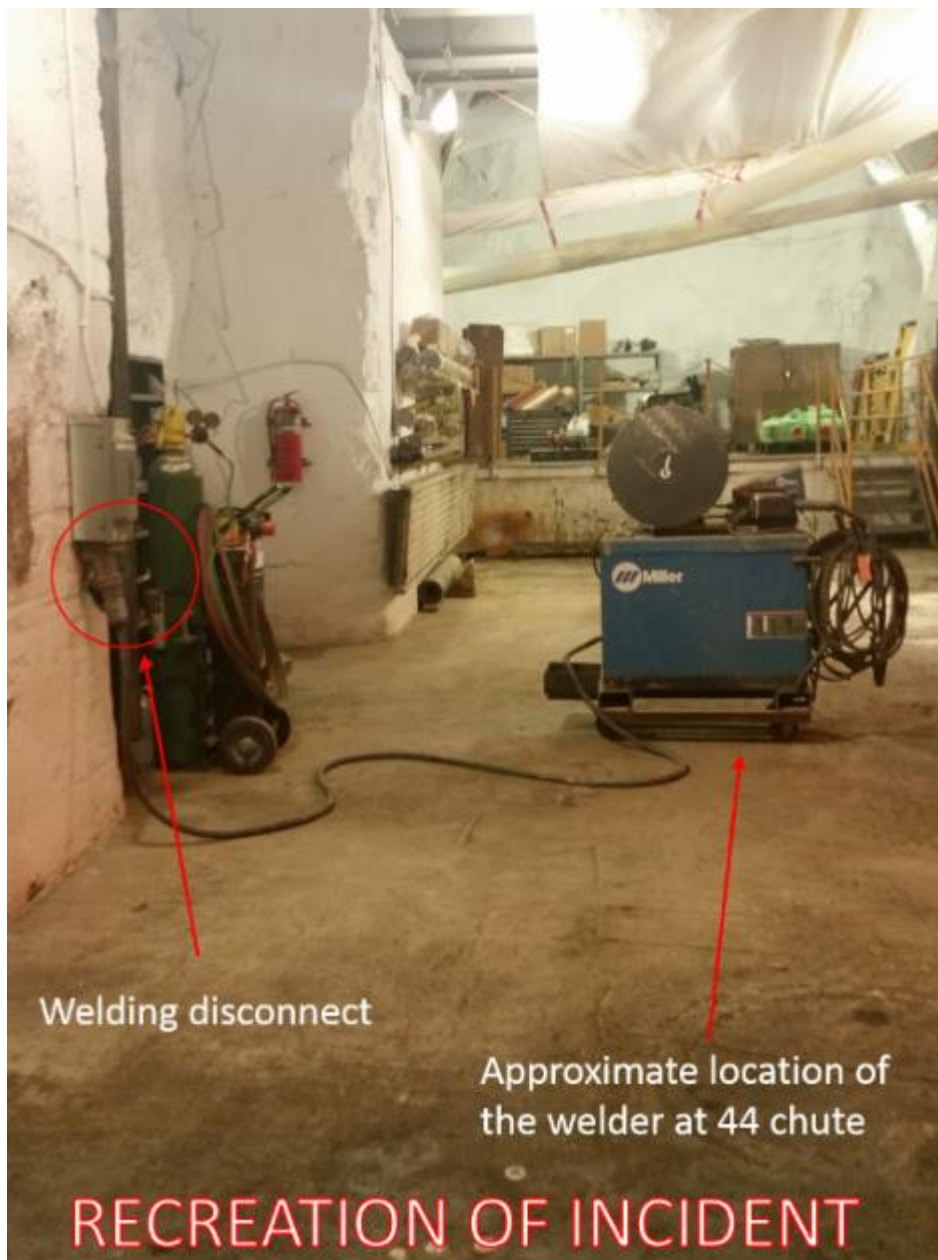
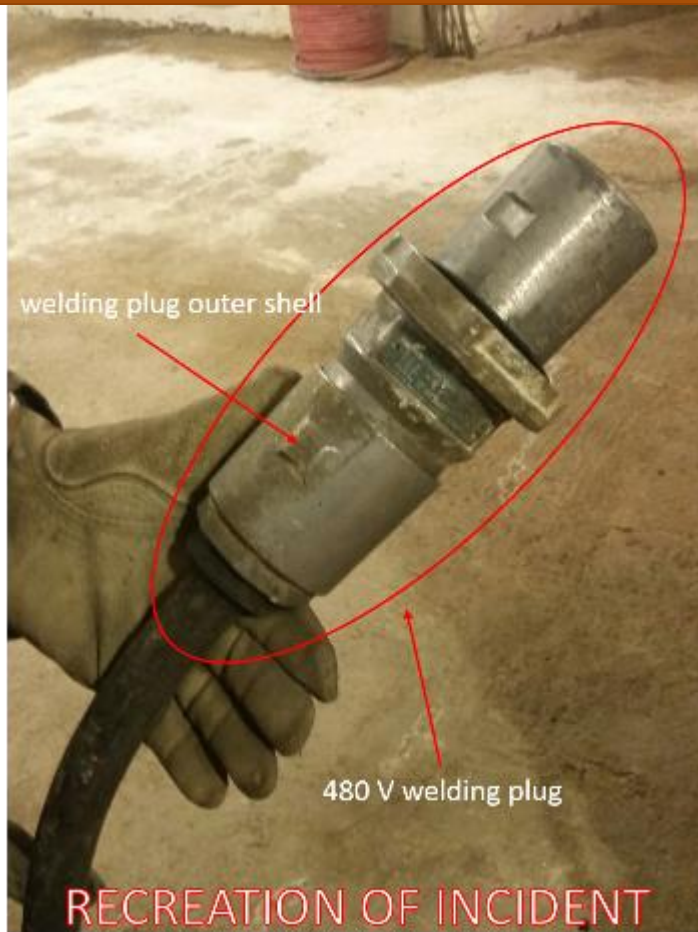
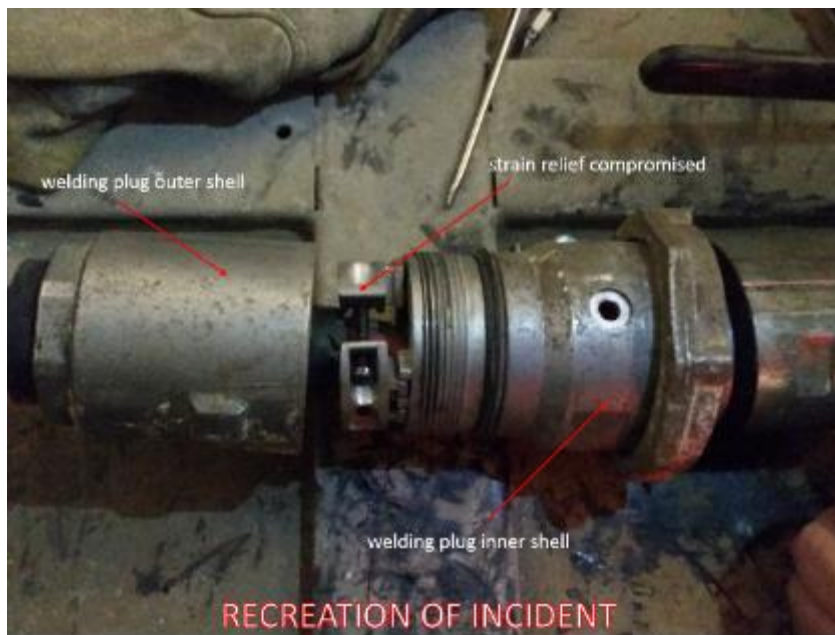
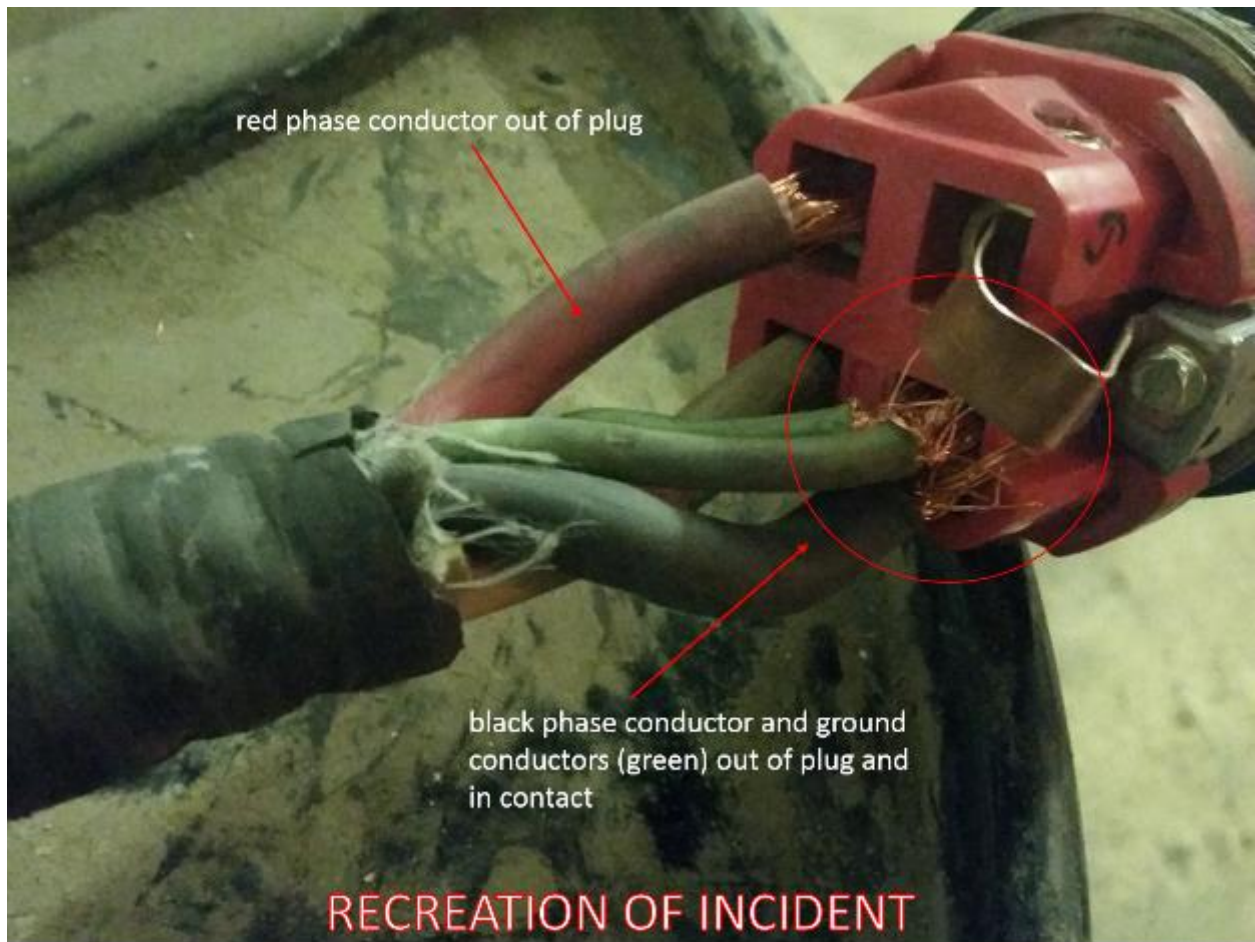
Inspecting with the plug shell removed, the electricians found the strain relief was no longer tightened to the outer jacket of the cable. Two phase conductors and the ground were completely out of the plug termination but one remained connected. The ground wire was contacting one of the phase conductors which had caused the frame to be energized.

Defective tools or equipment – welder frame was energized due to damaged plug
Inadequate assessment of risk - Employee was not able to visibly determine if cord was damaged during routine safety inspection of equipment because of the plug design (Basic cause)

Electricians to inspect all multi plug type electrical connections before use or operating.
Institute effective preventative maintenance action requiring inspection of plug components.
Perform a risk assessment on multi piece plug applications and develop controls to address the risks identified.
