Safford Tertiary Crusher Motor Arc Flash	Safety Alert #	SA – 2016 - 8
	IMS #	73464
	OPERATION:	Safford
	INCIDENT DATE:	11/26/2016
	TIME:	9:30pm
	TYPE:	Near Miss
Issued By: John Swagzdis		Contact For Additional Details: jswagzdi@fmi.com

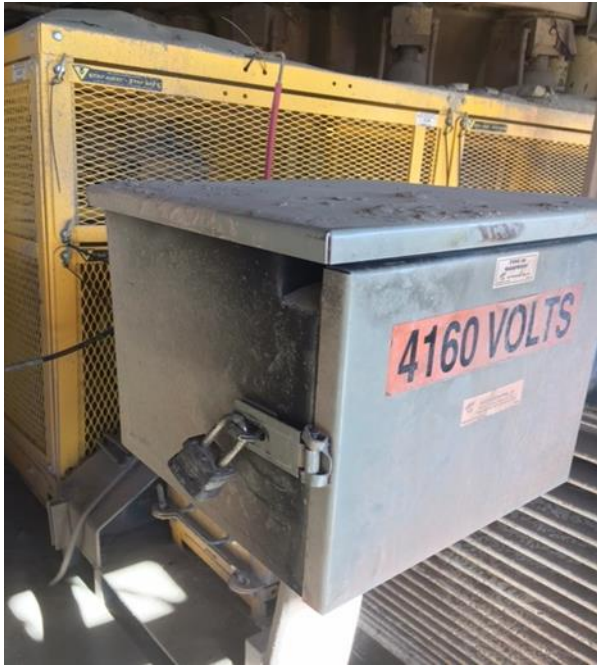
On Saturday 11/26/2016 at approximately 9:30pm, Tertiary Crusher #3 (2270CRU003) blew a 4160V fuse at the motor starter. Shift electricians investigated the cause and after testing the motor leads using a Fluke 87 meter they determined there was no issue and replaced the blown fuse. After the fuse replacement was completed, the electricians released the crusher to operations and called for a restart. Upon startup, the A&B phase fuses blew creating a significant arc flash which blew the motor tap box hinged cover open.

During the investigation it was determined that the motor tap boxes on all four tertiary crushers and the two secondary crushers were altered from the original design shortly after commissioning. This modification occurred because the original heavy cast boxes were breaking off the mounting arm due to vibration. The new design wasn't reviewed through the Management of Change (MOC) Process or by an Engineer and doesn't meet industry standards for a 4160 installation, and as a result were not able to adequately contain the arc flash.

Motor tap box after arc flash

- Test motor and replace faulty compression lug
- Repair current motor tap box
- Communicate finding with electrical team and proper motor testing methods using a 5kV megger.
- Flag off area perimeter around motor junction boxes and require LOTOTO to enter until permanent repair is made.

- Complete RCA
- Develop protocol for testing motors when they fault on overcurrent or ground fault conditions
- Communicate the need to have installations approved by engineering and following the formal MOC process
- Work with OEM to purchase and install original or approved alternative tap boxes and submit through the MOC process
- Ensure protection relay settings are correct for ground fault protection

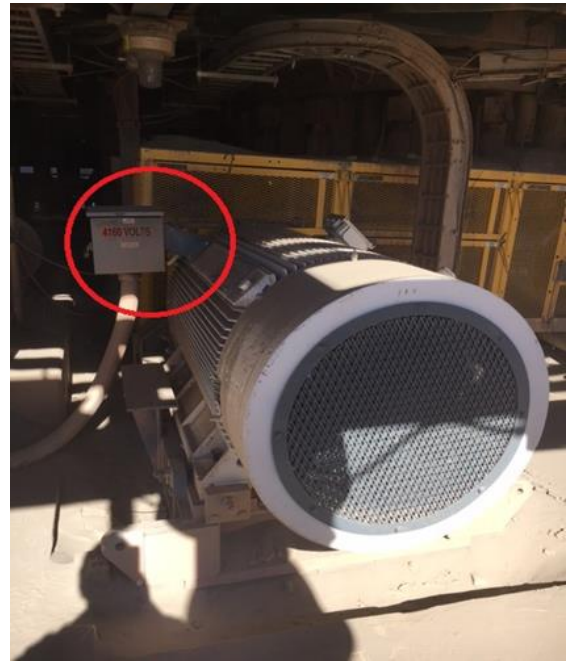
Mounting location for motor tap box

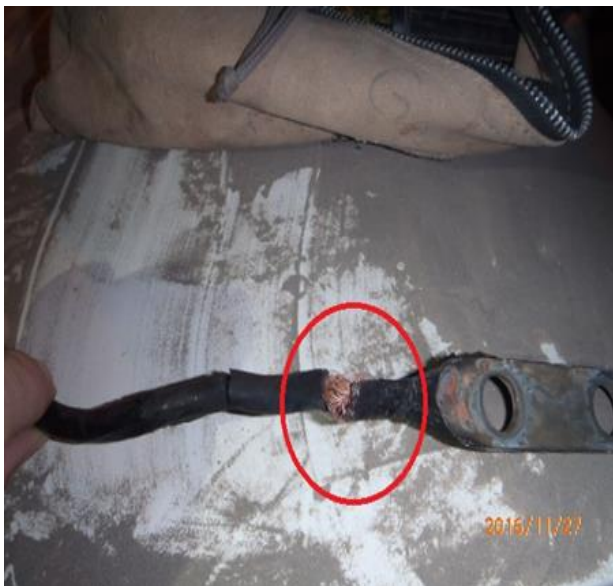
The motor for Tertiary Crusher #3 was previously replaced on June 16th, 2016. From the investigation it appears that during replacement, the compression lug on A phase was improperly installed leaving voids. This loose joint allowed minor arcing and heating of the connection to occur causing the insulation to deteriorate ultimately allowing the wire to make contact against the motor junction box steel wall. The second start resulted in a phase to phase fault which most likely created the arc flash that blew the hinge door open as it blew both fuses and had more energy.

- Improper Installation of the compression lug on the motor lead

Compression lug connection

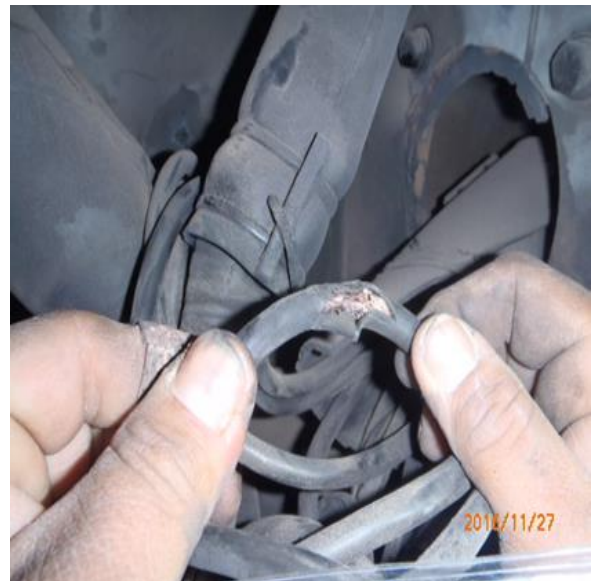
Deteriorated Insulation
