SAFETY ALERT NOTIFICATION		Safety Alert #	SA – 2019 - 13
		IMS #	99649

<b>Jump Starter Pack Explosions</b>	OPERATION:	Multiple Sites
		INCIDENT DATE:	8/20/2019
		TIME:	10 a.m.
		TYPE:	Injury
Issued By: <b>Tiffany Zaytsow, Health and Safety Manager-Morenci and Andrew Siersma, Health and Safety Manager-Henderson</b>		Contact For Additional Details: <b>tzaytsow@fmi.com (Morenci) or asiersma@fmi.com (Henderson)</b>

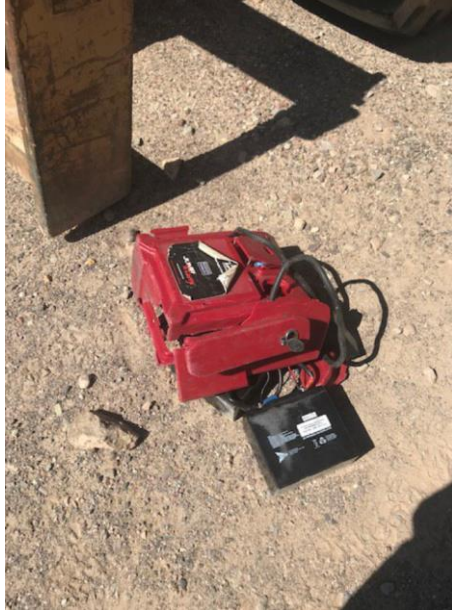
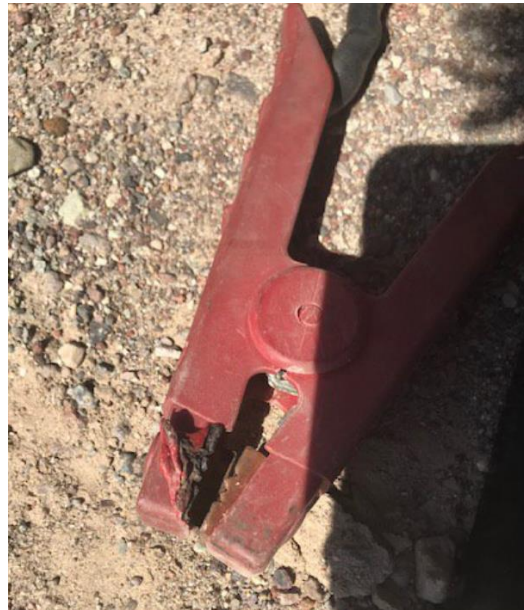
An initial investigation revealed the cross voltage generated flammable gases within the plastic casing of the jump starter that ignited when the grounding cable was reconnected. The jump starter also did not have a warning system to alert of improper voltage selection.
- Henderson:** A shop mechanic was repairing a rear-axle lift emergency stop control button that had come loose in the cab of a concrete transport truck. Once finished, the mechanic attempted to start the machine. It would not start so the mechanic assumed the battery charge was too low having been on for an extended period during repairs. The mechanic obtained a jump starter pack, connected the positive and ground leads, and began to plug the voltage selection cord into the 24-volt port on the jump starter when it exploded. The employee sustained injuries to the left hand and abdomen.

Damage to the jump starter pack (left) and positive grounding cable.

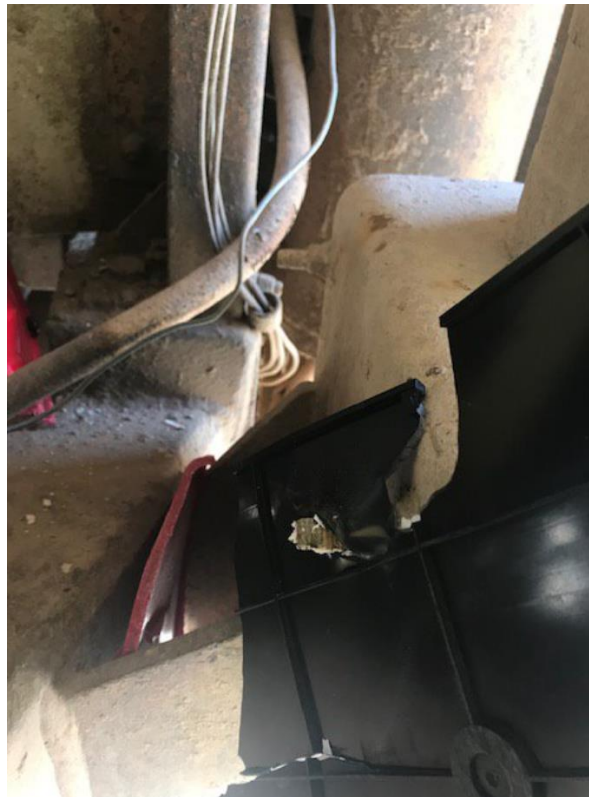
Back panel casing impaled during explosion.

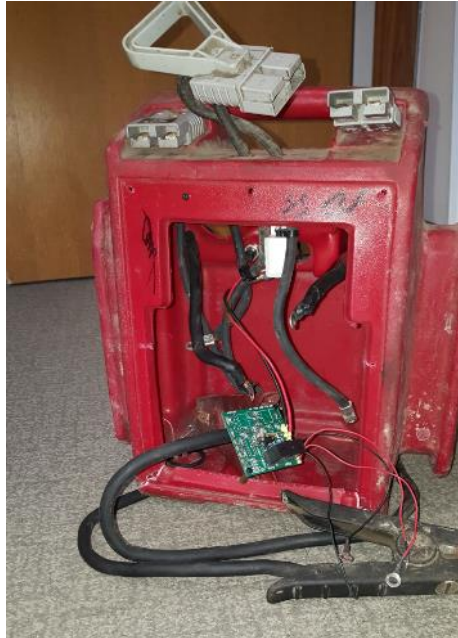
In the middle at top is the gray voltage selection plug.

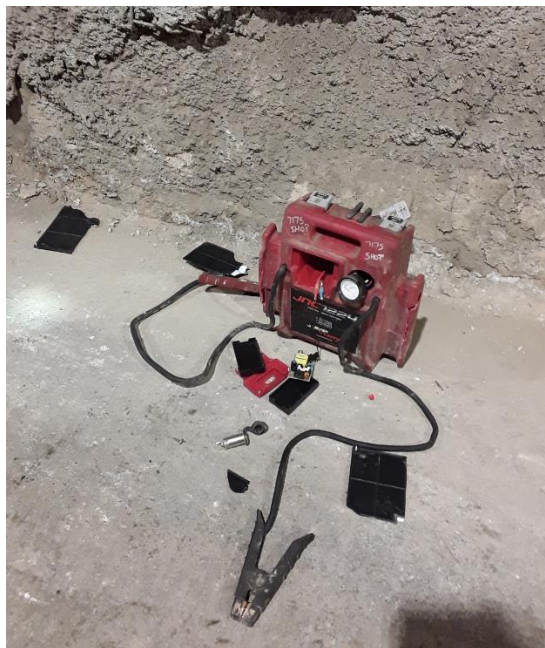
Damage to the jump starter.
