SAFETY ALERT NOTIFICATION		Safety Alert #	SA – 2019 - 4
  <b>Boom Contact with Overhead Power Line</b>		IMS #	96714
		OPERATION:	Morenci
		INCIDENT DATE:	4/16/2019
		TIME:	8:45 a.m.
		TYPE:	Near Miss
Issued By: <b>Scott Brack, Health and Safety Manager</b>	Contact For Additional Details: <b>Tim Summers, Plant Engineering Manager</b>

**Summary:** An arc flash occurred when the raised boom of an excavator came in contact with an overhead power line.

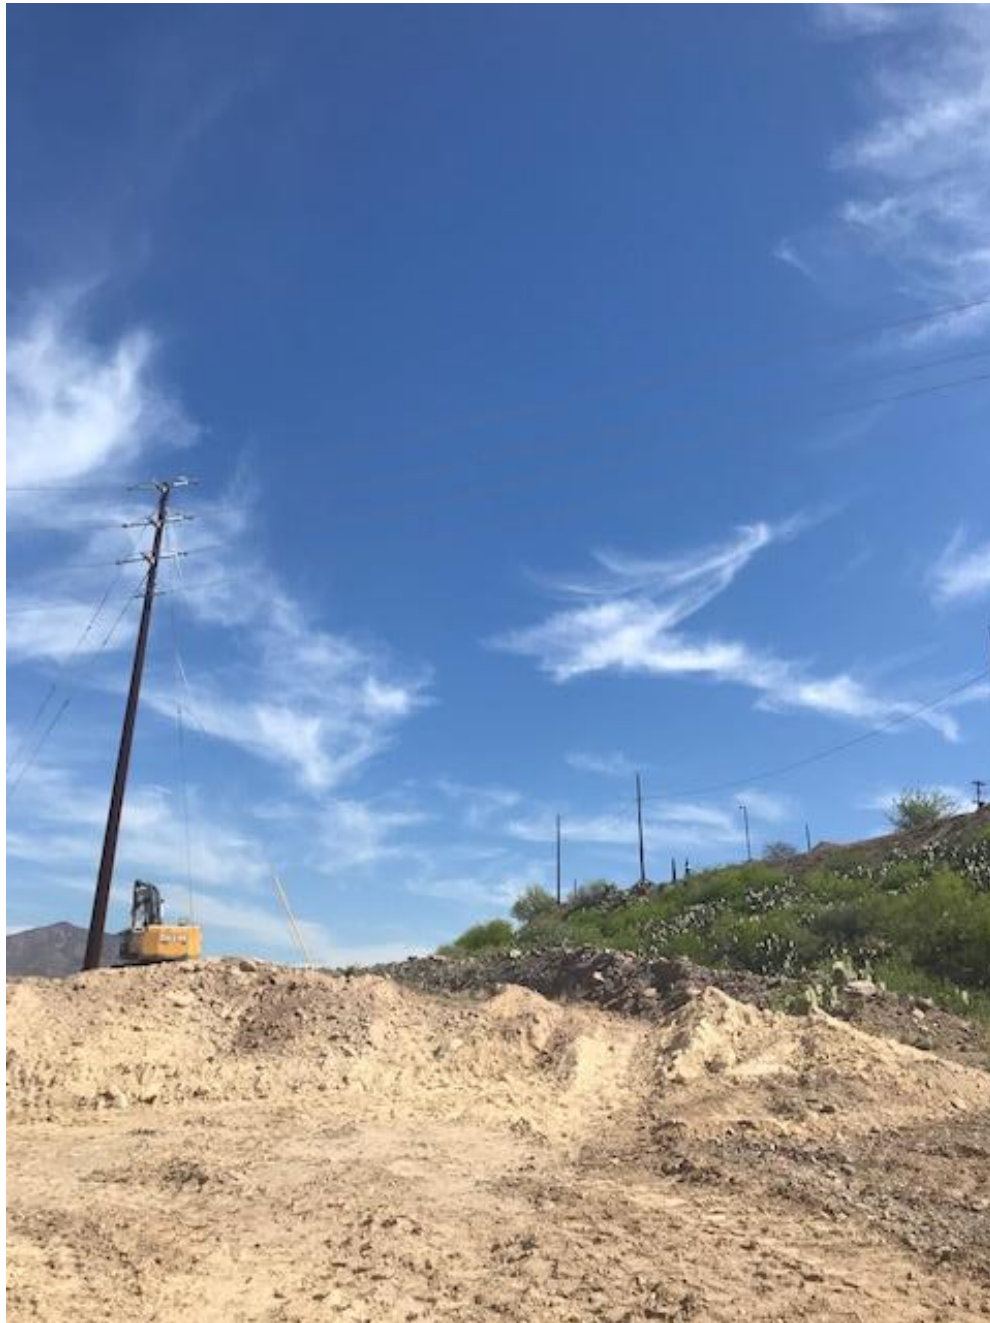
**Description:** A contractor employee was doing excavation work at the townsite tailings pond – a location that required driving under overhead power lines. After working several hours, including under the power line, the employee switched to a larger excavator and drove under the power line with the boom raised. The boom made contact with the ground wire and pushed it up into a phase wire, causing an arc flash away from the excavator and tripping the breaker. No injuries or property damage occurred, and the excavator was not energized. Auto-reclosure on the breaker re-energized the line soon after the excavator passed.

- Failure to re-assess the job after equipment change
- Failure to lower boom and keep a safe clearance distance from the power line
- Absence of a spotter while operating heavy equipment under the overhead power line

The area where the track hoe was driving underneath the power lines.

- Ensure proper spotting procedures are followed when operating equipment near overhead power lines
- Communicate the need to re-assess the job after a change in the scope of work and / or equipment
