Preliminary Incident Details		
Operation	Climax	
Date / Time	July 5, 2023 / 5:18 a.m.	
Туре	Property Damage	
Summary	A fully loaded haul truck was traveling downhill on a haul road and failed to make a turn. The truck went through two berms before coming to a stop against the face of a hill near a steep drop off. The contractor driver was assessed at the clinic and released without any injuries.	
Fatal Risk	Vehicle Collision or Rollover	
Risk Category	Monitor	
Pre / Post Rating	Significant (3) Possible (2)	
Findings / Missing Controls	Failure to engage downhill speed control	
Applicable Policies / Procedures	Interaction with Heavy Mobile Equipment (2.6)	
Employee Condition	No injury	
Contact	Tanner Thetford, Superintendent-Mine Operations

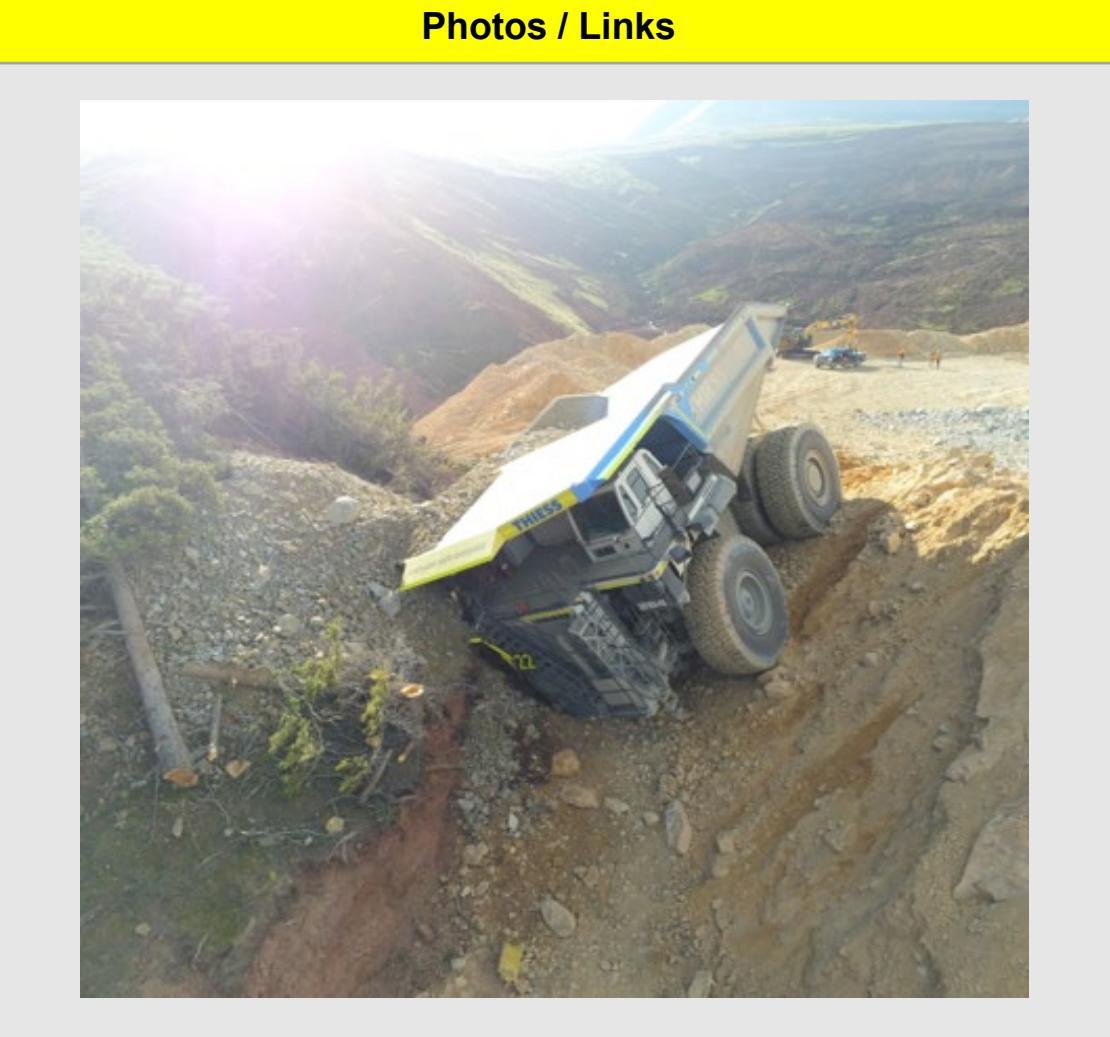
Final location of haul truck

Causal Factors	I		
 Haul truck operator traveled at 15 mph down a 10% grade ramp (no grade % or speed signage exists) with a 240-ton load without activating the dynamic braking speed control, as suggested by manufacturer Haul truck operator feathered the dynamic brakes, which was an ineffective action to keep the haul truck (Liebherr T264) within the braking capabilities Haul truck operator did not use the service brake (secondary) to slow the truck down when the dynamic braking system (primary) was ineffective 		Operating Con Fit For Work a Vehicle Preop • Have I condu	
Action Items	Hierarchy of Controls	the vehicle)?	
Install grade % and speed signage as a visual cue for haul truck drivers on downhill ramps	Administrative	Access Contro Segregation –	
Retrain operators (task training) on use of Liebherr T264 dynamic braking application, downhill speed control and service brake application	Administrative	Signage and D Road Design A

Set the adjustable speed limit (brake governor) on all Liebherr T264 trucks on-site. Climax and Thiess will determine the proper speed	Engineering		
Additional Learnings / Opportunitie) S		
 Climax and Thiess health and safety personnel will have ongoing converge pre-job expectations Thiess supervisors will conduct routine checks to verify operators are we Thiess will assign a ReadiWatch to employees to meet its fatigue manage Climax has communicated DSS eyewear requirements to supervisors 	aring the proper PPE
