**July 2016**  
**Contractor Safety Meeting**

# Weekly Safety Share – Open Hole

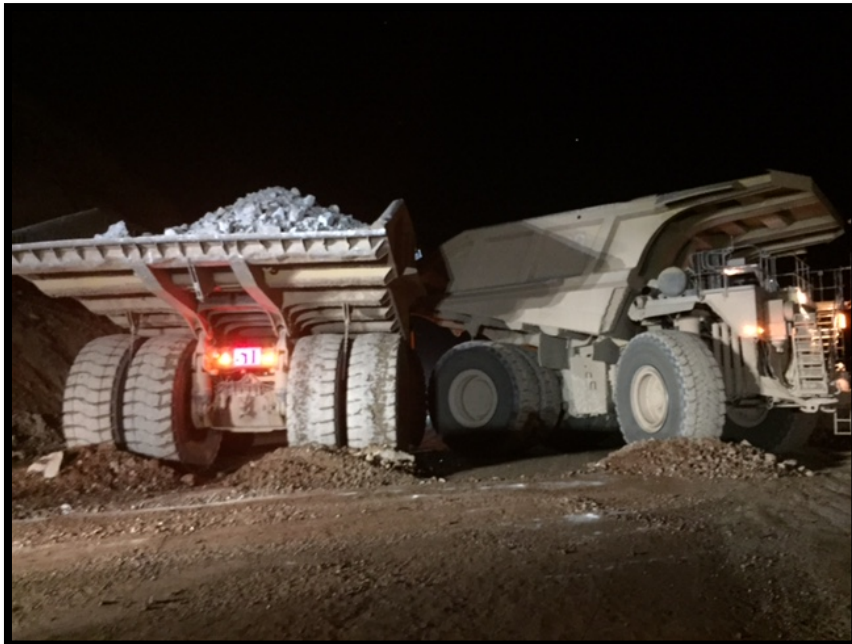
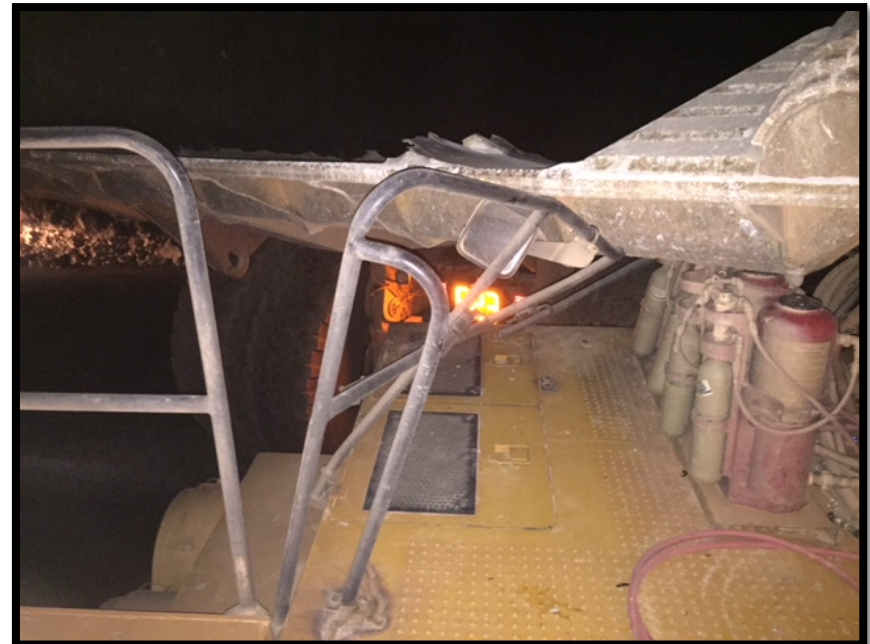
| <b>Brief Description</b> | While traveling down the 801 ramp the 623HT saw the 592HT slowed down in front of it and reduced speed causing it to go into a slide. The 623HT was going approximately 18MPH when the retarder and service brakes were applied. The 623HT slid 180 ft. and the bed made contact with the non-cab side guard rail of the loaded 571HT that was traveling up the ramp. The 801 ramp was heavily watered. | | |

1. Drive to road conditions
2. Follow roadway watering procedures

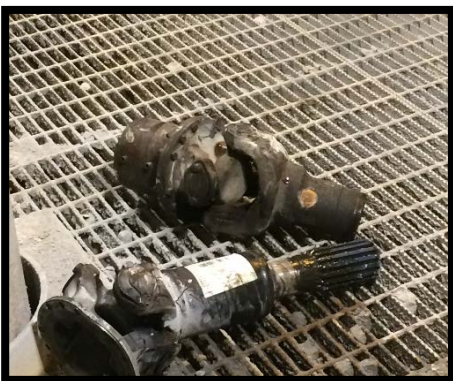
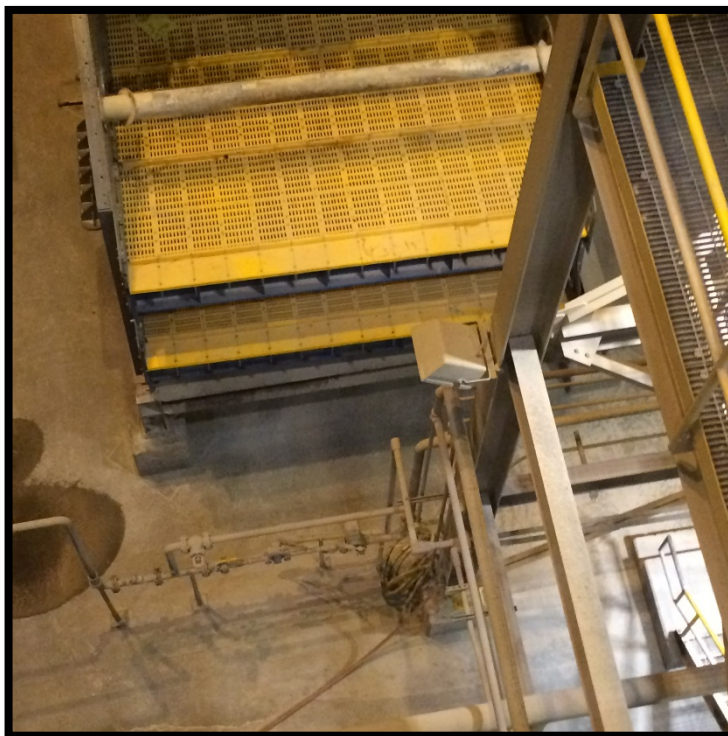
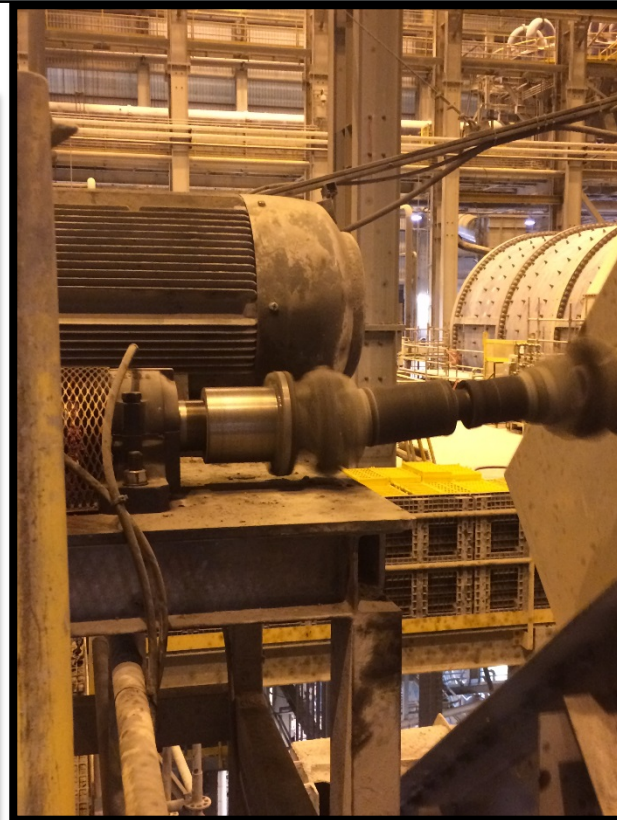
| <b>Brief Description</b> | Employee reported that the #2 Wet screen drive shaft (Weighing approximately 30 lbs) broke off and landed approximately 60 feet to the ground. No employees were in the area. Safety will be investigating it further to classify the event. | | |

1. Ensure adequate workplace exams are conducted.
2. Update PM process to identify potential failures
3. Identify and Implement controls to prevent reoccurrence of failure

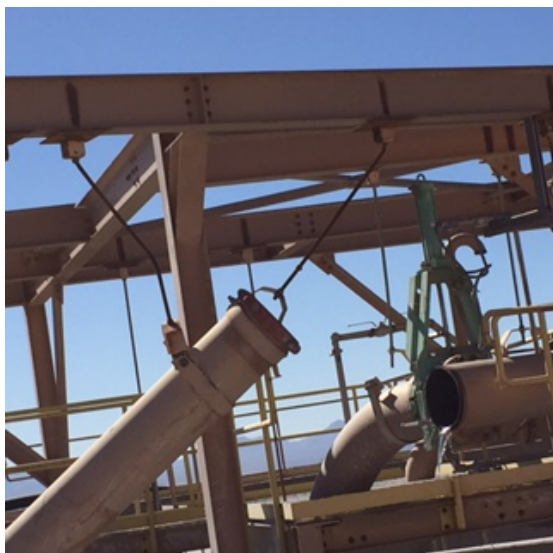
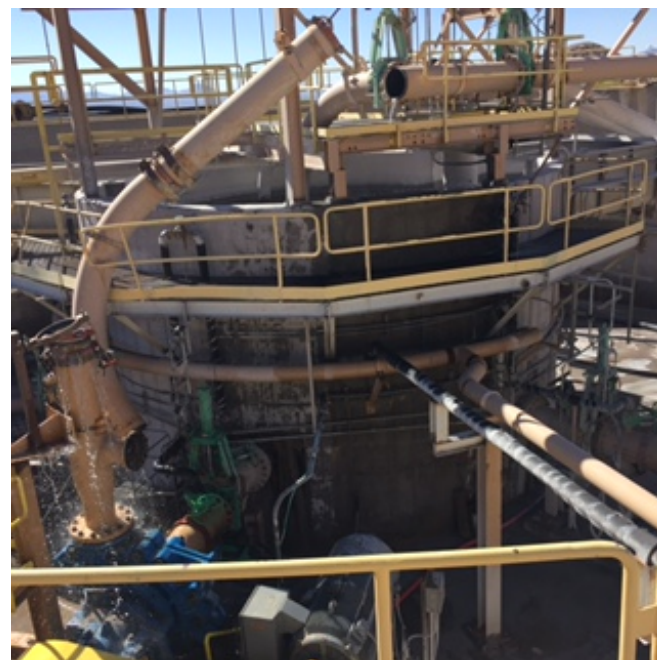
| <b>Brief Description</b> | Two Tailings mechanics were tasked with welding brackets onto the frame for the cylinoid so they can place a switch to control the valve. They went and shut the valve off. Employees were waiting on the operator to come so they could show him how to open and close the valve if needed to. Employees then heard a loud pop and were soaked with water. Both employees turned and started to run as they didn't know what had happened. As one employee was running he still had his welding shield on. His shield had been down because he water that was coming down had pushed it down. Employee ran into something (shield was down he couldn't see). Co-worker then helped guide employee. Once out of area safely they were able to see that the #2 train discharge sweep blown off just above them hanging on by two hooks and the handrail from keeping it from falling below. Investigation is ongoing. | | |

1. Conduct a thorough JSA prior to starting task
2. Review SOP and identify procedures and sequences for denergizing
3. Train employees on system operations

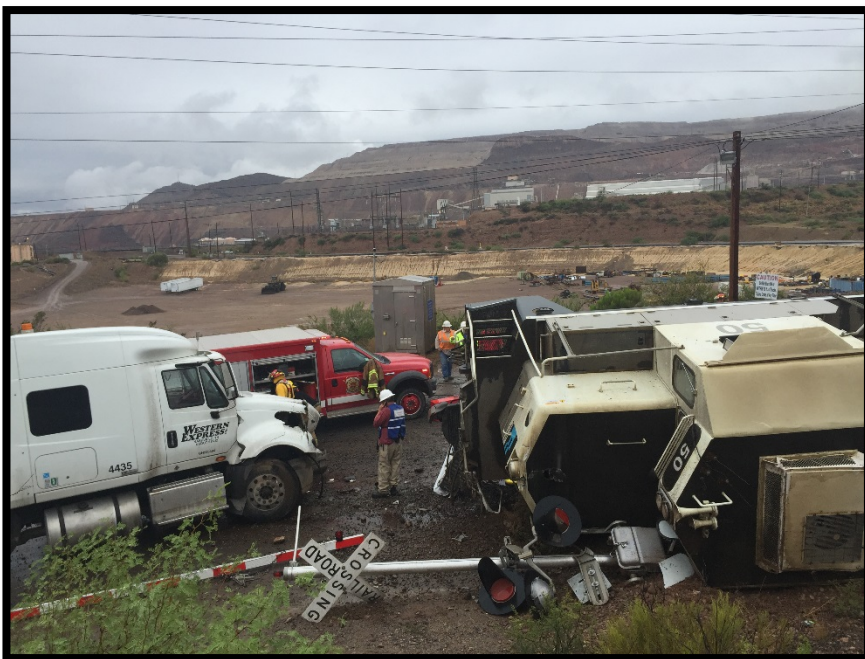
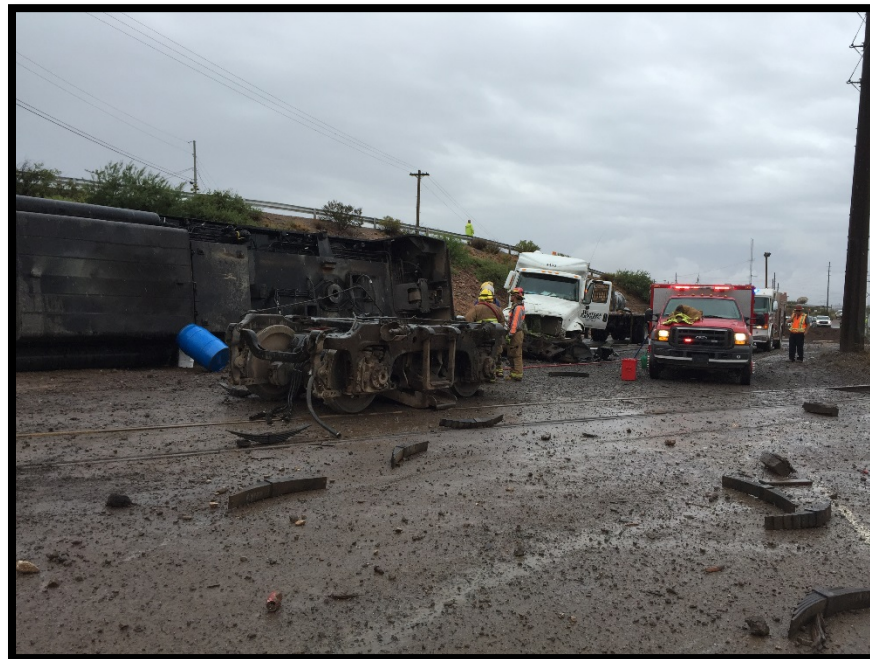
| <b>Brief Description</b> | At Approximately 7:25 a.m. a single locomotive, #50, pulled out of the locomotive shop to travel up to Morenci Mill. After pulling away from the shop the operator of the locomotive lost his brakes. He was not able to gain control of the locomotive and it went unmanned towards the Columbine Gate. The locomotive went off the tracks shortly after the columbine gate. The train tipped on its side after coming off the tracks hitting a semi truck head on. | | |

1. Complete a pre-shift inspection prior to operation.
2. Upon completion of maintenance, ensure equipment is operational ready.

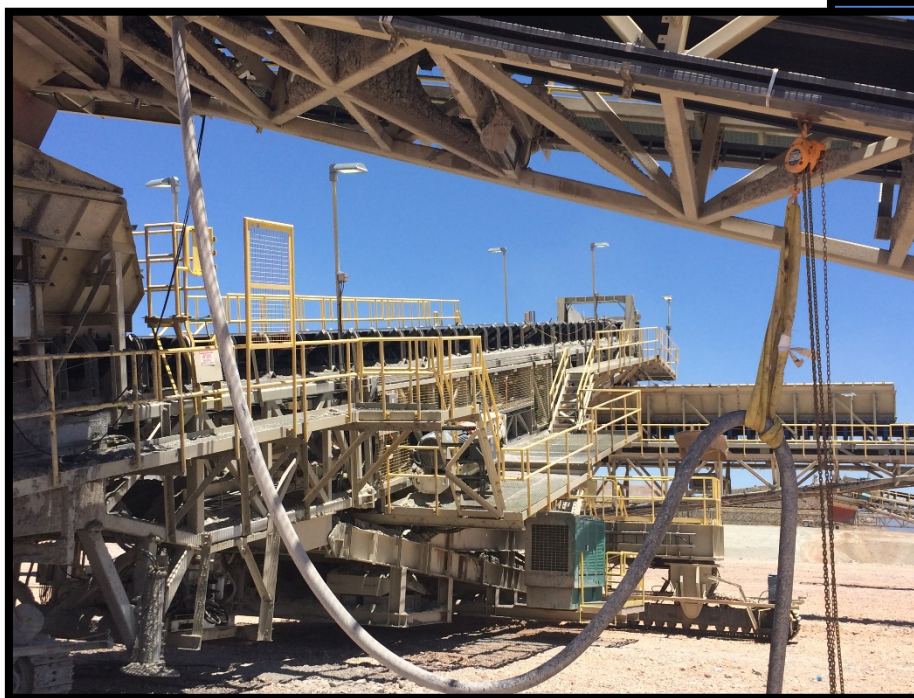
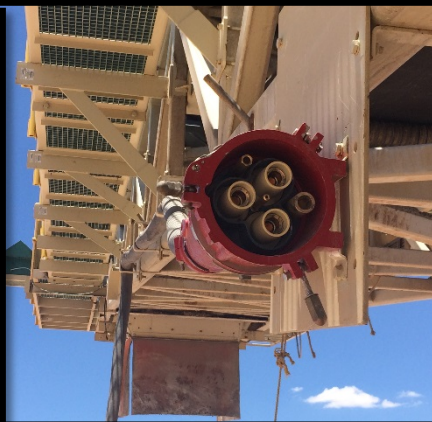
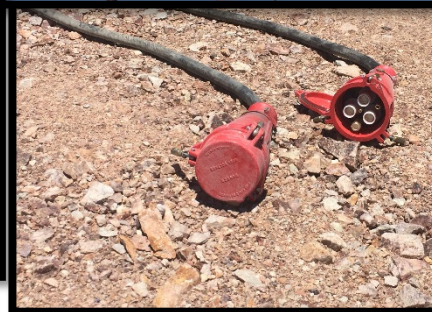
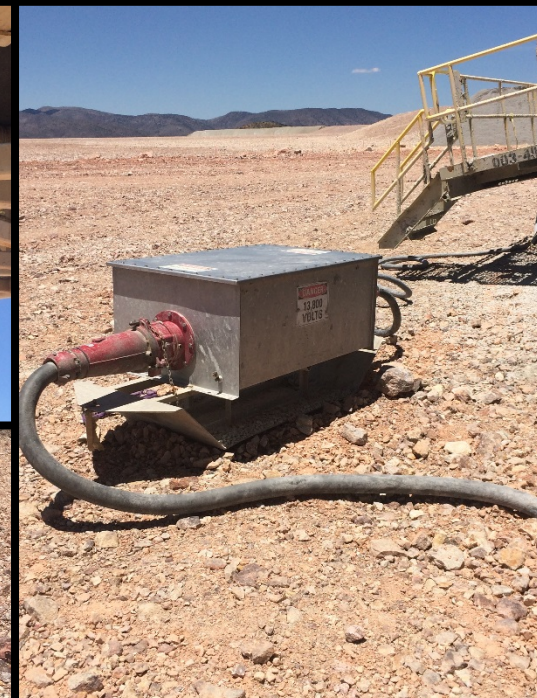
| <b>Brief Description</b> | An employee was assisting in the retiring of ultra portable RP8 and was adjusting the cable and pot head on the cable behind the horizontal feed conveyor when he received a shock | | |

1. Always complete a thorough pre-shift inspection/ Workplace Exam/ JSA
2. Ensure personnel receive the proper training for the task.
3. Utilize the Stop Work Authority

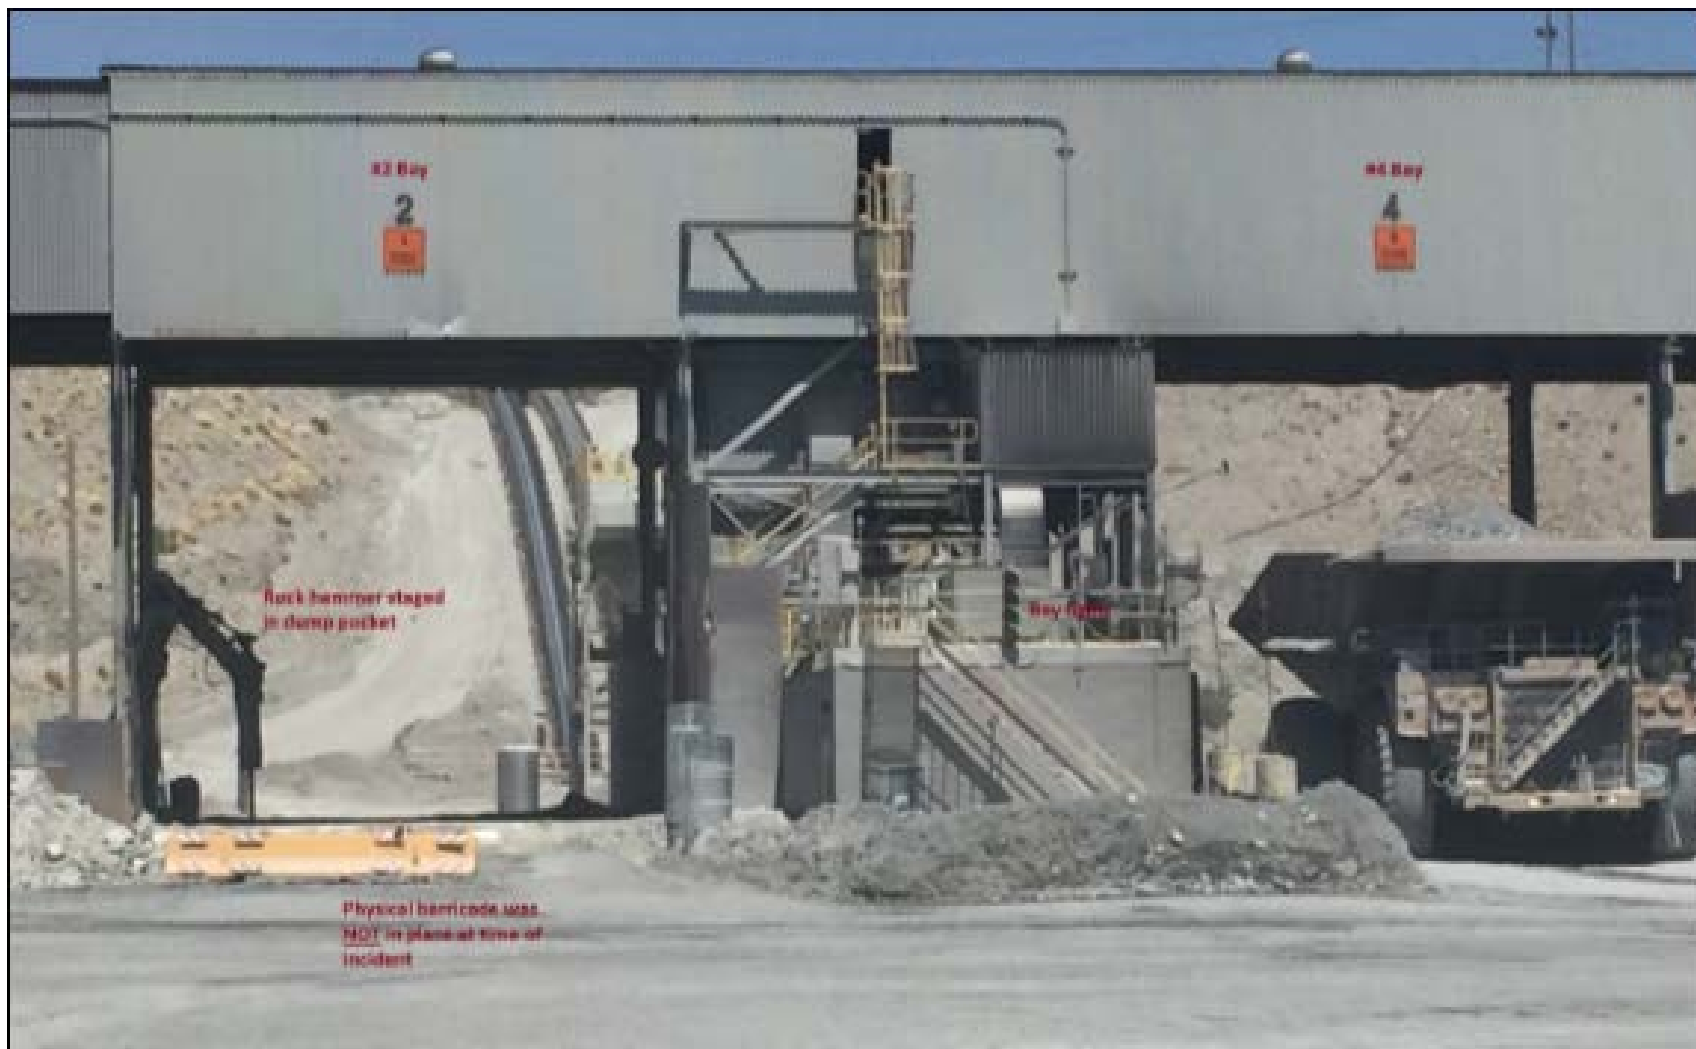
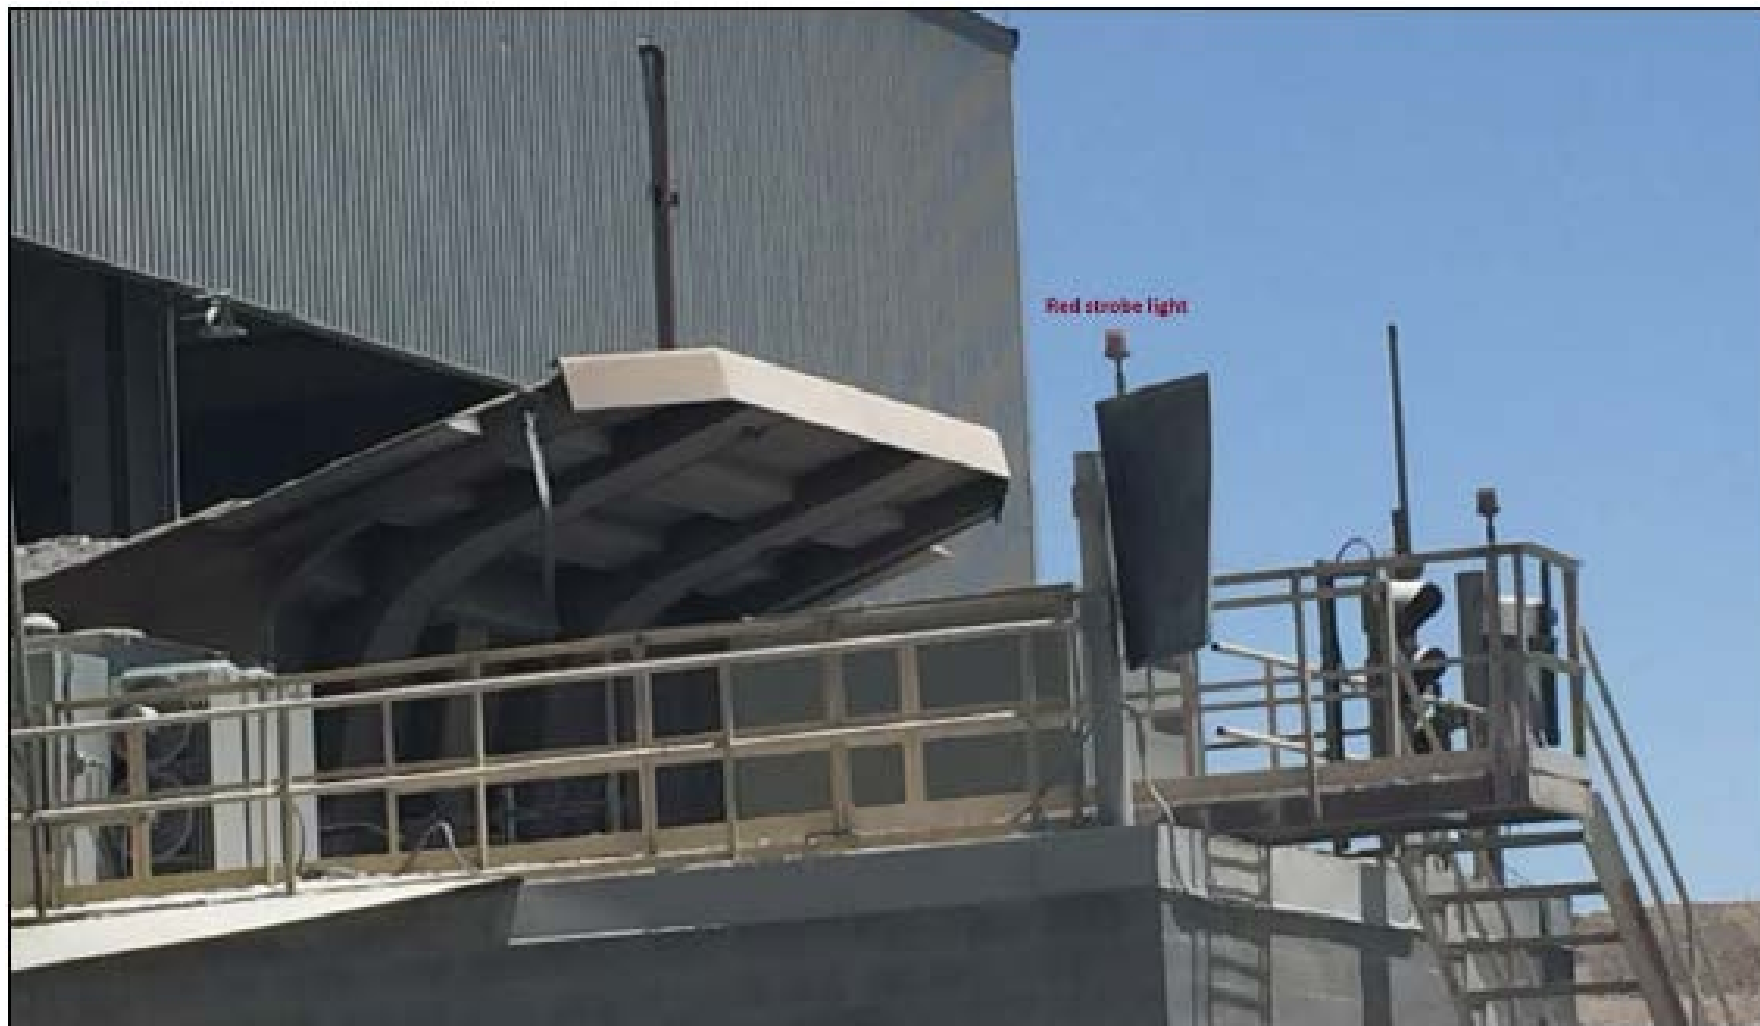
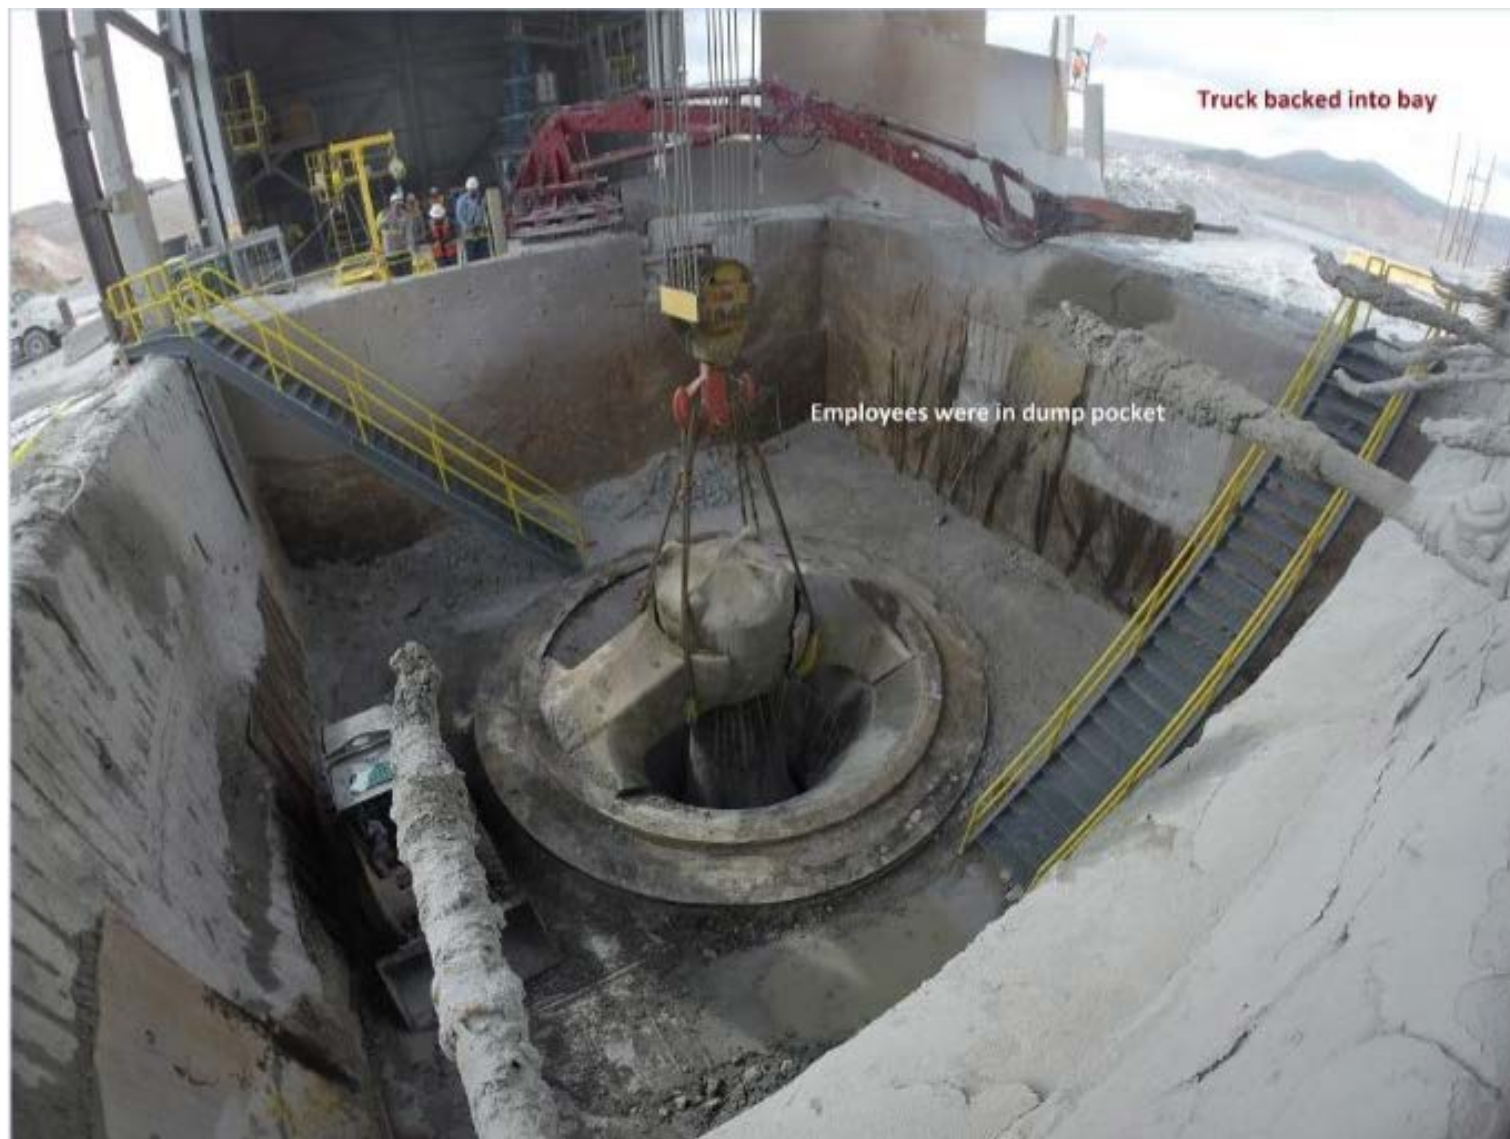
# Sierrita – Crusher Dump Pocket

While the mechanics were performing work in the dump pocket a fully loaded Caterpillar 793 Haultruck began backing into the A-side crusher bay. When the 3 mechanics heard the haul truck backing up and saw the loaded truck was in position to dump they hurried to exit out of the dump pocket via the stairs.

After fully backing into the bay and striking the rock hammer, the truck driver heard an alarm sounded by the crusher operator causing him to stop. At that time he noticed that the red strobe light was on, indicating that dump pocket was down. He pulled out and proceeded to move to the B primary crusher (bay #4) to dump out.

- Critical controls not in place or ineffective
  - Failure to place physical barricade.
  - Flashing strobe light was not noticed by the haul truck operator.
- A-side maintenance was not communicated in the morning tailgate meeting.
- The pre-job JSA did not indicate the need for the hard barricading.
- The SOP for the job had not been updated with the current method of hard barricading (jersey barrier).

1. Flagging and Barricading. During maintenance activity inside the crusher dump pocket, dumping of haul trucks is prohibited. Access by haul trucks is controlled by a hard barricade that was not in place at the time of the event.
2. Failure to follow a SOP.
  - A physical barricade must always be placed prior to personnel entering the dump pocket.
  - A red strobe light indicates Haul Trucks are not to back into the crusher bay.

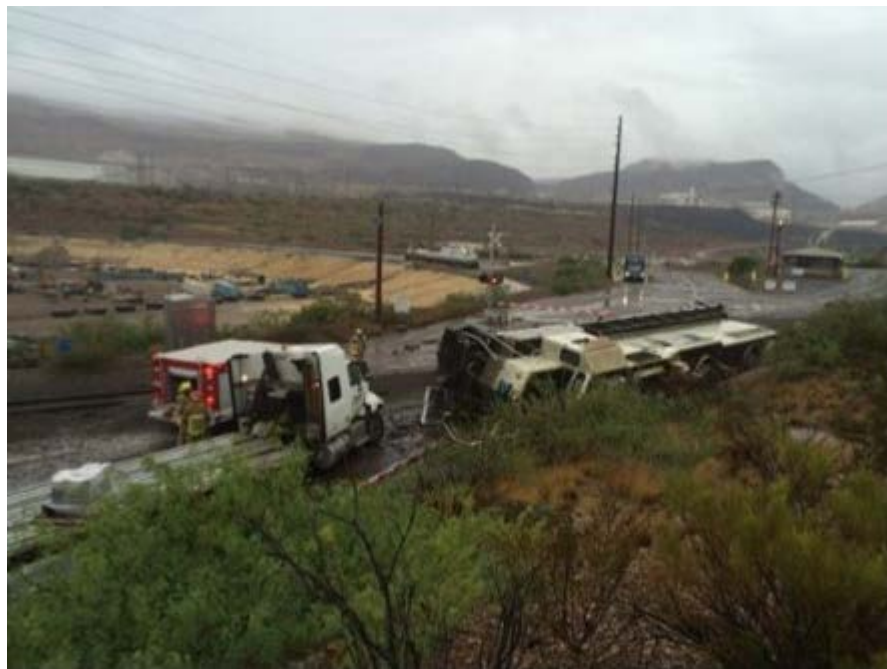
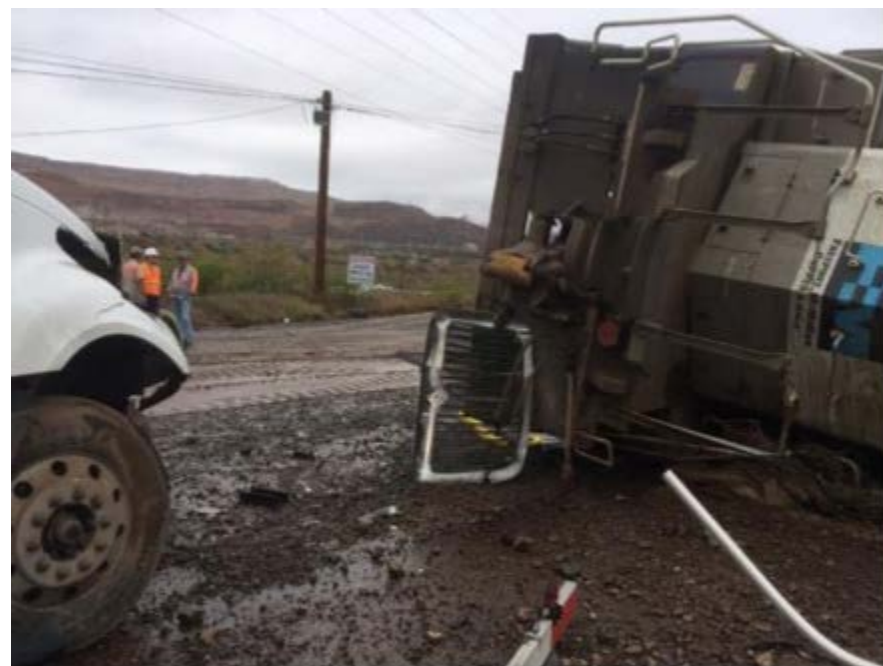
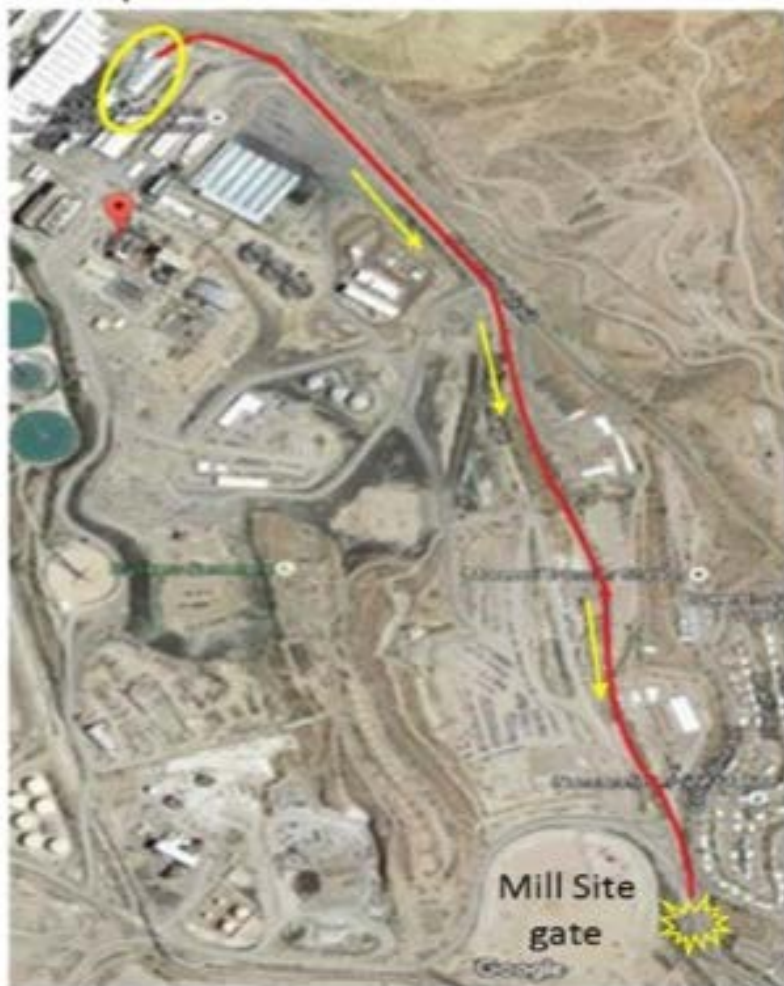
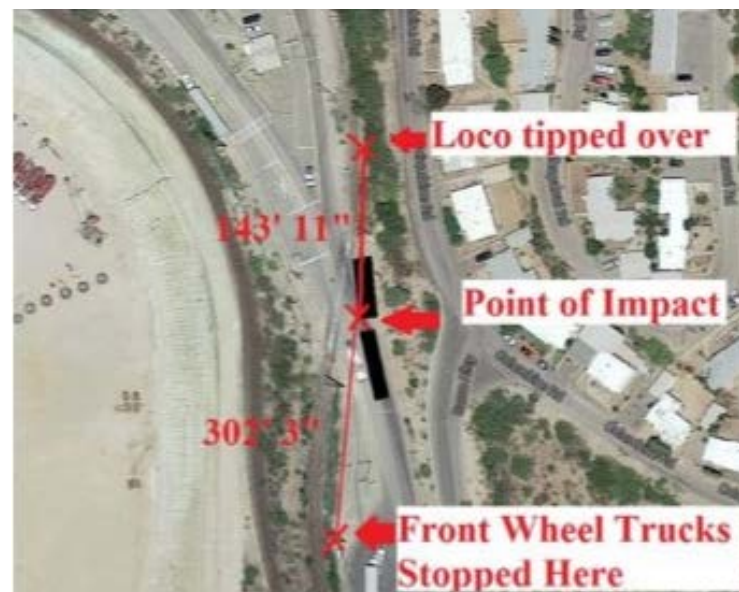
# Morenci Runaway Locomotive

A locomotive pulled out of the repair bay approximately 100 yards to be returned into service after preventative maintenance. As the locomotive was approaching an area where the tracks descend on a 3% grade, the engineer noticed the brakes were not functional. Engineer asked the groundsman walking beside the locomotive to check the position of the brake pistons. It was identified the brakes were not engaged and the locomotive continued to gain speed. He further attempted to stop the locomotive with the emergency and dynamic brakes. When the operator realized he had lost control of the locomotive, he called a Mayday on the radio and dismounted off the stairway.

The locomotive traveled approximately half a mile gaining speed towards the railroad crossing at the mill site security gate, where traffic and delivery trucks enter/exit the property. When the locomotive reached a curve near the truck crossing the weight and momentum caused the locomotive the lay over on its left side. It slid approximately 130 feet and impacted a semi-tractor that was stopped at the crossing waiting to enter the mine in the inbound lane. The locomotive's trucks separated from the body when it laid on its side. The leading locomotive-truck rolled approximately 300 feet until it impacted a metal power pole, where it came to a stop. Another semi coming on property had just crossed the tracks.

Initial investigation revealed the air for the braking system was not valved in after maintenance was performed and this was not identified during the pre-shift examination. The sole injury was a sprain/strain experienced by the semi-truck operator.

Post equipment check for placing equipment back in service  
Placement of derailleurs
