THE POWER OF COPPER

February Contractor Safety Meeting

2-13-24

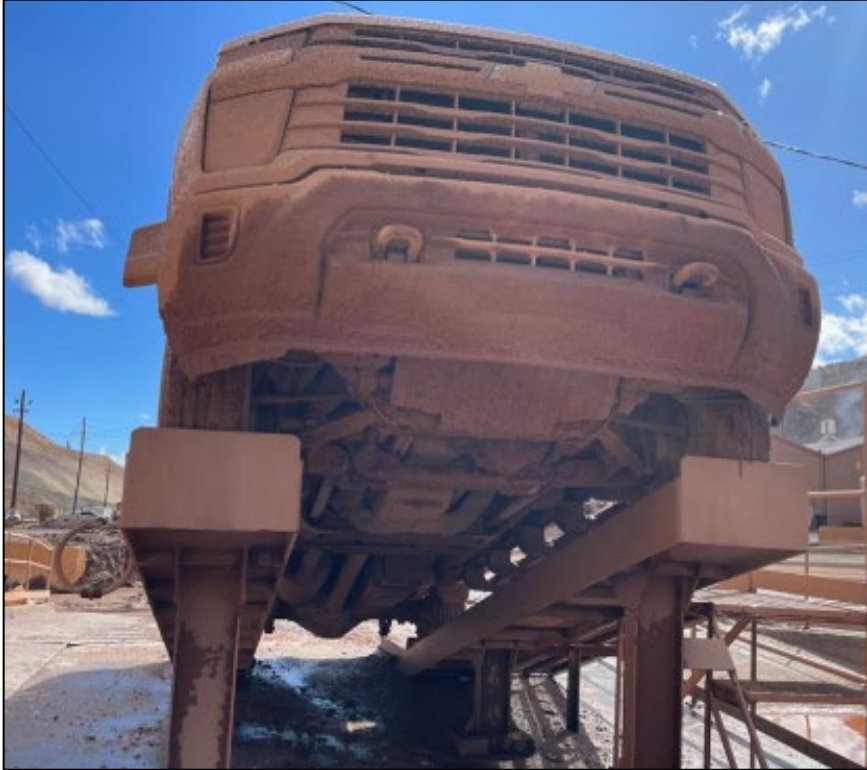
Came out of mine and my NEW truck had trouble shifting into reverse. Hosed truck from bottom up- all good now,. RW garage posted pics for Morenci Morning Check In requesting regular cleaning of undercarriage. FYI- that mud hardens like concrete and can play havoc with park brakes and gear linkage.

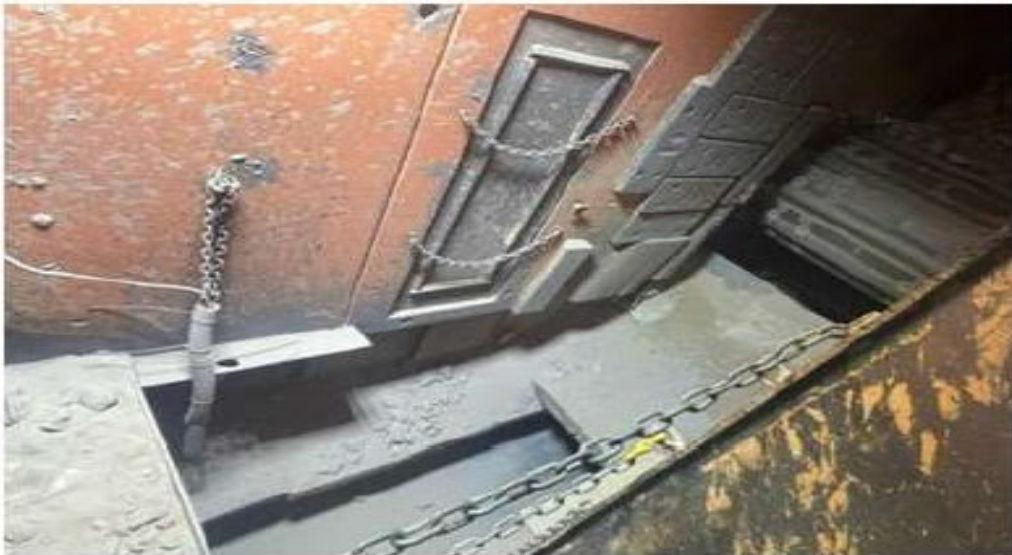
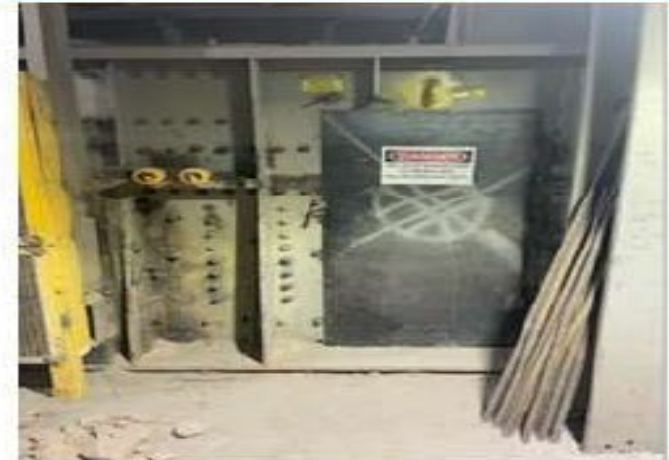
Fatal Risk – 32B Confined Space 10-3-2023

- 32B belt was overloaded at 2:43 AM, job was turned over to dayshift
- Confined space paperwork and ECC was started
- An employee was found to be inside the confined space without the completion permit paperwork or attendant in place

- Training was outdated for the employee involved
- Planning and execution of work failed to define clear roles & establish leaders
- Fill-in supervisors not aware of responsibilities

- Build onboarding and selection process for fill-in supervisors
- Formalize training/transfer process to ensure employees have required training before starting work
- Create work instructions for routine jobs that have a fatal risk

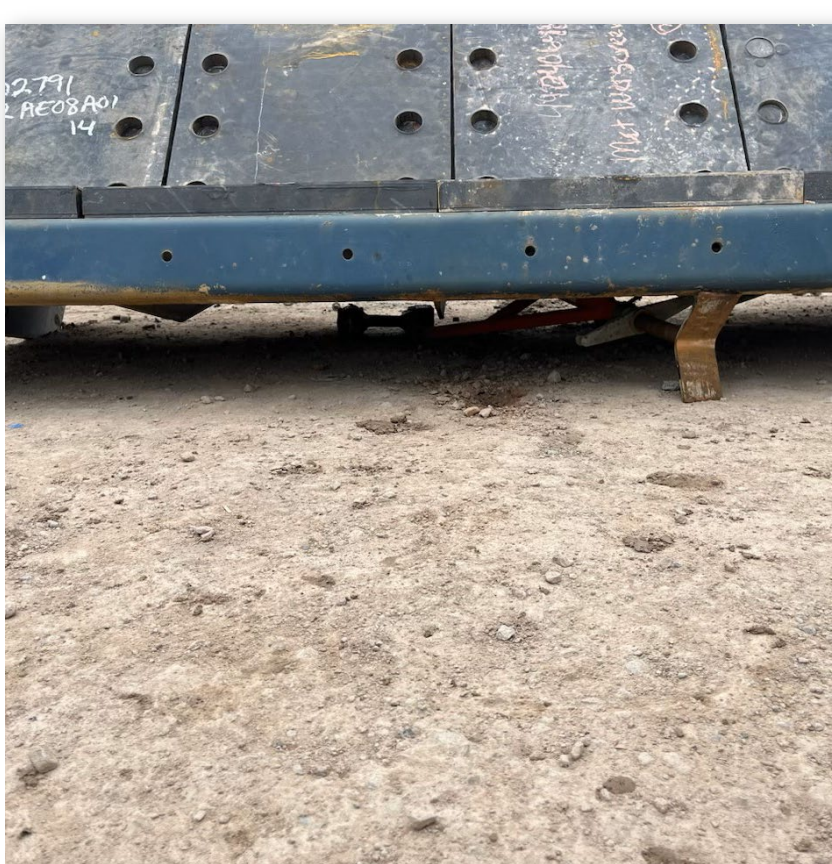
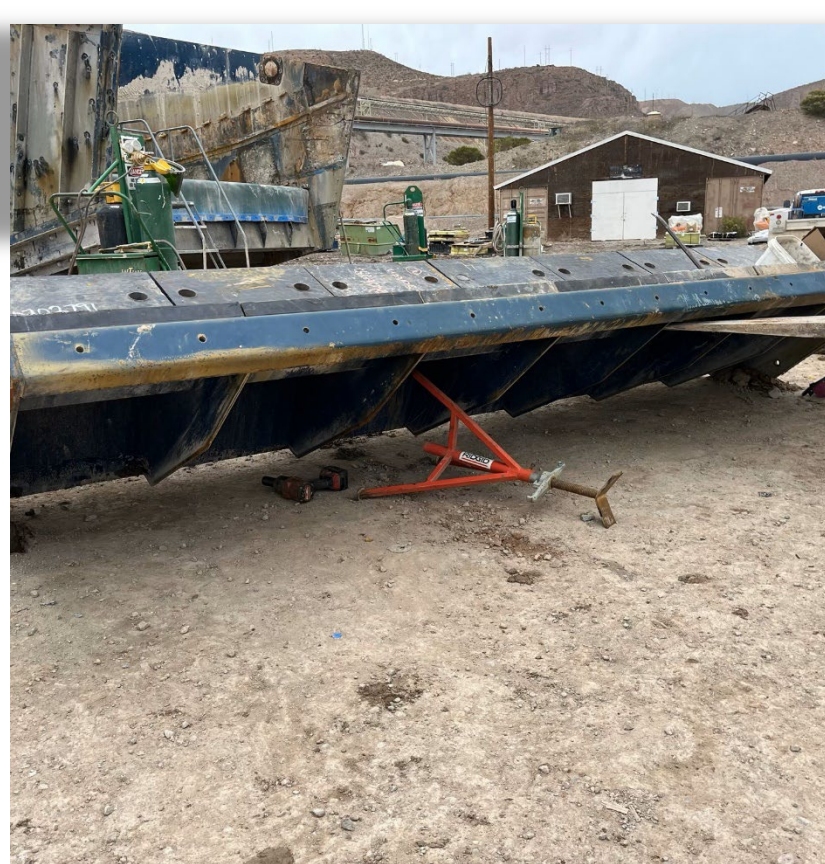
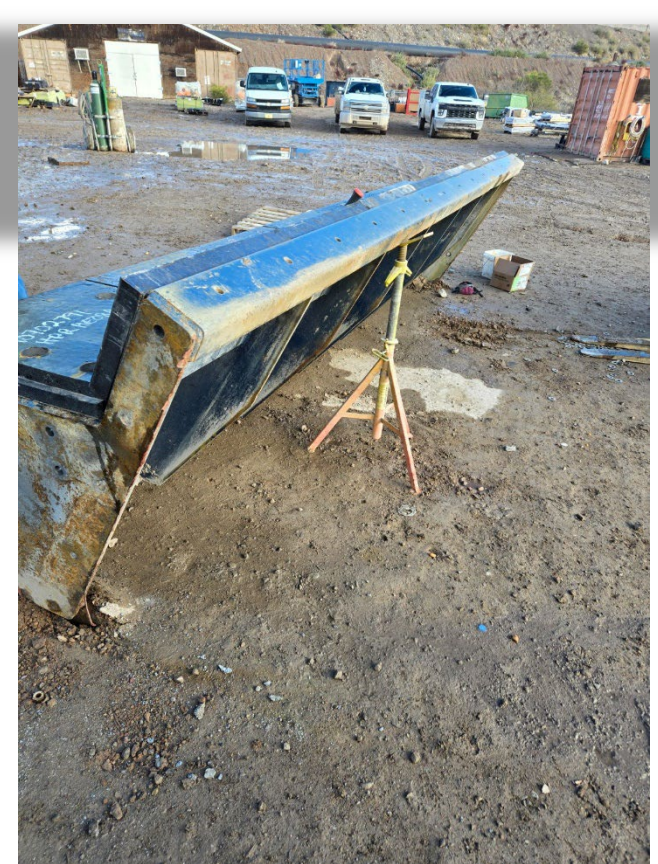
Upper Feed Box Incident

Employees were working on rebuilding the wet screen. One of the task is to install new liners on upper feed box. As employee was installing bolts on the back side of the feedbox the jack stand fell, causing the feed box to tipped backwards smashing jack stand and employees left side of his lower body.

After Further investigation jack stand was not installed in proper location to keep feedbox from tipping backwards. Blanket JSA was created, not for specific task of relining the upper feedbox.

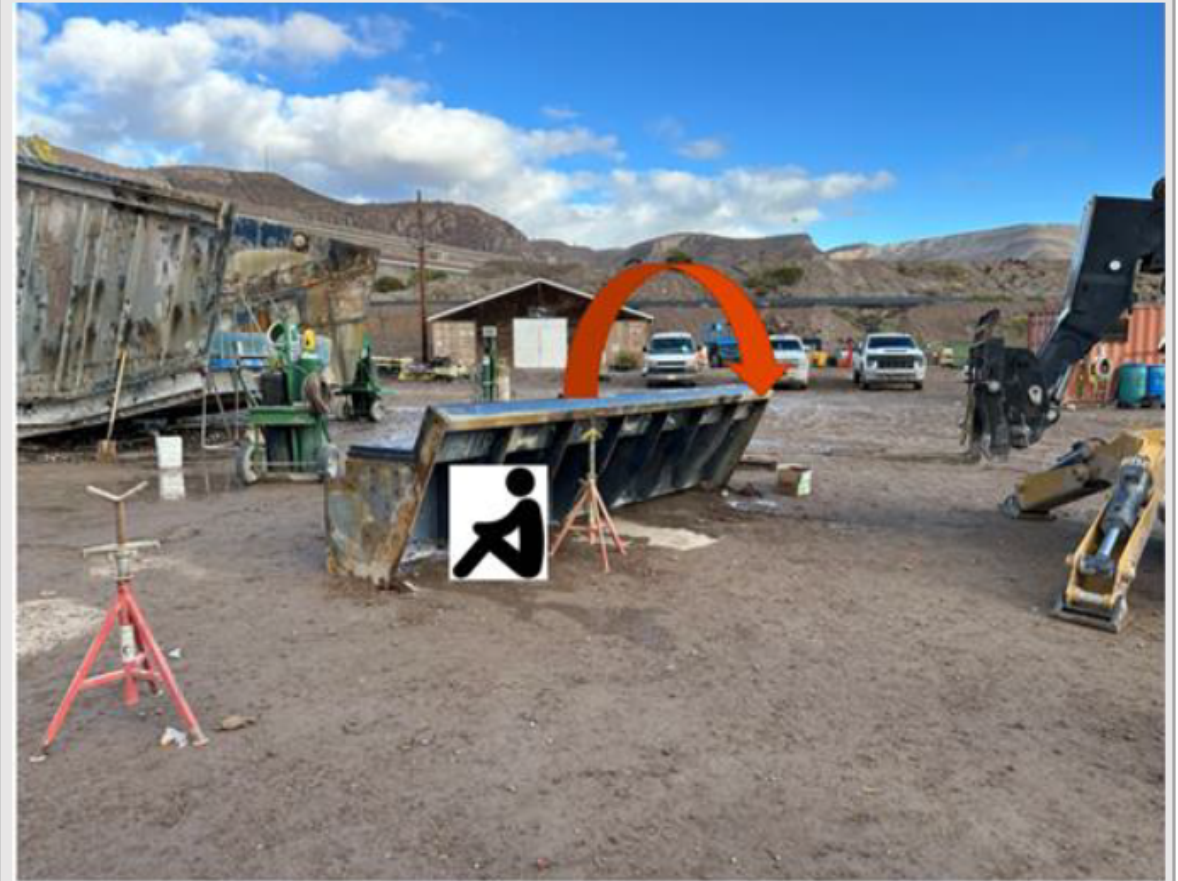
Position of employee, placement of pipe stands and direction the feed box tipped.

- Method – set-up is common practice for ground repairs
- Balance can become unstable as liners are installed- this is why pipe jack is used.
- JRA was for Screen repair- energy dynamics changed as job scope changed
- Pipe jack was not properly set up- potential slack in adjustment or saddle not placed properly
- Low experience
- Work instruction is for feedbox repair while mounted on screen

- Risk assessment
- Rigging ineffective – insufficient cribbing
- Routine work – no yellow flags
- Work instruction-SOP
- Lack of feedback process for JRA

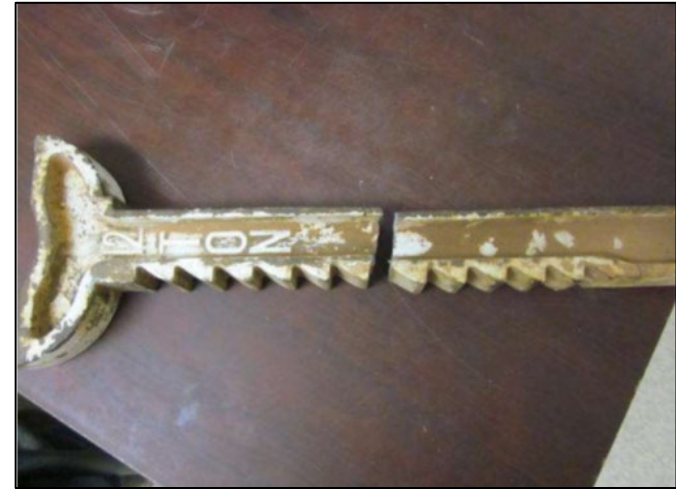
The PFE occurred when a 12 ton jack stand broke in half after weight placed on jacks exceeded capacity of jack stand and the jack stands were improperly used (side loaded). The Morenci light duty garage was targeted for inspection as a primary user of jack stands.

- Visual inspections identified several defective stands/ removed from service.
- MPT testing discovered conditions such as incomplete penetration, overlap, undercutting of welds plus cracking on support structures.
- Chinese stands were discovered to be defective (at a ratio of about 2 to 1).
- ASME PALD Standard 2009, American Society of Mechanical Engineers / Portable Automotive Lifting Devices. Requires jack stands to meet 200% of advertised load capacity for a specified time without impacting function or components. Performance requirements have evolved from 125% to the current 200% of advertised capacity.

- Inventory jacks stands and other secondary blocking apparatus in shop
- Inspect and audit items on inventory monthly.
- Commission Reliability Centered Maintenance services to perform Magnesium Particle Testing to test stands for structural defects where visual inspection would be unable to detect.
- Provide training/ refresher training for use of jack stands and importance of knowing weights of equipment being lifted or supported
- Require field examinations of blocking apparatus before each use.
- Work with Globe sourcing to ensure jack stands are no longer purchased when manufactured in China. Develop process to purchase stands made in America.

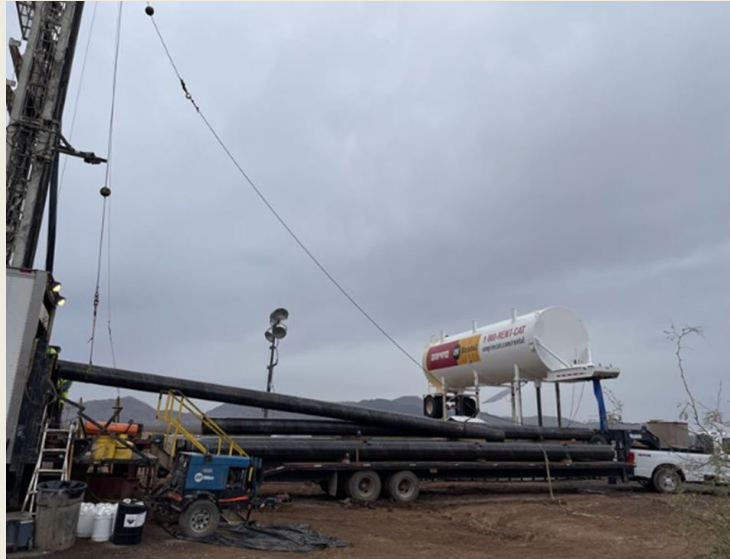
<p><i>The drill rig cables used during the pipe installation process.</i></p>

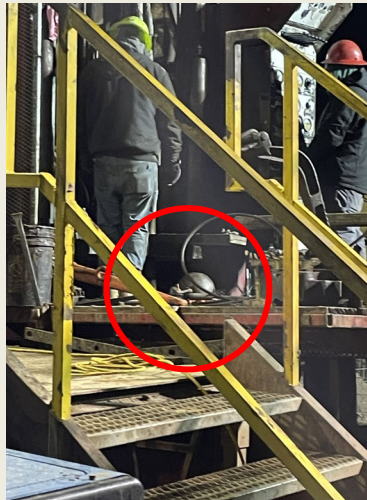
<p>Discovered Sheave on top of mast was pinching auxiliary line</p> <p><i>Circled in red is the 100-pound steel ball that fell 13 feet to the drilling platform where two contractor employees had been working.</i></p>

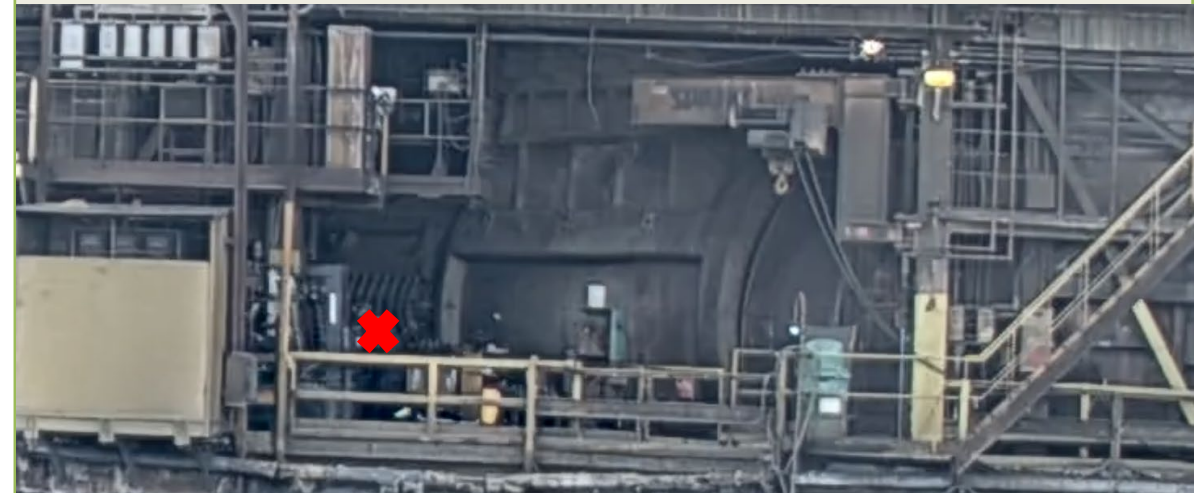
The red X marks where the forklift struck the employee.

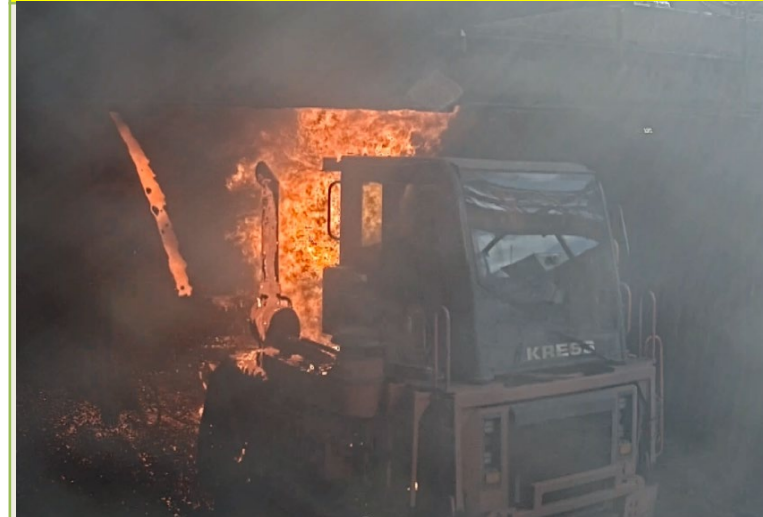
The slag hauler caught fire after molten material flowed onto it.

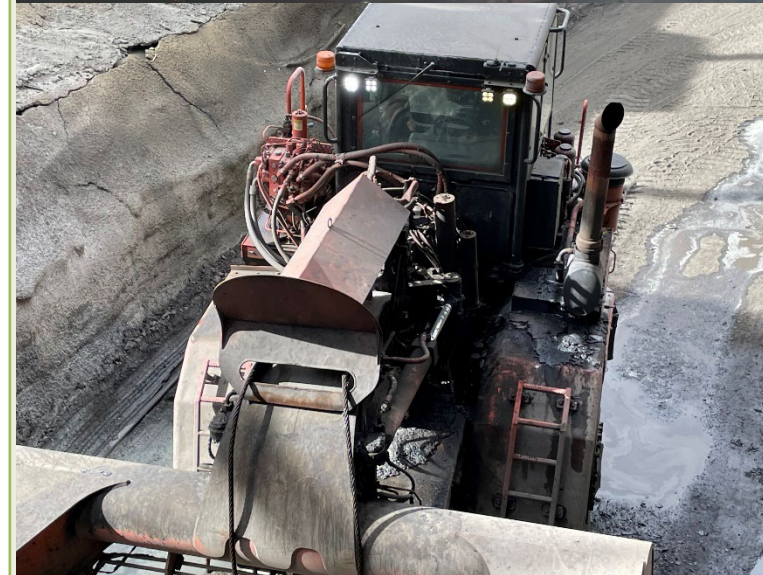
Damage to the slag hauler.

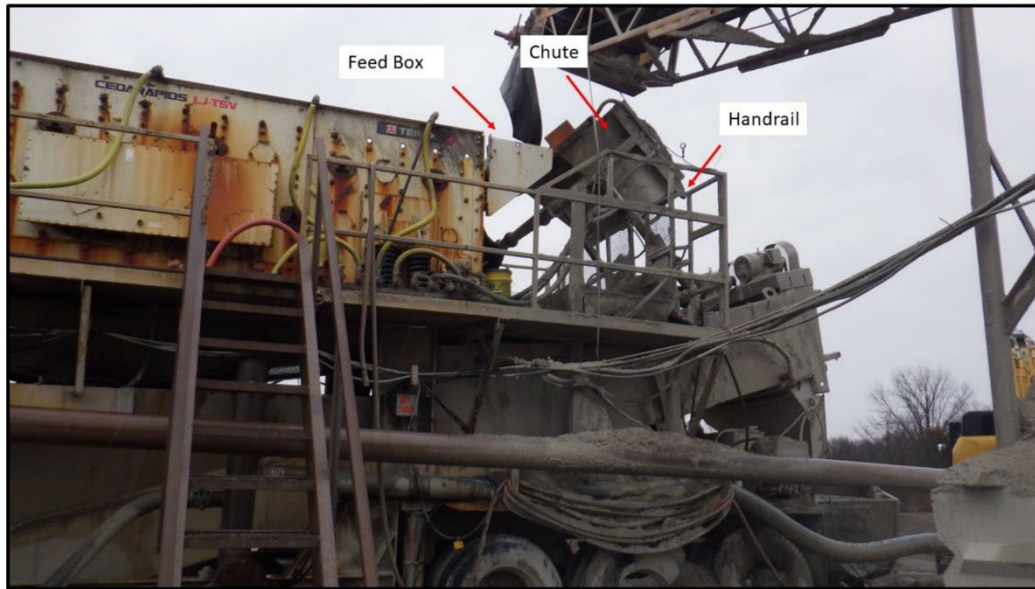
MSHA Fatality Alert – Bison No.1

MINE FATALITY – On December 14, 2023, a miner died while preparing to repair flanges on the feed box. In the process of lowering the chute into the maintenance position, the chute pinned the miner between the chute and the handrail.

- Block machinery components against motion before beginning maintenance or repairs and verify miners are in a safe location before moving equipment and components.
- Examine work areas during the shift for hazards that could be created while performing the work.
- When conducting a non-routine task, review safe procedures before starting work and ensure all safety components are in place.
- Do not work under suspended loads.

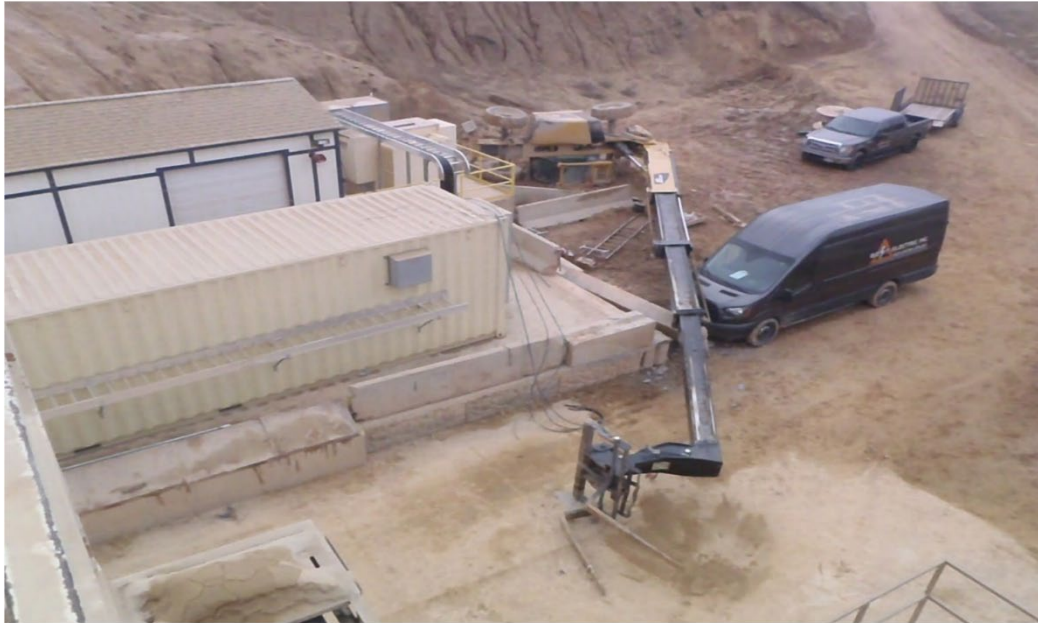
MSHA Fatality Alert – Beck Street

MINE FATALITY – On December 14, 2023, a contractor died while delivering parts to the mine when an all-terrain telehandler pulling cable, tipped over, striking him.

- Do not exceed the load radius and load limits of lifting equipment.
- Ensure miners position themselves in a safe manner while working around equipment.
- Barricade and sign affected areas in case equipment or loads fail or tip.
- Ensure visitors entering the mine receive site specific hazard awareness training.
- Maintain good communication between co-workers.
