Contractor Safety Meeting
October 10, 2023

Morenci Mine

Potential Fatal Event: Employee Struck by Light Vehicle

High-Risk: Swivel Lifting Eye Failure

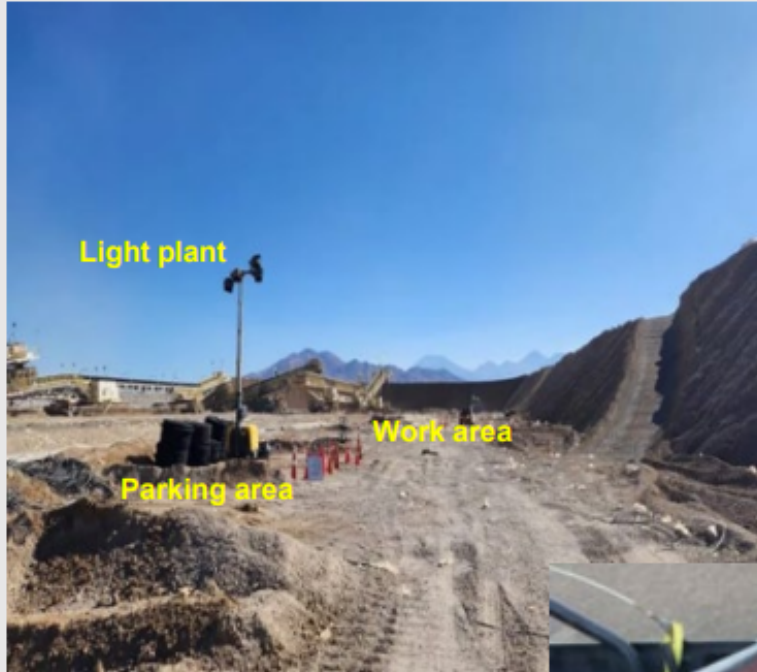
View of incident area.

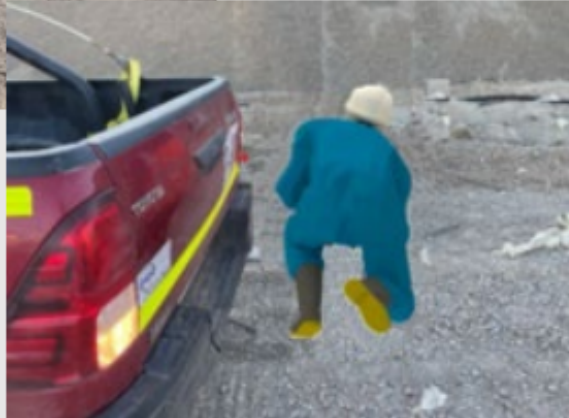
Position of injured employee

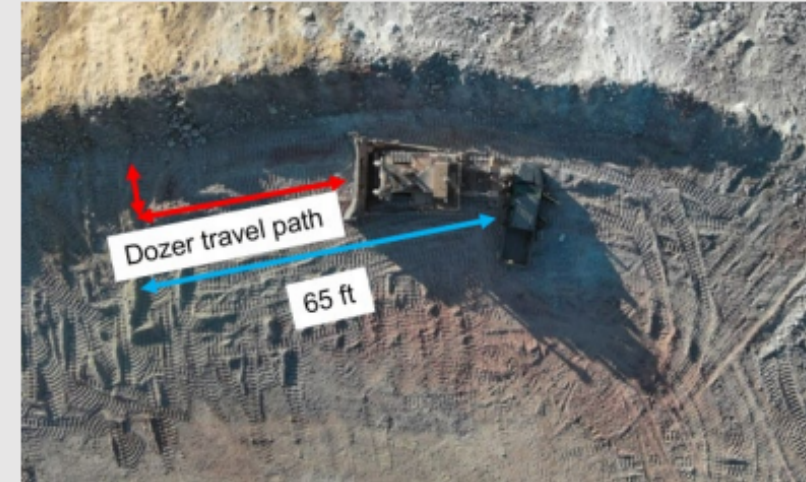
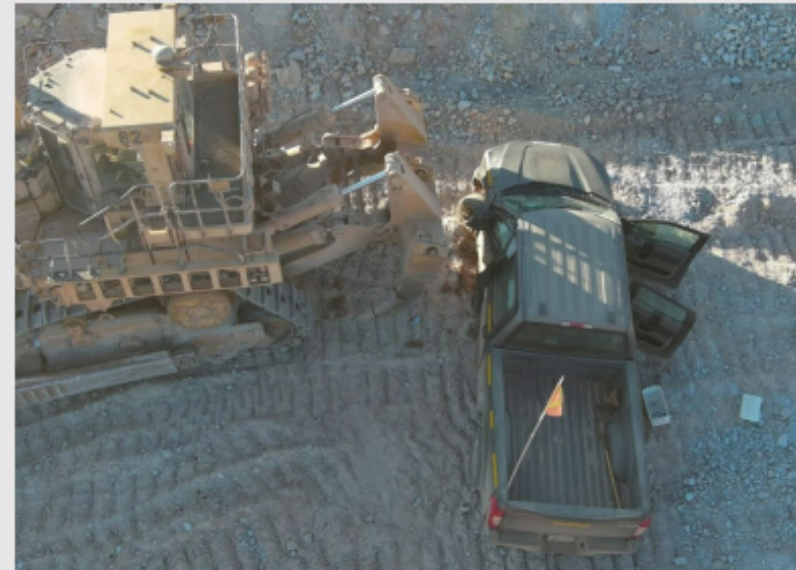
Operation	Morenci
Date / Time	September 6, 2023 / 4:05 p.m.
Type	Injury
Summary	<p>A dozer operator trainee was pushing material to maintain appropriate berm height at a dump. The support equipment lead and dozer mentor pulled up to the dump face in a light vehicle to inspect the berm height. The dozer operator trainee was about 65 feet away and started to back up. The support equipment lead noticed the trainee was headed towards the LV and not stopping. The lead tried to put the LV in reverse. The dozer trainee felt resistance while backing up and discovered they had contacted the LV.</p>
Fatal Risk	Vehicle Collision and Roll Over
Risk Category	Actionable
Risk Rating	Significant (3) Likely (3)
Absent / Insufficient Controls	<ul style="list-style-type: none">Failed to make positive communicationApproaching and parking in the blind spot of heavy equipment
Applicable Policies / Procedures	<ul style="list-style-type: none">FCX – 23 Interaction with Heavy Mobile Equipment

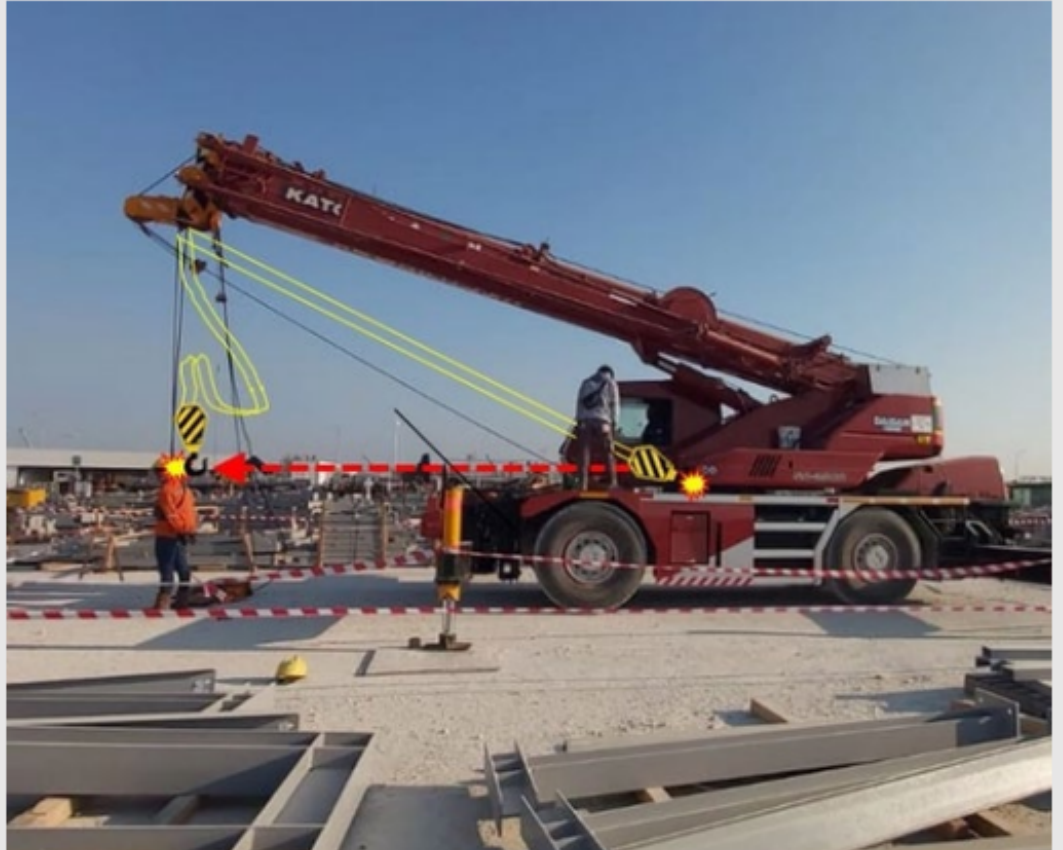
Operation	Manyar Smelter Project
Date / Time	September 3, 2023 / 8:35 a.m.
Type	Injury
Summary	<p>A contractor crew was preparing a crane for operations. The main hook was secured using a makeshift shackle. The operator began to raise the boom, which caused the shackle to break. A spotter in the line of fire was struck on the left side of the head by the crane hook.</p>
Fatal Risk	Falling Objects
Risk Category	Monitor
Pre / Post Rating	Significant (3) Possible (2)
Findings / Missing Controls	<ul style="list-style-type: none">• Employee position (line of fire)• Missing barricading/segregation• Sub-standard equipment modification
Applicable Policies / Procedures	<ul style="list-style-type: none">• Flagging and Barricading
Employee Condition	The employee sustained head trauma that required multiple surgeries. Currently hospitalized and recovering.
Contact	Zach Scrivner, Manager-Corporate Project Engineering Safety

Illustration of crane hook movement when shackle broke

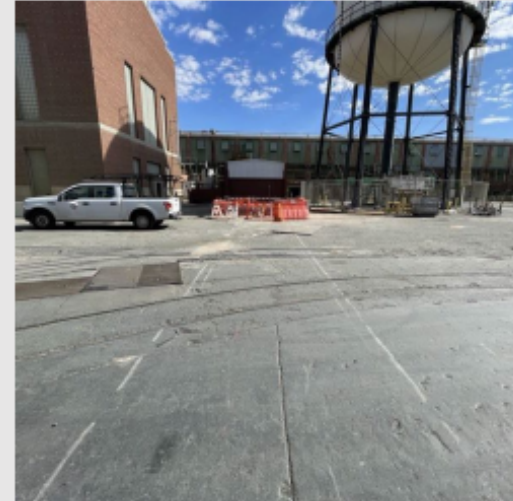
Area marked for excavation; not all utilities marked with correct color

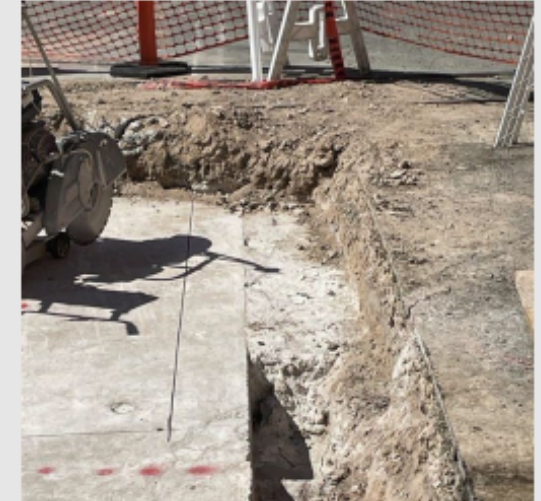
Excavation made outside of white paint

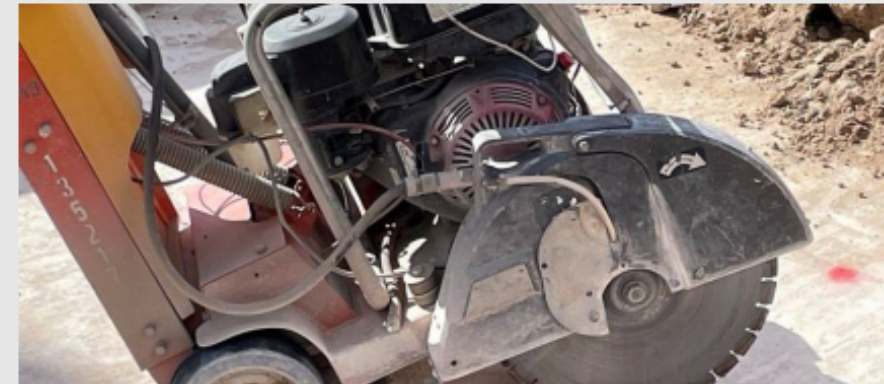
Saw used to make cut into concrete

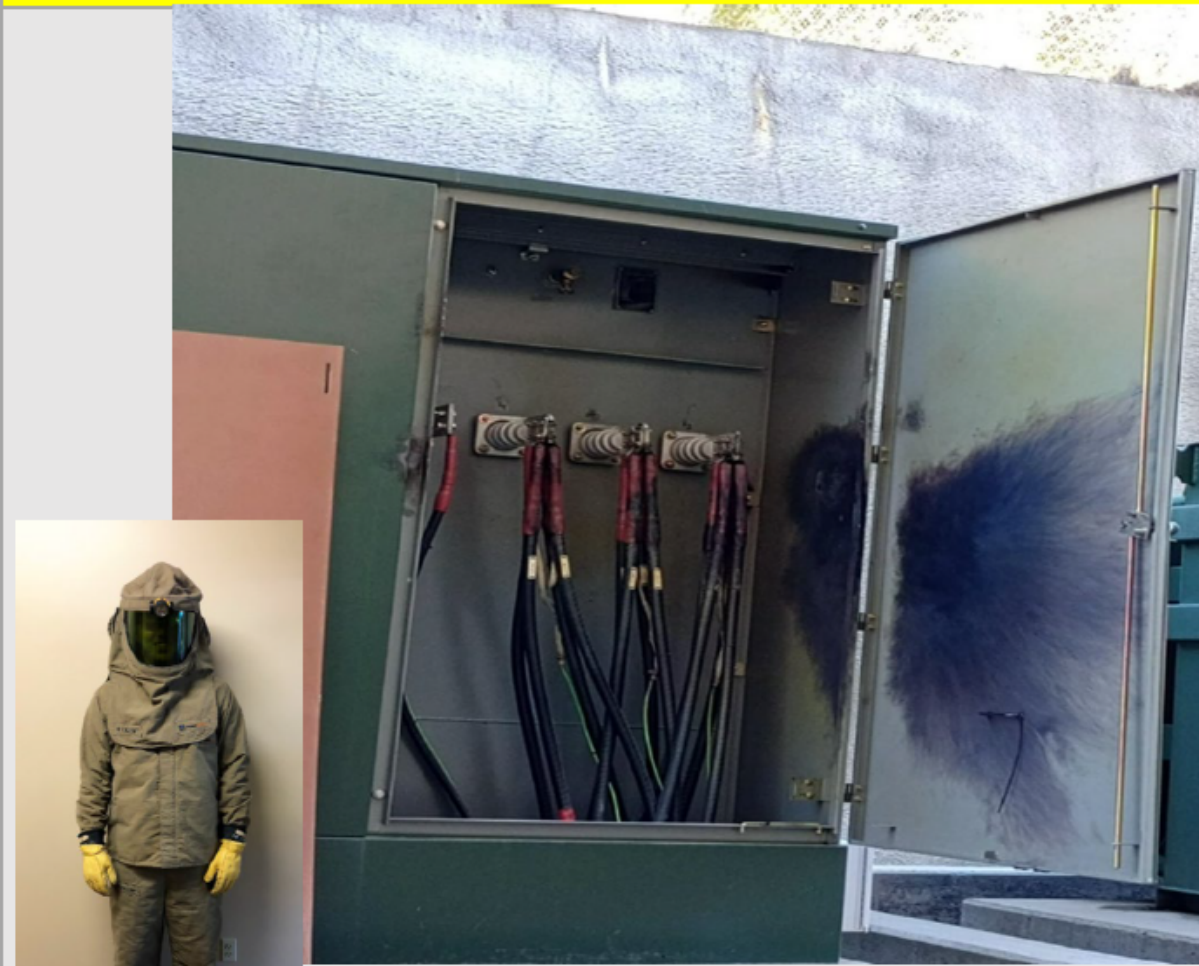
Operation	Climax
Date / Time	September 30, 2023 / 8:10 a.m.
Type	Injury
Summary	<p>Two electrical subcontractors involved in rerouting a power line for the new water treatment plant under construction at Climax were preparing to check the phase rotation of a 4160-volt transformer that had not been de-energized. When they attempted to attach the meter, an arc flash occurred.</p> <p>The workers were not wearing the proper PPE, and both sustained burns to the face. One was treated at the hospital and released while the other was hospitalized with second-degree burns.</p>
Fatal Risk	Exposure to Electrical Hazards
Risk Category	Monitor
Pre / Post Rating	Significant (3) Possible (2)
Findings / Missing Controls	<ul style="list-style-type: none">Contractors were not using appropriate PPEInstrumentation was rated for 600 volts
Applicable Policies / Procedures	FCX-HS03 Electrical Safety Policy
Employee Condition	Both workers sustained first- and second-degree burns to the face.

At left: Proper PPE required for the job (not worn during the incident)

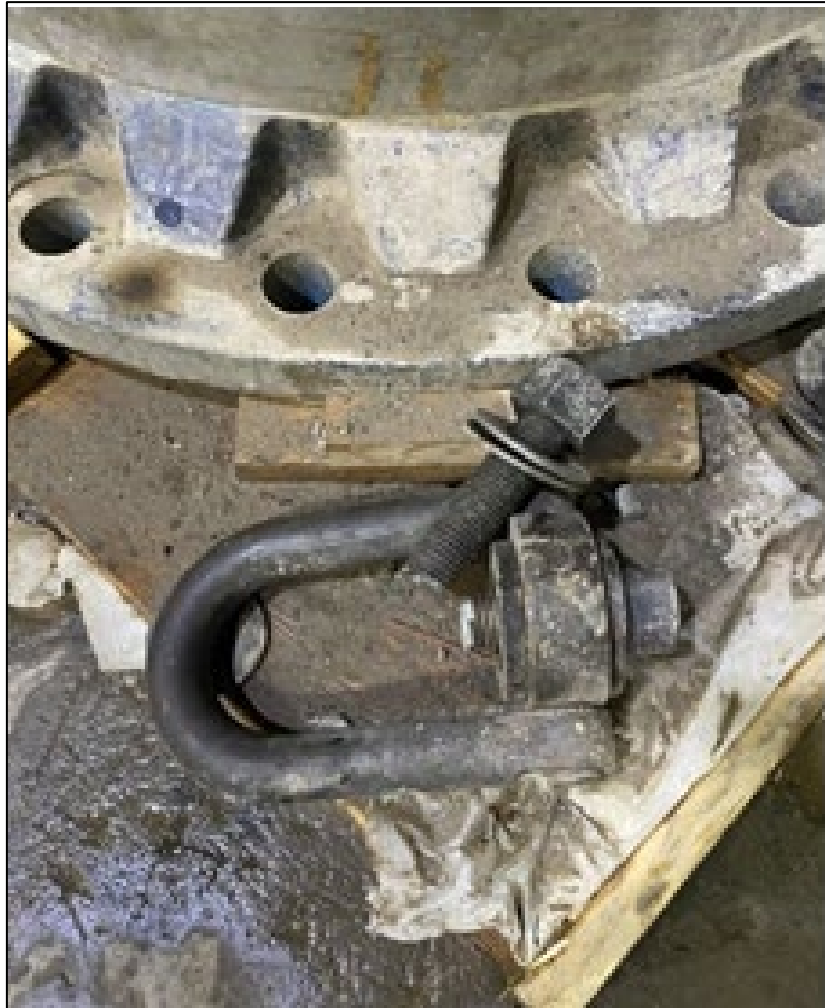
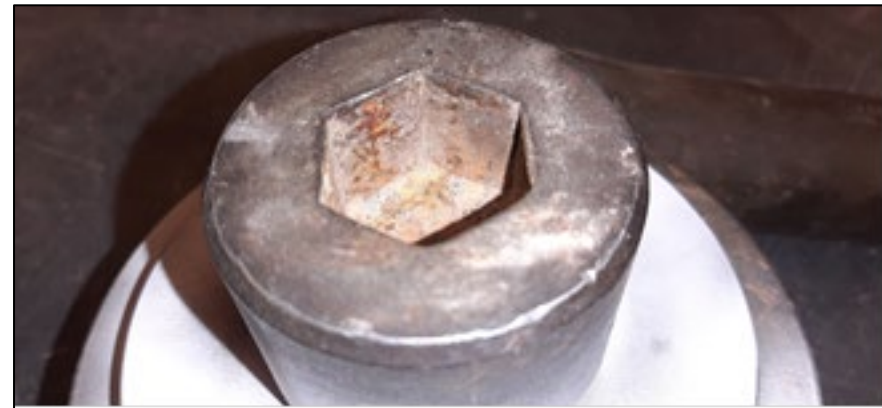
While lifting the discharge end of the ball mill in the west repair bay Morenci Concentrator, the lifting eye failed causing the discharge end of the ball mill to fall to the ground. It was approximately 3.5' in the air when it fell. The employees state they were a safe distance from the load, no one was in the line of fire. When it fell to the ground, there was damage to one of the liner bolts on the piece discharge end of the ball mill. Employees reported to day shift supervisor close to shift change.

Analysis: This lifting eye failed due to improper use and installation. There is no evidence or markings that this hoist ring was torqued to the proper spec. The threaded shank of the bolt is bent with a brittle fracture. There is also evidence of a pipe wrench being used to tighten the bolt from the teeth marks on the side of the head of the bolt.

- RCM tested inventory of lifting devices at West Repair bay
- (NDT) using eddy current and visual methods.
- Place this action on a recurring work order 28 days
- inventorying critical lifting devices that require scheduled NDT inspections
- Develop work standard on lifting operations of feed/discharge end maintenance
- Train on Hy-Torque Impact wrench

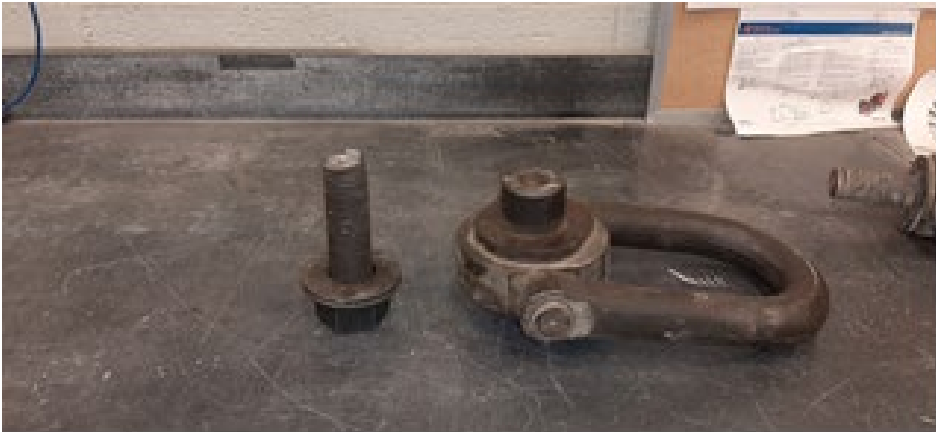
High-Risk: Swivel Lifting Eye Failure

- Could not determine who installed lifting device
- Bolts on swivel eyes are installed in different orientations
- Practice: Bolts are not torqued to spec by FMI or contractors
- JRA did call out Lifting Operations and rigging
