Monthly Contractor Safety Meeting

March 12, 2019

Meeting Agenda

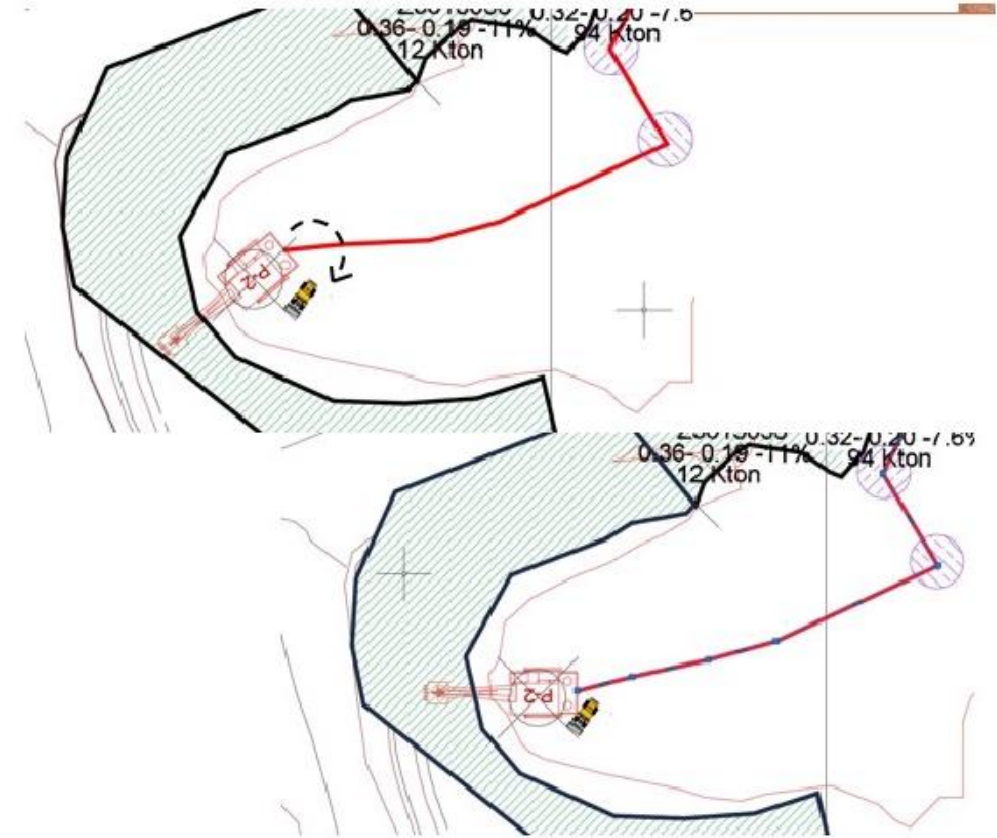
PFE – 2019-1

DESCRIPTION / DETAILS OF ADVISORY	
<p>Summary: A rubber tire dozer operator was struck by the counterweight of a shovel after entering the swing radius to remove an oversized rock.</p> <p>Description: A rubber tire dozer operator entered the swing radius of a 4100 shovel on the blind side to remove an oversized rock. When the shovel moved to load a haul truck, the left side of the counterweight struck the right side of the dozer cab, damaging the handrails, mirrors and windshields. The dozer operator immediately moved the vehicle out of the swing radius and reported the event to the Supervisor. The operator was not injured.</p>	
FATAL RISKS	
Vehicle Collision	N/A
OTHER SIGNIFICANT RISK (specific to site or task not categorized as global)	
N/A	
ABSENT / INSUFFICIENT CONTROLS CONTRIBUTING TO THE EVENT	
<ul style="list-style-type: none"> Failure to follow procedures for entering the shovel swing radius / request authorization to enter and remove the rock

Top diagram – the position of the dozer to the shovel and the clockwise movement of the shovel.

Bottom diagram – the location of the shovel and dozer after impact.

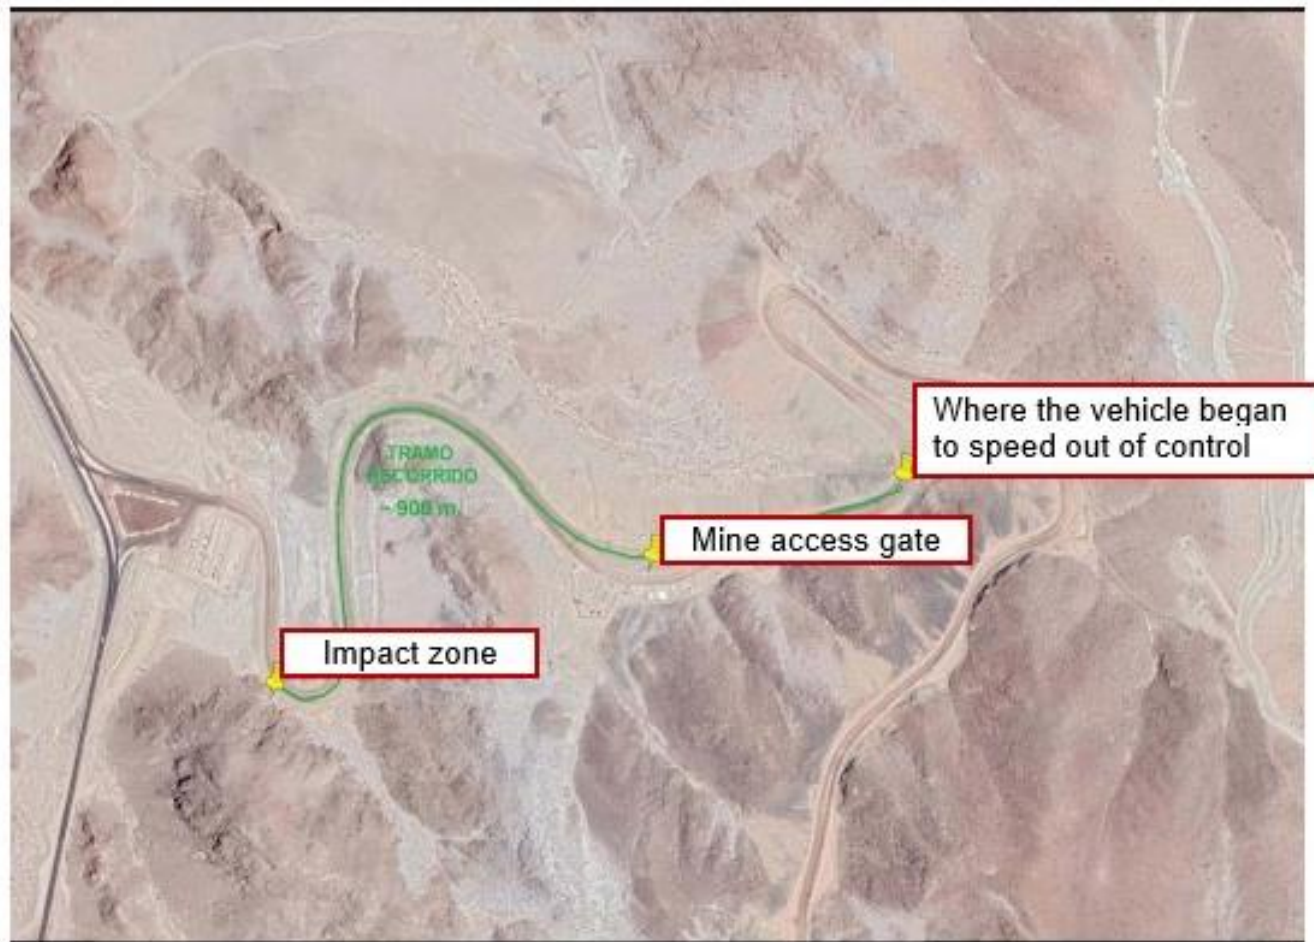
PFE – 2019-2

DESCRIPTION / DETAILS OF ADVISORY	
<p>Summary: Two sewage contractor employees were injured when their sewage truck sped out of control, went over a safety berm and rolled on to its right side.</p> <p>Description: Two sewage contractor employees were approximately 265 meters (869 feet) from the mine access gate when their sewage truck began to speed out of control. The truck drove through the gate and hit a plastic jersey barrier without stopping. It continued to pick up speed, traveling downhill approximately 900 meters (3,000 feet) before crossing into the opposite lane of traffic at a curve in the road. It then went over the safety berm (more than three-quarters the height of the truck tire), rolled on to its right side and slid approximately 9 meters (30 feet) before stopping.</p> <p>Each employee was wearing a seat belt. Both sustained injuries but were able to exit the vehicle without assistance. The vehicle was sent for full inspection. An investigation currently is underway.</p>

The sewage truck's route during the incident.

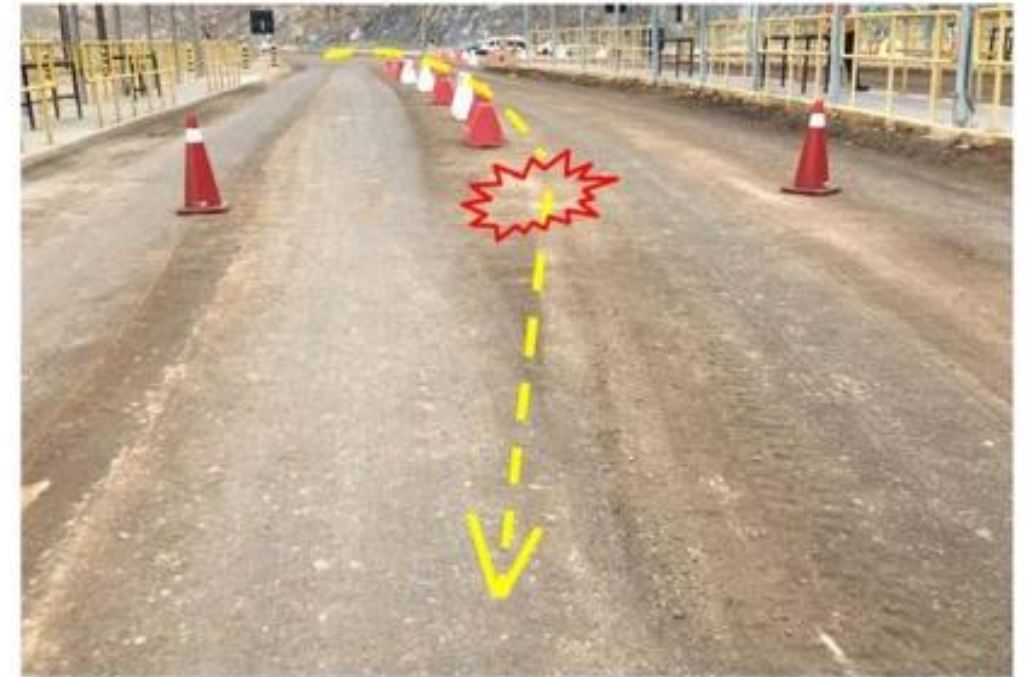
The dotted yellow line shows the path of the truck through the mine access gate. The red starburst is where it hit a plastic jersey barrier without stopping.

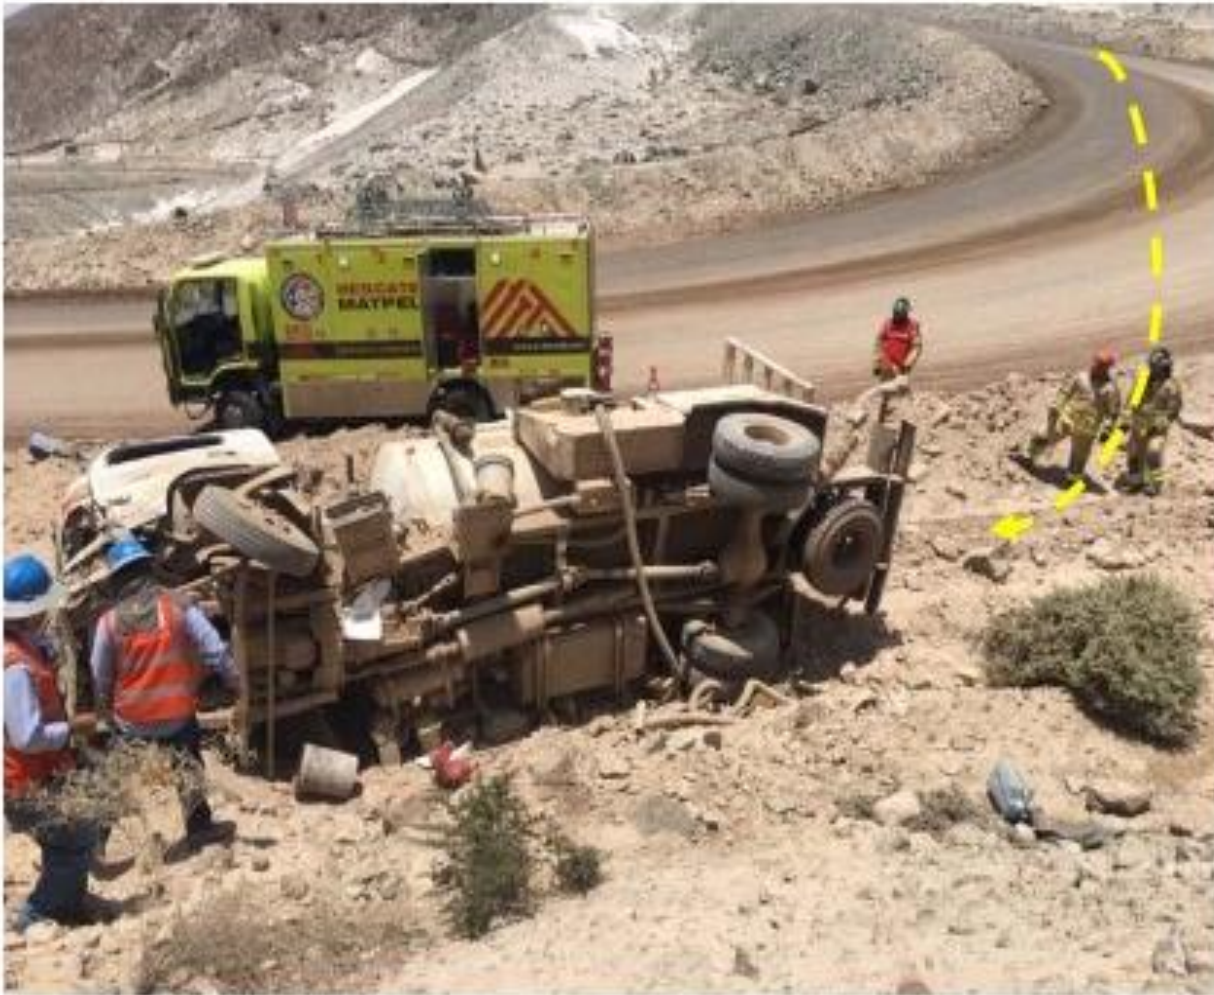
PFE - 2019-2

The dotted yellow line shows the path of the truck around the curve.

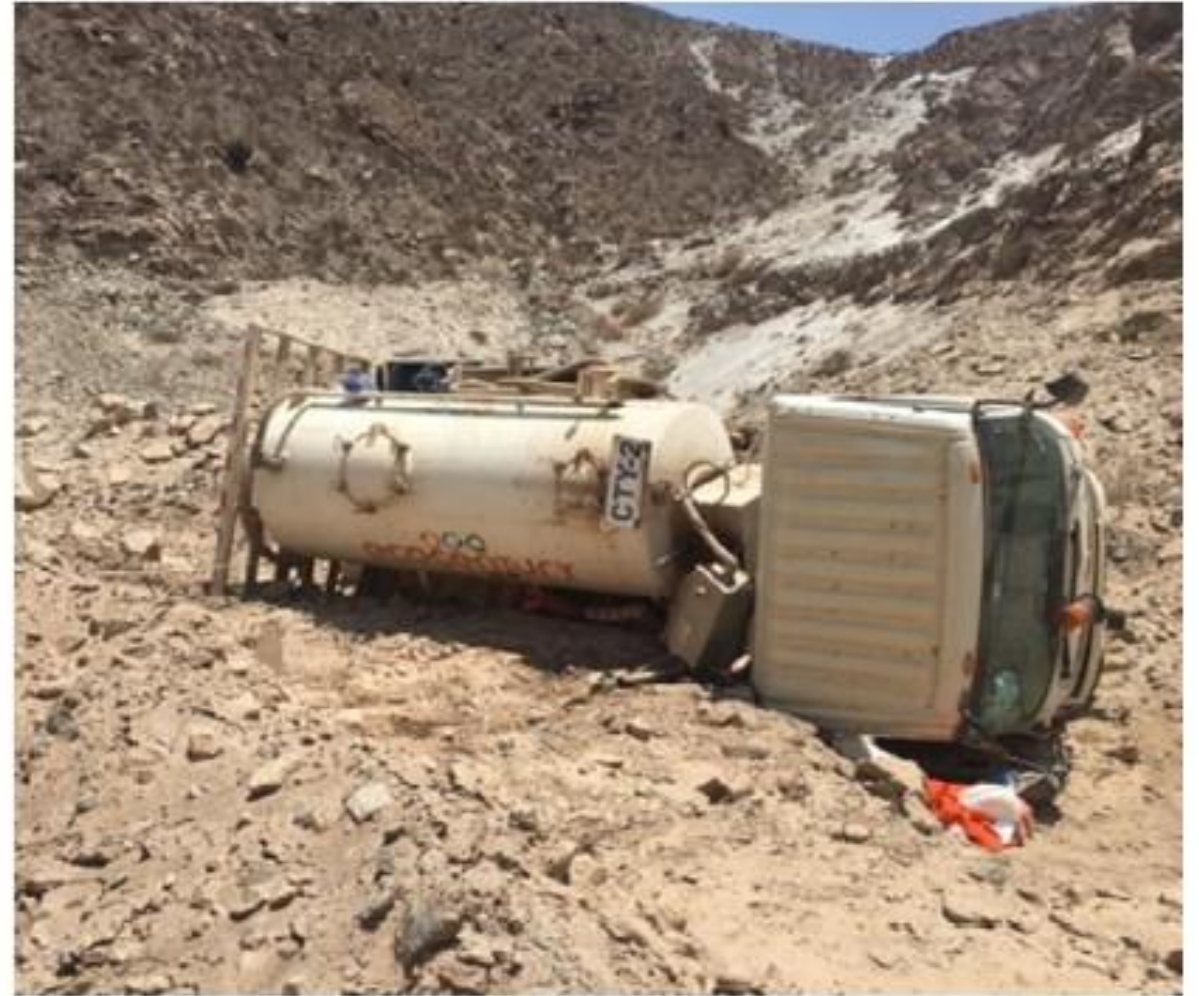
Final position of the sewage truck.

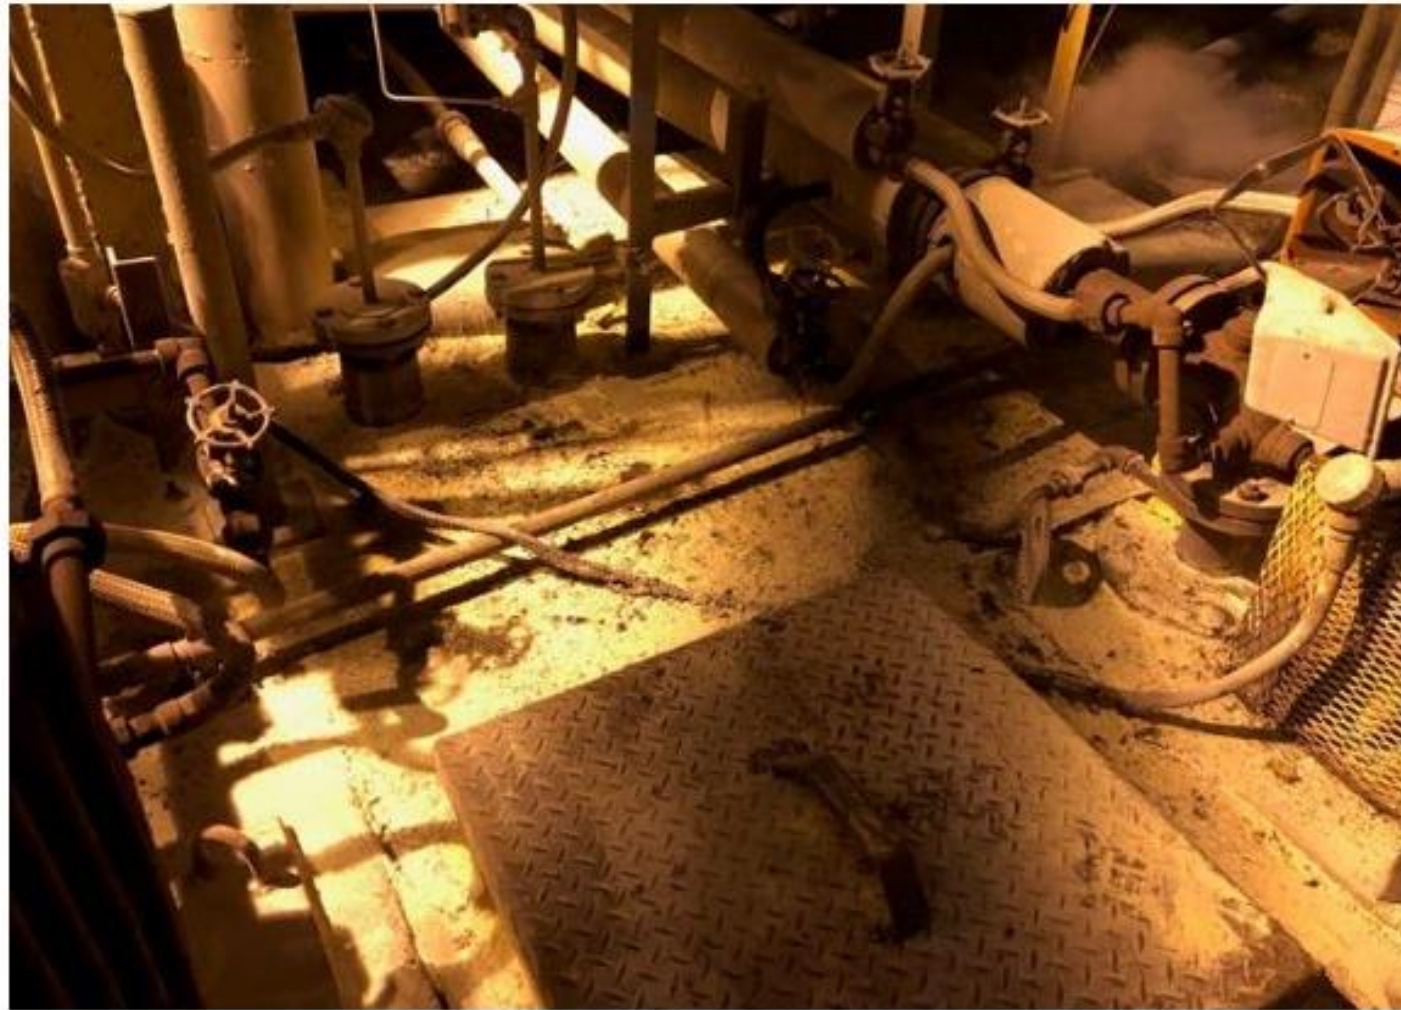
- Pyrophoric iron ignition leading to sustained sulfur fire – based on employee accounts of shallow, blue, sparky flames and fairly clear combustion gas, it was determined that the fire was sustained by the presence of elemental sulfur. Pyrophoric iron ignition is a common cause of fires within refinery and sulfur systems. See Supporting Documentation section for more information.

Burned power cables to the sulfur pumps.

- Put out fires using extinguishers and steam.
- Stopped roaster feed throughout the day and night while sulfur pit fires continued – spotter monitored fires overnight.
- Shut down acid plant for heat conservation purposes – outside ambient temperature was below freezing point.
- Replaced burned cables and restarted acid plant.

- Install steam piping in small sulfur pit (steam snuffing system)
 - Similar to the existing installations in the large sulfur pit and the sulfur tank
- Review construction materials for the small sulfur pit pump platform
 - If the materials are carbon steel, then replace with stainless steel or add a coating
- Install adequate vent system on small sulfur pit
- Review RCM plan for sulfur furnace feed pumps to increase frequency of seal/bearing inspection so issues are noted early
- Reset expectations around sulfur storage housekeeping
- Request Oxbow assist with conducting an audit of sulfur system in 2019

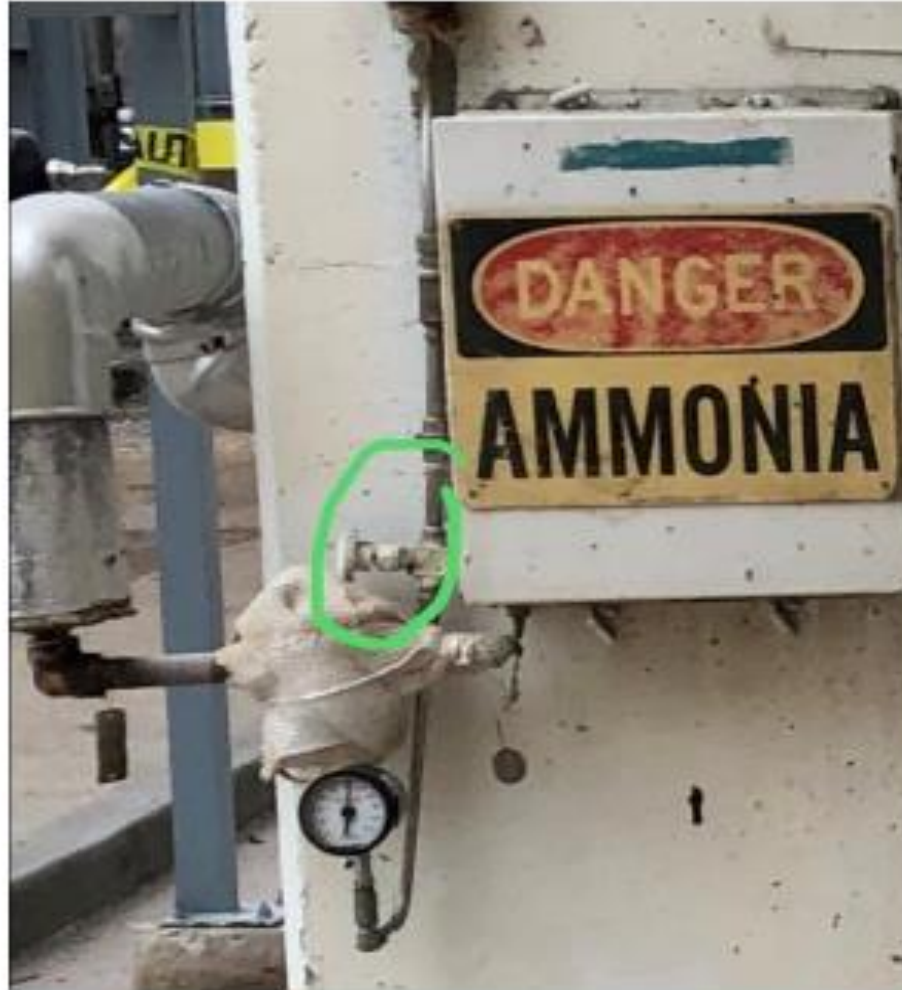
Circled in green is the needle valve that was leaking.

- Activated site wide evacuation
- Notified surrounding businesses and residents of release
- Opened valve to return conditions back to normal – all clear was announced
- Conducted incident debrief immediately after incident
- Conducted Root Cause Analysis
- Fixed needle valve that was leaking once all subject matter experts were on site

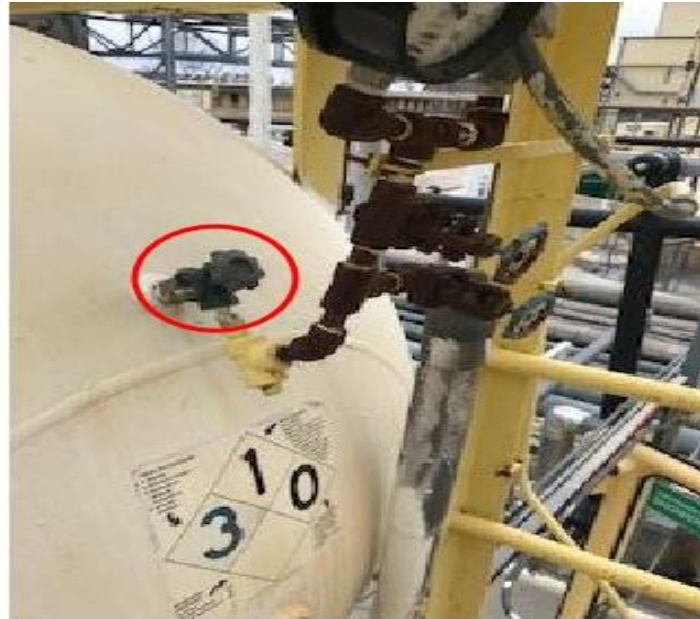
Description: Chemical plant operators closed a valve on the ammonia storage tank in order to make a repair on a leaking needle valve. This isolated the pressure control loop and the high pressure alarm switch, causing the control loop to read zero pressure. As a result, the liquid ammonia control valve opened and excess liquid ammonia flowed into the vaporizer. The tank then became over pressurized, and ammonia vapors came out of two pressure relief valves – one on the vapor line going to the chemical plant and one by the ammonia truck unloading area.

- Lack of knowledge / skill – This job is not performed very often and the procedure that exists is not specific to the task performed.
- Inadequate instructions, orientation and / or training – The Safe Job Procedure for isolating the ammonia tank did not include steps to isolate the needle valve.
- Inadequate identification and evaluation of risks – Consequences of shutting the valve were not clear.
- Inadequate work planning – Subject matter experts on the ammonia system were not consulted.

Circled in red is the closed valve that caused the tank to become over pressurized.

- Update / develop Safe Job Procedures for any work being conducted on Ammonia Storage Tank
- Develop / update training to include valve isolation procedures
- Follow up on conditions that caused the deluge system to delay
- Review other critical systems on site and train employees
- Re-emphasize the obligation to stop the job with employees

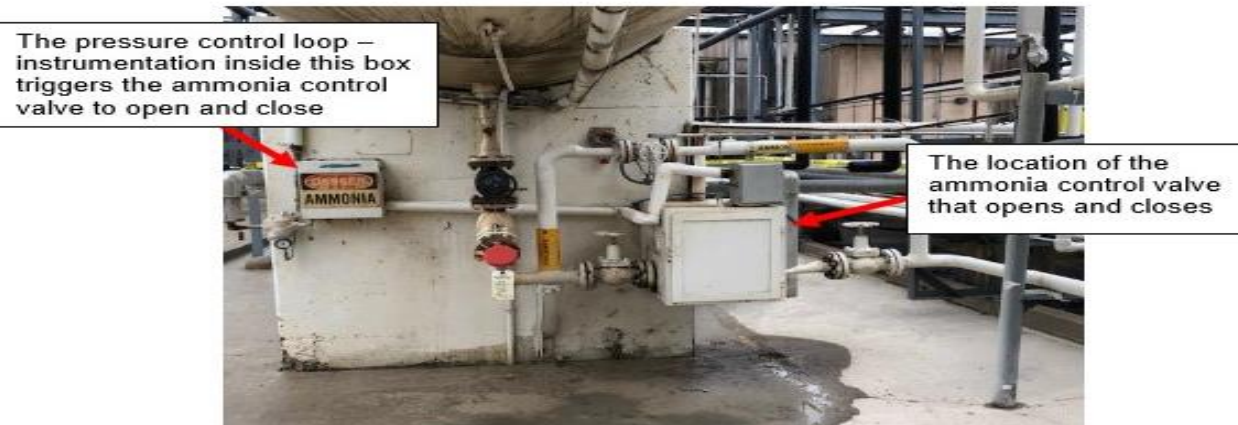
The pressure control loop – instrumentation inside this box triggers the ammonia control valve to open and close

The location of the ammonia control valve that opens and closes
