Monthly Contractor Safety Meeting

April 9, 2019

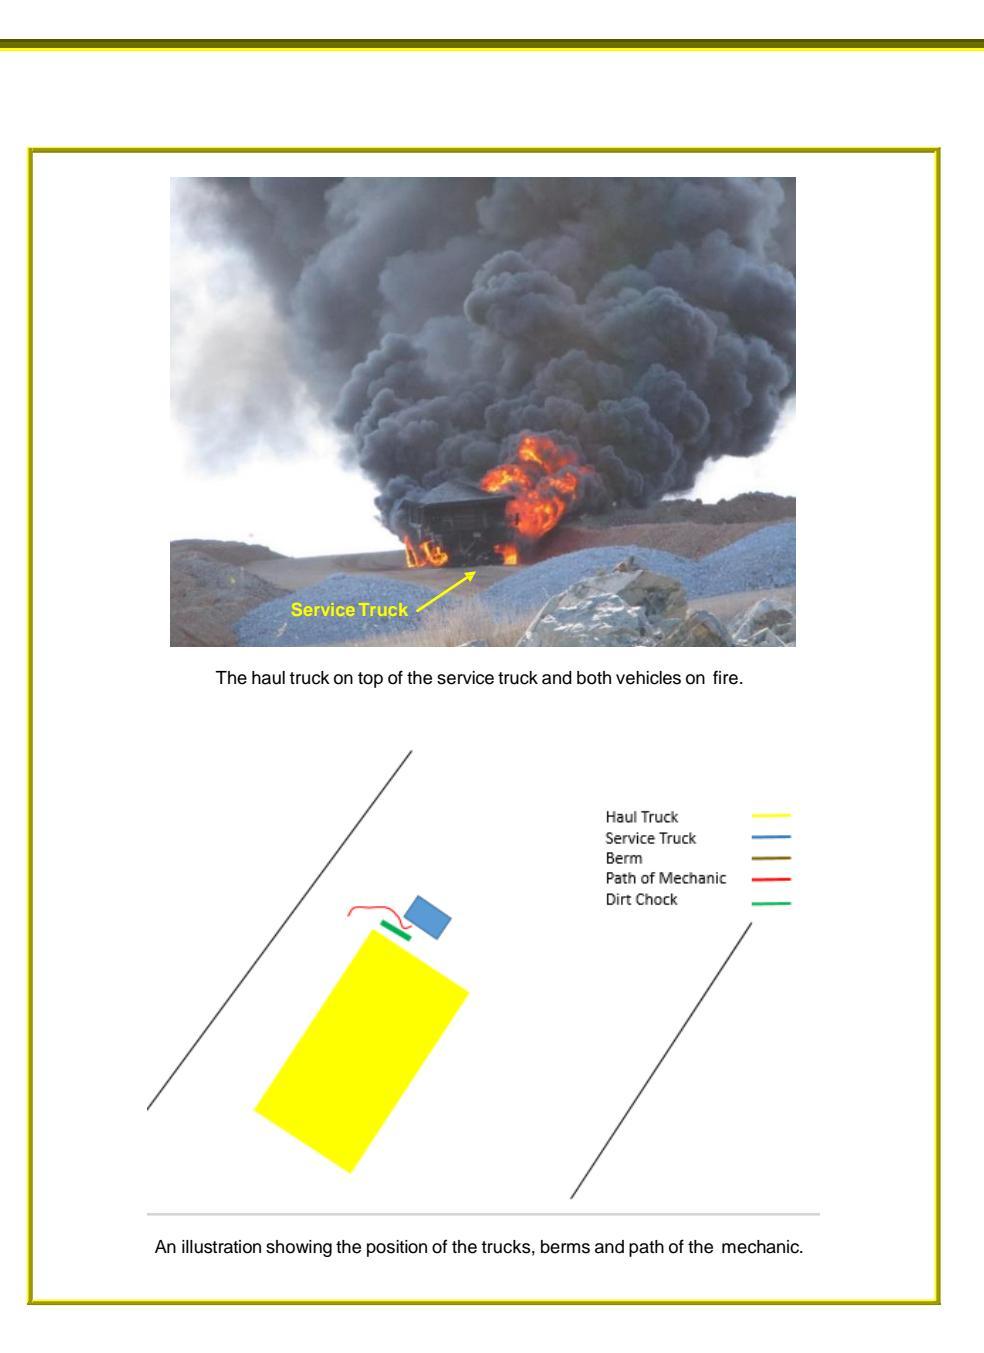
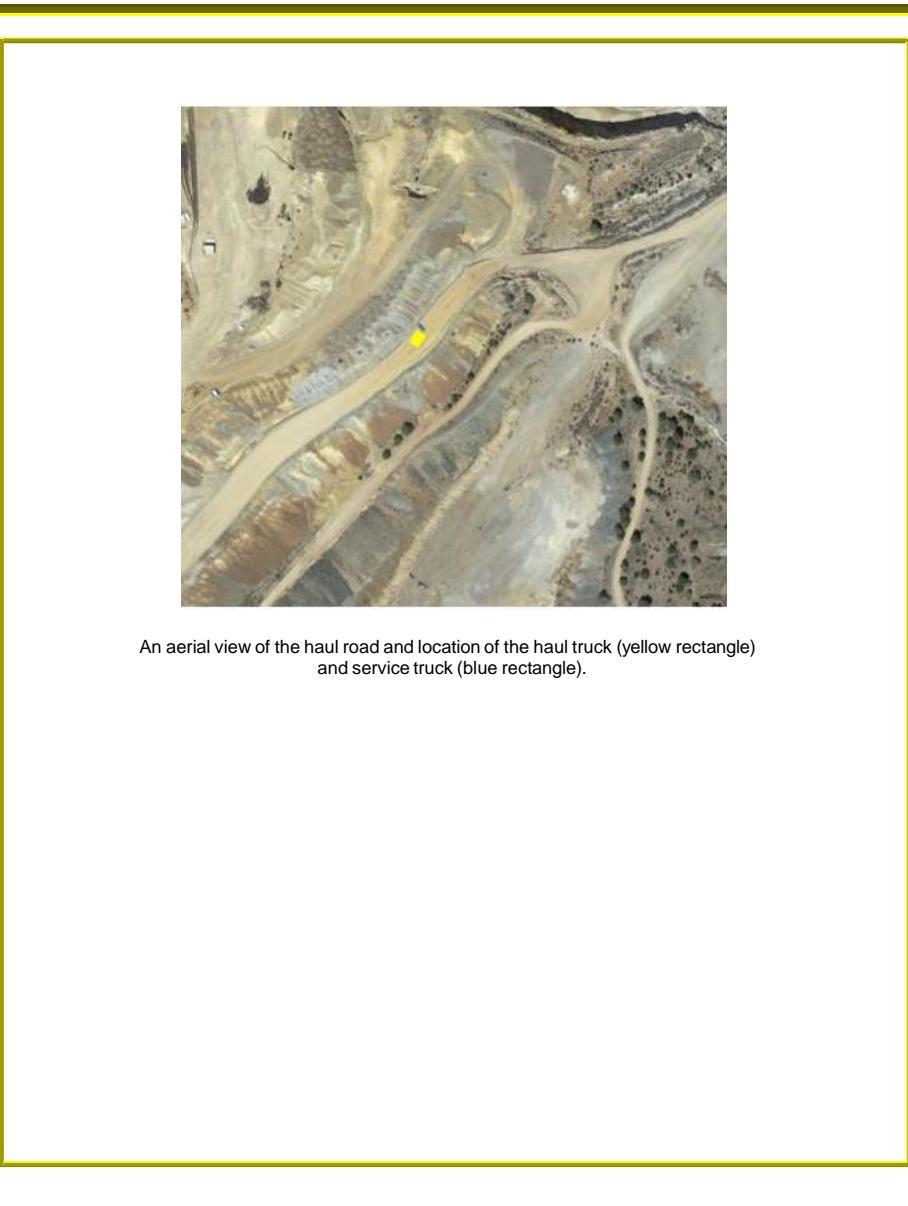
Summary: A high-energy event occurred when a loaded haul truck rolled and stopped on top of an unoccupied service truck

after the haul truck had been manually started with air following brake work. Both vehicles caught on fire.

The haul truck proceeded to roll over the chocking berm and stopped on top of the service vehicle. The haul truck's front bumper struck the air compressor, which caused the service truck and then the haul truck to catch on fire. The driver saw flames from under the cab, activated the fire suppression system and was able to safely dismount the truck. The mechanic's handheld radio was in the service truck – to call a Mayday, the employees ran 3/4 of a mile on the haul road until they found an employee with a radio.

Vehicle Impact to Person N/A			
OTHER SIGNFICANT RISK (specific to site or task not categorized as global)			
 Inadequate risk assessment to include the energy associated with a haul truck on a grade 			
ABSENT / INSUFFI	CIENT CONTROLS CONTRIBUTING TO THE EVENT		
Placement of chocking berm – the ber	rm was 5 feet in front of the tire, a distance that allowed the truck to		
Placement of chocking berm – the ber build up enough momentum to roll ov Placement and proximity of the servic Method for testing the brakes of a load Failure to move service truck from wo	rm was 5 feet in front of the tire, a distance that allowed the truck to the the berm e truck to the haul truck ded haul truck on a 9 percent downward grade rk area prior to operating the haul truck		
Placement of chocking berm – the ber build up enough momentum to roll ov Placement and proximity of the service Method for testing the brakes of a load Failure to move service truck from wor	rm was 5 feet in front of the tire, a distance that allowed the truck to the berm e truck to the haul truck ded haul truck on a 9 percent downward grade rk area prior to operating the haul truck CIES APPLICABLE STANDARDS / POLICIES /

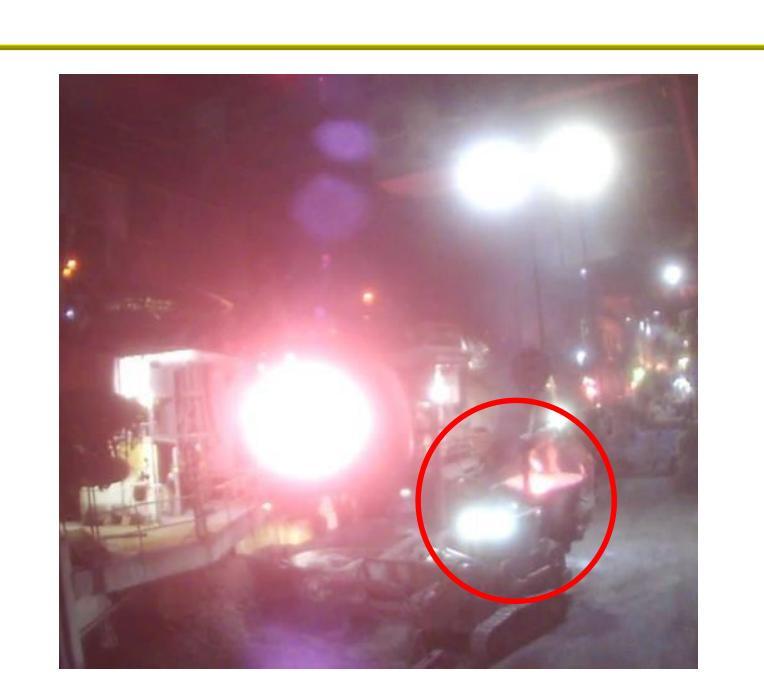
Circled in red is the ladle making contact with the track loader.

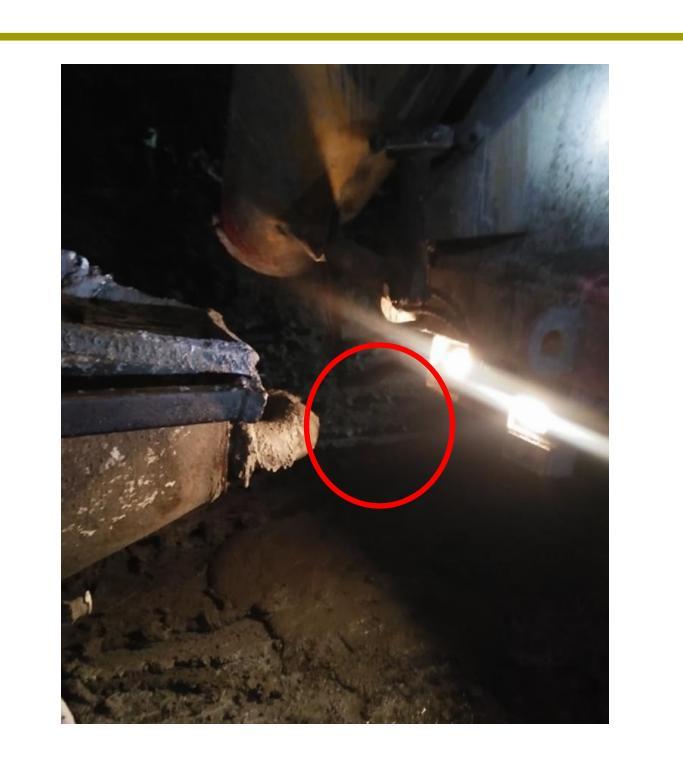
Circled in red is the location of the employee when pinched between the concrete mixer truck (left) and shotcrete sprayer truck (right).

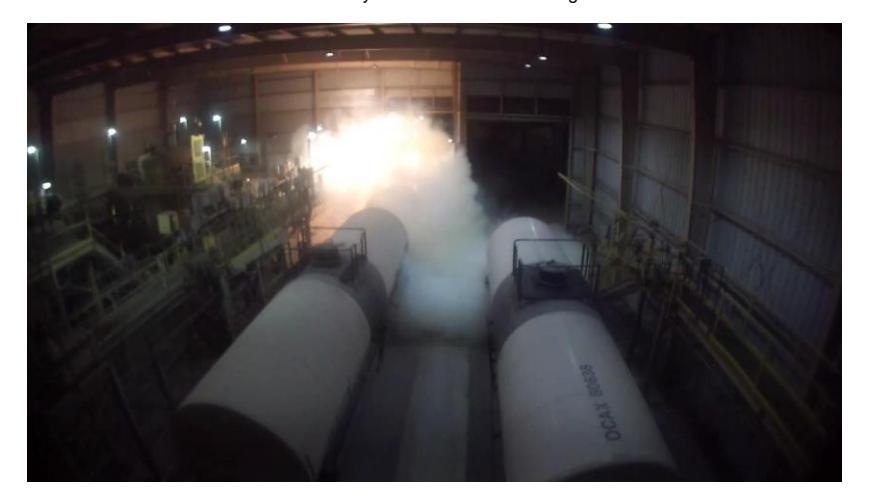
Summary: Material incompatibility between a new titanium dump valve and dry chlorine resulted in a chlorine release and fire.

East railcar at the most intense period of the fire.

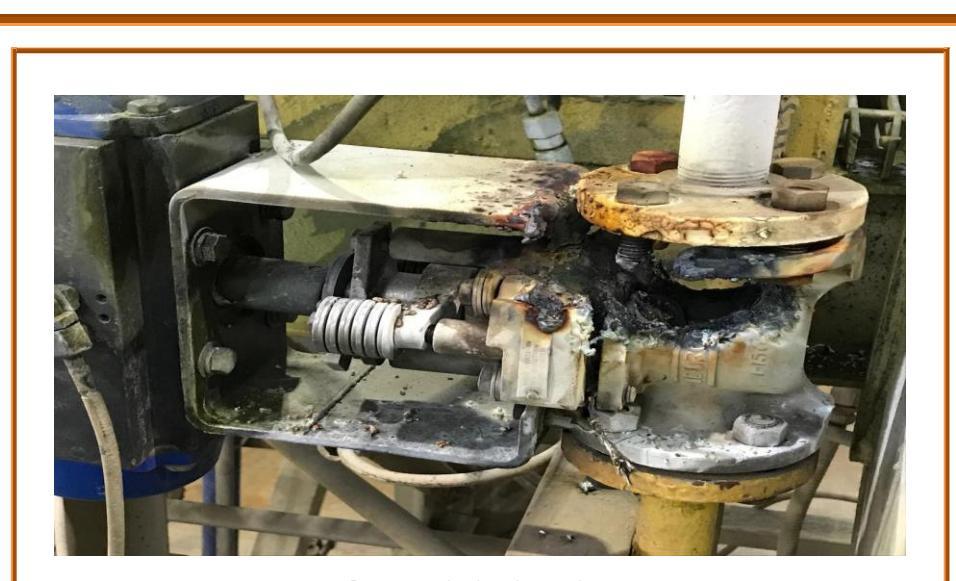
An investigation revealed a new titanium dump valve had been installed on the east railcar unloading station

approximately two weeks before the incident. Designed for wet chlorine use, the titanium reacted violently with

the dry chlorine used at site.

Material incompatibility – the titanium dump valve was designed for wet chlorine use and reacted violently to the dry chlorine (<1000 ppm water) used at site. Historically, lined cast-iron dump valves were used that required frequent replacement. To extend equipment life and reduce the risk of employee exposure to chlorine, valve vendor IPT Valves, Pumps and Services recommended switching to Titanium-body Flowserve Durco TSG4 valves.

Damage to titanium dump valve.

- Implement practice to keep building roll-up doors closed with the exception of during rail car movements. Review incident with vendor who recommended the titanium valve. Change existing labels to read dry chlorine instead of chlorine. Review and update the Chlorine Emergency Response Plan. Complete and implement RCA actions. •
- •
- ٠
- •
- •
