# ACTIONABLE LESSONS LEARNED: Railcar Acid Burns

Exposure to Hazardous Substance - Acute

Fort Madison, May 13, 2024

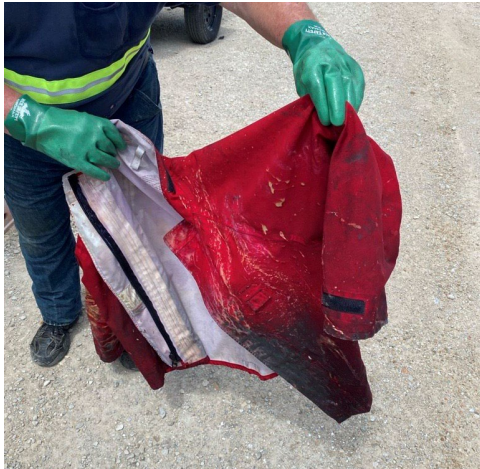
A contractor was depressurizing an acid railcar. While attempting to check the low-side pressure valve assembly, the employee was unable to maintain a tight seal on the valve and was sprayed with 93% sulfuric acid. The contractor was wearing chemical gloves, a suit, boots, face shield and goggles.

- Contractor attempted to check low-side pressure valve assembly using left hand while the rail car was depressurizing.
- Inadequate PPE – contractor was not wearing a hood, and suit sleeves were not cuffed.

- **Engineering** – Evaluate the addition of pressure gauges to create a “christmas tree” configuration. This will help the transload operator determine if it safe to open the low-side valve. The Sulfuric Acid Steering Team will review this action and determine if a global action item is needed.

- **Engineering** – Evaluate adding an elbow to the 2-inch, low-side pipe to redirect sulfuric acid away from the transload operator if residual pressure exists in the railcar. The elbow would connect to a hose that would discharge any acid in the line to a tote. The Rail Steering Committee will review this action and determine if a global action item is needed.

- **Administrative** – Ft. Madison employees and contractors will attend a Sulfuric Acid Bulk Handling training. Employees and contractors will conduct inspections, task audits, emergency response, and risk and hazard assessments together.

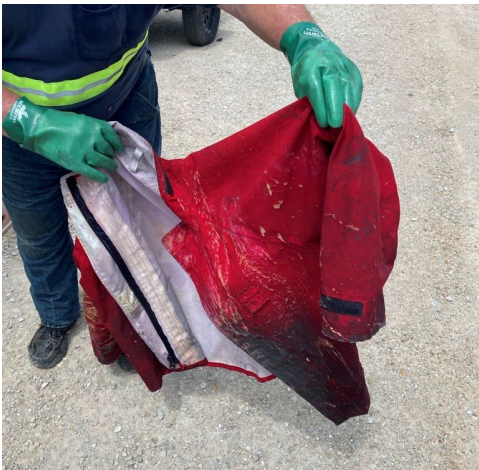
A contractor was depressurizing an acid railcar. While attempting to check the low-side pressure valve tree, the employee was unable to maintain a tight seal on the valve and was sprayed with 93% sulfuric acid. The contractor was wearing chemical gloves, a suit, boots, face shield and goggles.

- Ensure all personal protection equipment (PPE) is in good, suitable condition. PPE must be worn according to manufacturer specifications and for the hazardous material you are working with or around.
- Rail cars must be fully vented before attempting to check valves.
- Be cognizant of hand placement. Avoid placing any part of your body in areas that have potential for harm.
- Make sure you have participated in Sulfuric Acid Bulk Handling training.
- Know the emergency notification procedures and be sure to follow them.

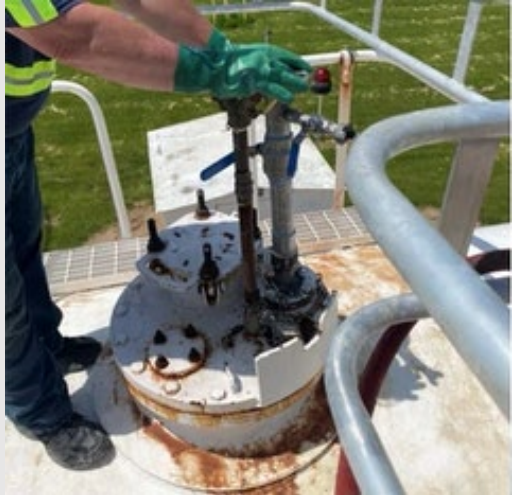
Re-enactment of valve assembly.

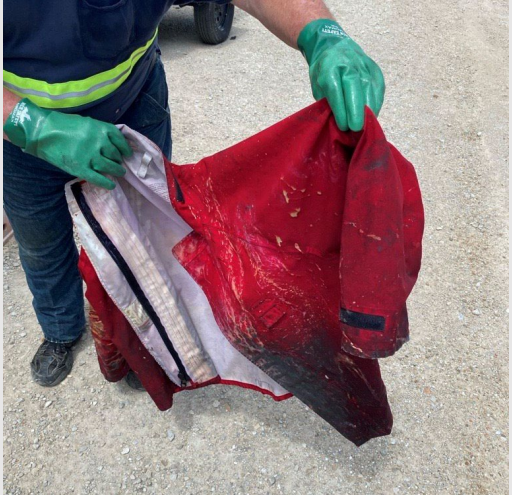
Contractor suit following acid exposure.

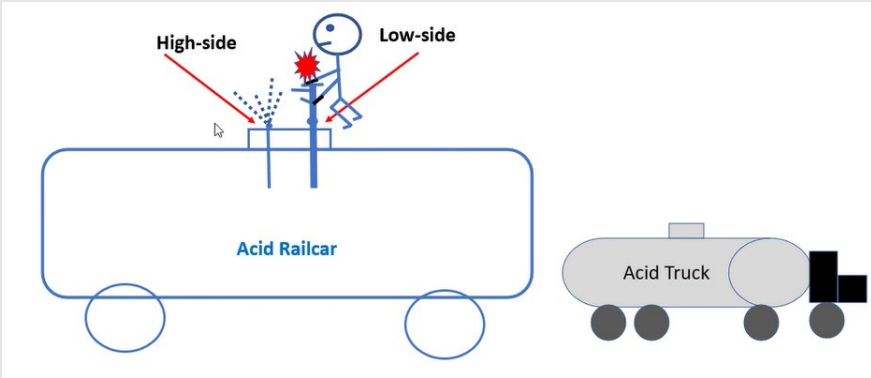
Railcar tank set up.
