# ACTIONABLE LESSONS LEARNED: Fallen Idler

## Falling Objects

Morenci, March 11, 2024

# Actionable Event: Fallen Idler

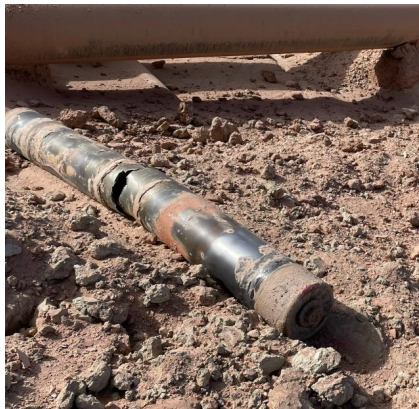
A contractor crew was cleaning buildup underneath the head end of a conveyor near the transfer tower. While on their lunch break and stationed across the street, the crew witnessed a return idler that fell 20 feet down from the conveyor. The idler landed close to the crew's working area. The conveyor was running, the idler was mounted and in use at the time of the event.

- Elimination** – Perform gap analysis on Freeport Material Handling Conveyance Handling policy and align Morenci Production Standard 2.2 (Conveyor Safety).
  - Identify and correct any deviations from the policy and submit recommendations for improvement.
  - Hold accountability conversations with leadership at all levels.
  - Clarify expectations that leaders are responsible for verifying that employees and contractors understand and are working within policy.

- Engineering** – Identify and correct gaps in idler inspection and planning processes.
  - Implement planned component replacement for idlers in areas with high employee exposure.
  - Evaluate and test engineering options that may extend idler life and assist with failure identification.

- Administrative** – Improve Freeport engagement with contractor work and support. Develop or modify processes to help ensure Freeport engagement with contractors prior to work starting.

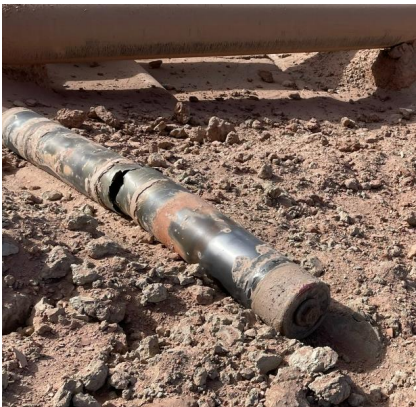
A contractor crew was cleaning buildup underneath the head end of a conveyor near the transfer tower. While on their lunch break and stationed across the street, the crew witnessed a return idler that fell 20 feet down from the conveyor. The idler landed close to the crew's working area. The conveyor was running, the idler was mounted and in use at the time of the event.

- Maintain good housekeeping under conveyor belts to avoid build up.
- Do thorough inspections on all idlers to make sure you identify any that are damaged and could become a hazard.
- Employees should not work under moving conveyors, follow applicable procedures and policy to prevent injury when working around or under conveyors.

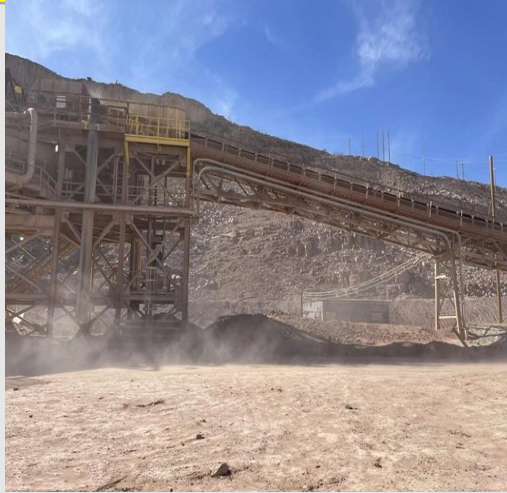
<b>Operation</b>	Morenci
<b>Date / Time</b>	March 11, 2024 / 1:15 p.m.
<b>Event Type</b>	Near Miss
<b>Summary</b>	A contractor crew was cleaning buildup underneath the head end of a conveyor near the transfer tower. While on their lunch break and stationed across the street, the crew witnessed a return idler that fell 20 feet down from the conveyor. The idler landed close to the crew's working area. The conveyor was running, the idler was mounted and in use at the time of the event.
<b>Risk Category</b>	Actionable – Significant (3) Likely (3)
<b>Findings / Missing Controls</b>	<ul style="list-style-type: none"> <li>• Conveyor was left on while unattended</li> <li>• Need to set up segregation or turn off belt while unattended</li> <li>• No baskets or guarding were used under the idler</li> </ul>
<b>Applicable Policies / Procedures</b>	N/A
<b>Employee Condition</b>	No injuries
<b>Contact</b>	Corina Rodriguez- Senior Supervisor-Health and Safety

*Location where idler fell*

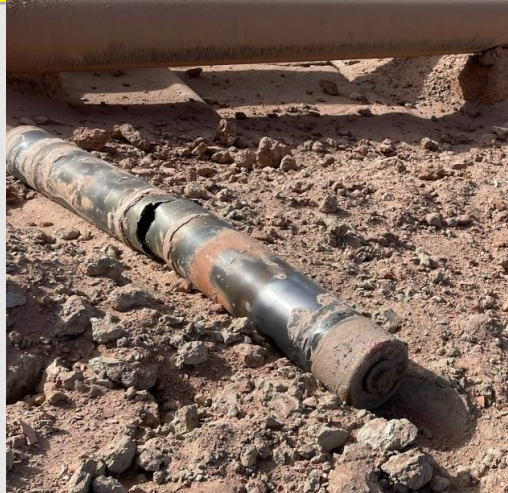
- Contractors were tasked by Freeport supervision to clean under a running conveyor when overhead hazards were not effectively controlled.

*Worn idler that fell from conveyor*

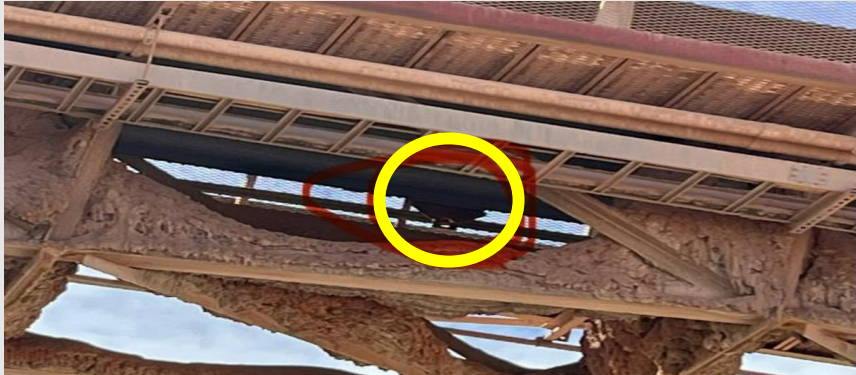
*Idler fell from section of conveyor circled in yellow*
