Potential Fatal Event: Landslide Hits Light Vehicle

Preliminary Incident Details

Operation	PTFI – Road Maintenance and GeoEngineering
Date / Time	June 11, 2024 / 1:58 a.m.
Event Type	Property Damage
Summary	A light vehicle was escorting a cargo convoy on the Mine Supply Route (MSR). The vehicle was hit by landslide material, damaging the vehicle’s hood and left front end. A driver and three passengers were in the vehicle and sustained no injuries. The landslide came from hanging material on the upper slope, which was residual hazard from a landslide on June 3, 2024.
Risk Category	Actionable – Significant (3) Possible (3)
Findings / Missing Controls	<ul style="list-style-type: none"> A Trigger Action Response Plan (TARP) was in place at the time of the incident. <ul style="list-style-type: none"> It triggered an inspection of the previous landslide area approximately two hours before the new slide but did not require a road closure. A newly developed TARP was in the review process the night of the incident. <ul style="list-style-type: none"> The new process proposed a road closure trigger, which was implemented the next day (June 12).

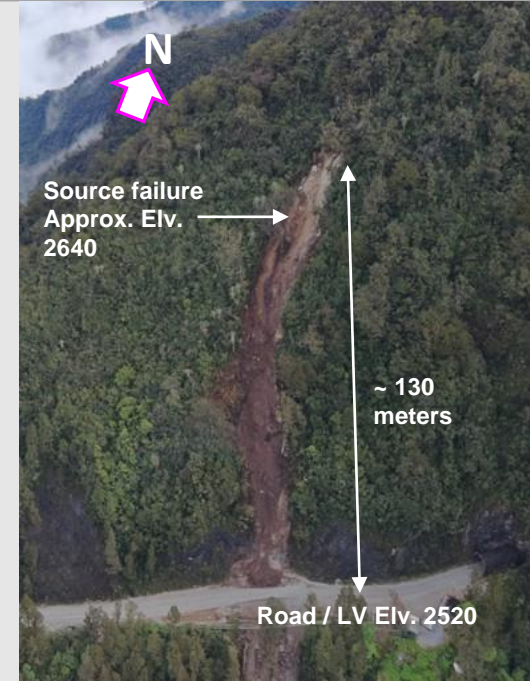
Source of the landslide came from upper slope. Consisted of topsoil, vegetation and boulders.

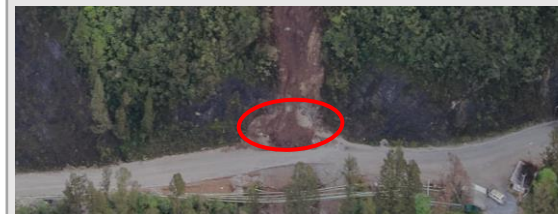
Small material retained inside the temporary berm.

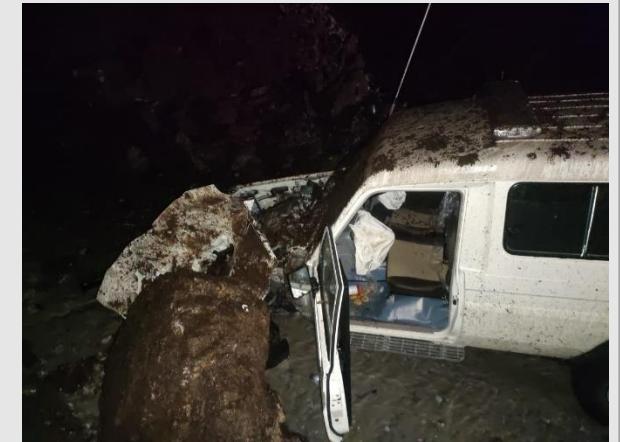
Boulder from the landslide struck light vehicle after passing through a tunnel.

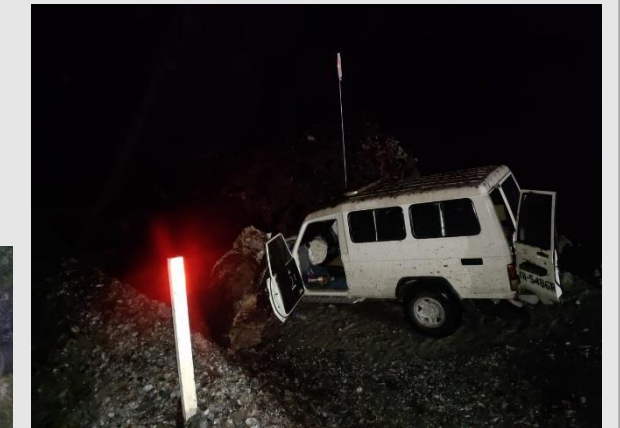
Front and rear passengers were able to exit the vehicle uninjured.
