Potential Fatal Event: Pressured Acetylene Cylinder Erupted

Preliminary Incident Details

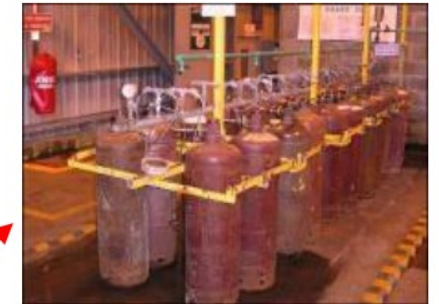
Acetylene Filling Station

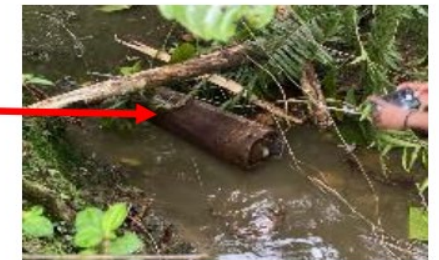
Acetylene cylinder stopped in the wood
