PFE LESSONS LEARNED: Feedbox Rollover Onto Contractor

Uncontrolled
Release of Energy

Potential Fatal Event: Feed Box Rollover Onto Contract Worker

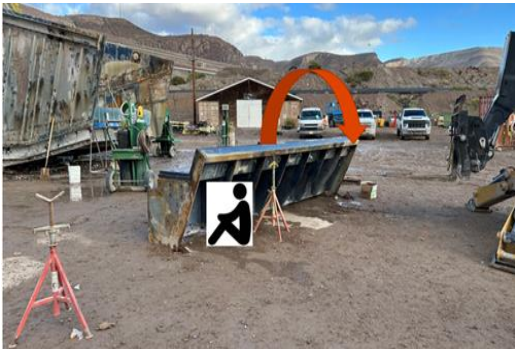
A contractor was installing liners on a wet screen feed box that had been placed on the ground for maintenance. As the liners were added, the two-ton box rolled over onto the worker, who was trapped underneath. After unsuccessful attempts to move the box by hand, a forklift was used to free the worker.

- Contractor used pipe stand to support weight of feedbox.

- **Engineering control** – Engineer a stand to secure feedboxes when liners are being changed outside of wet screen. Immediately eliminate the practice of changing liners outside of wet screen until new stand is fabricated.

- **Administrative control** – Create SOP for task that includes the following safety guidelines:
 - Only use engineered stand
 - Use cement slab in yard for level, stable ground
 - Ensure stand placement adequately and evenly supports feedbox weight

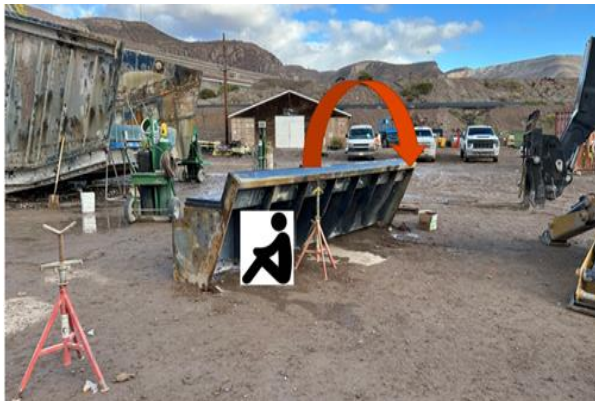
A contractor was installing liners on a wet screen feed box that had been placed on the ground for maintenance. As the liners were added, the two-ton box rolled over onto the worker, who was trapped underneath. After unsuccessful attempts to move the box by hand, a forklift was used to free the worker.

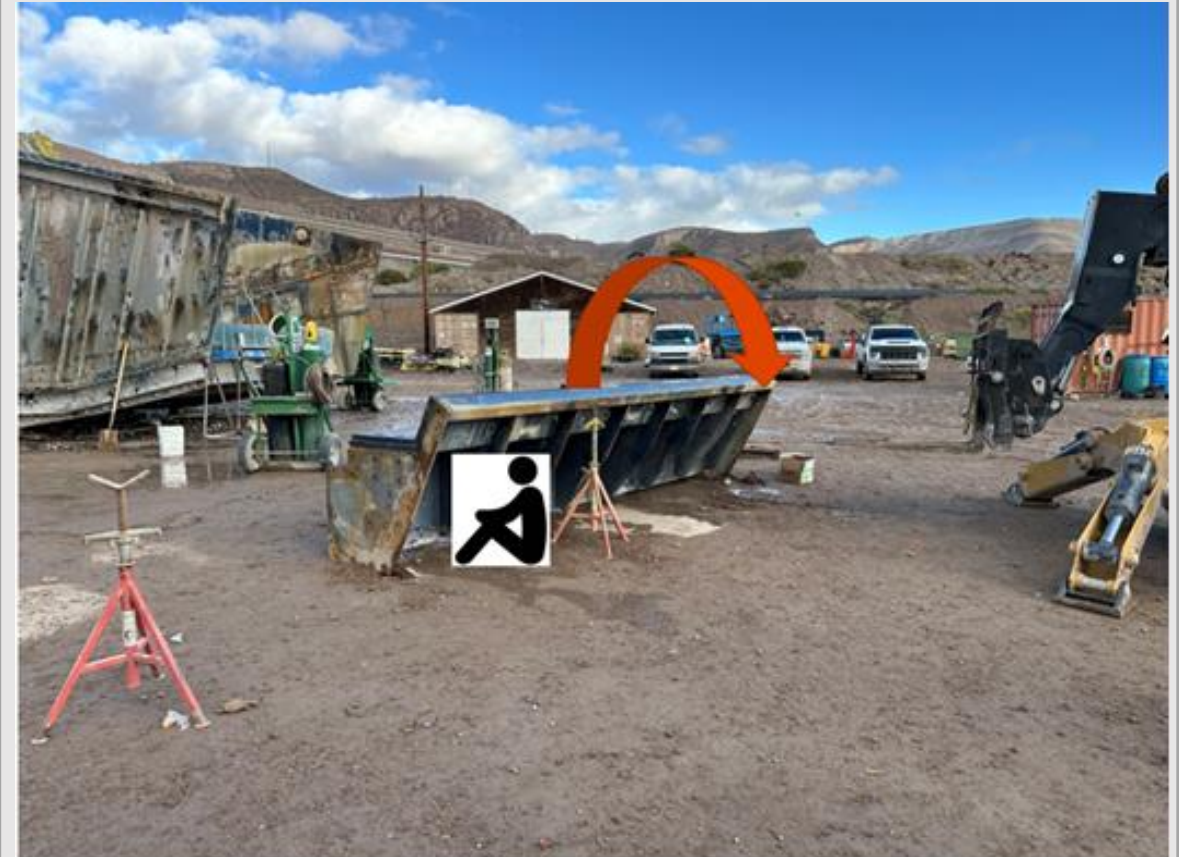
Operation	Morenci
Date / Time	February 6, 2024 / 12pm
Type	Injury
Summary	A contractor was installing liners on a wet screen feed box that had been placed on the ground for maintenance. As the liners were added, the two-ton box rolled over onto the worker, who was trapped underneath. After unsuccessful attempts to move the box by hand, a forklift was used to free the worker.
Fatal Risk	Uncontrolled Release of Energy
Risk Category	Actionable
Risk Rating	Significant (3) Likely (3)
Findings / Missing Controls	<p>Blocking for maintenance work and energy isolation</p> <ul style="list-style-type: none">• Inadequate risk assessment• Pipe stands were BO and not intended for this use• Pipe stands were used instead of cribbing or engineered cradle• Placement of the stand cradle was not secure to the feed box• Ground was not level/potentially soft
Applicable Policies / Procedures	Control of Hazardous Energy

Position of employee, placement of pipe stands and direction the feed box tipped.
