PROVINCE OF METALS

Contractor Safety Meeting

06/14/2016

PFEA

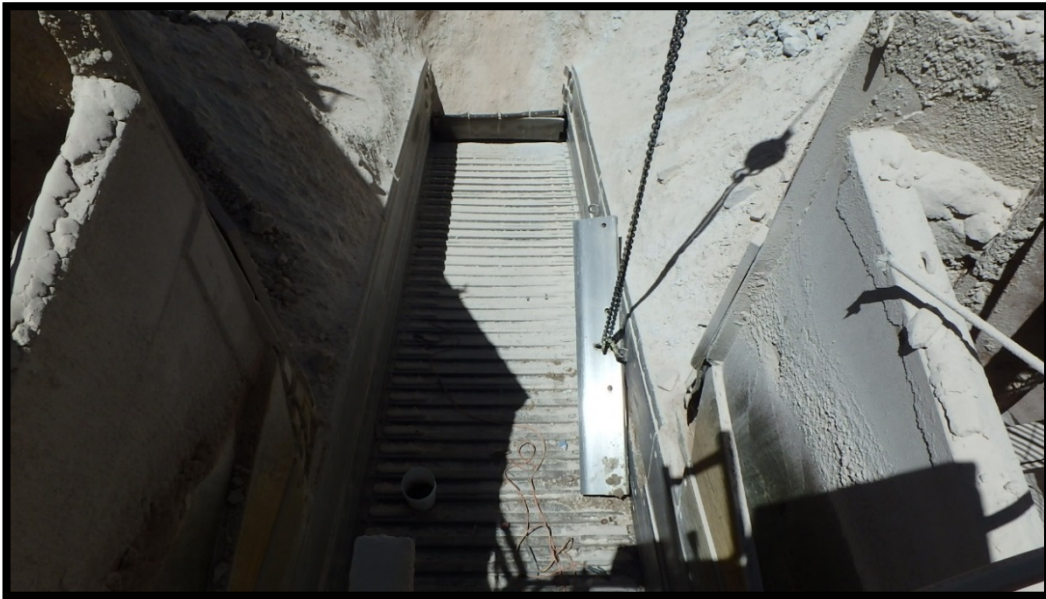
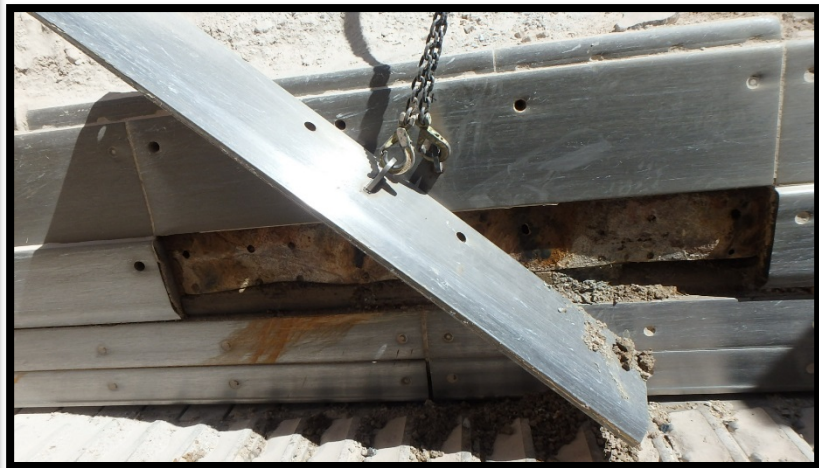
Restricted Duty

Incident Detail			
Date	05.31.2016		
Organization	Processing		
Division	Crush & Convey		
Potential Risk	3	2	6
	Consequence	Likelihood	Potential Risk
Brief Description	While changing out the liners of the apron feeder the employee was hit on the top of the left foot with the edge of the liner. The employees had welded a D-ring in the center to support the liner with the crane, although when the liner popped off the wall the end of the liner swung down hitting the employee's left foot just past the metal toe protection. The liner weighed 2500 lbs. new and by the crane estimate 1500 lbs. now. It measured 108 inches by 18 inches and 3 ½ thick.

Best Practices
<ol style="list-style-type: none">1. Conduct a thorough risk assessment, to include line of fire, prior to starting work.2. Stay out of the line of fire3. Use proper rigging techniques

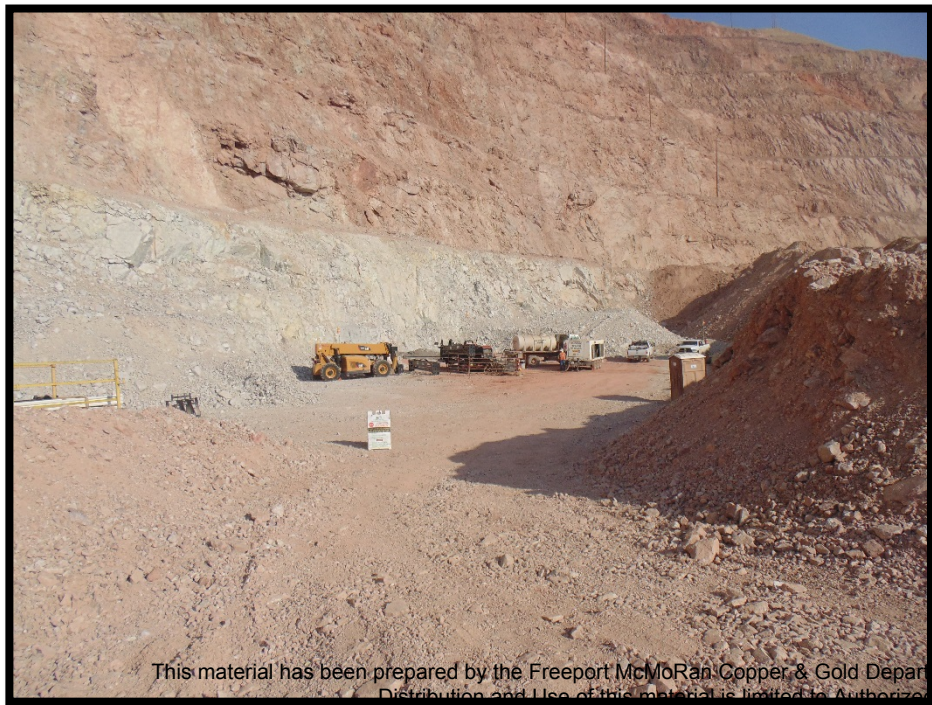
Near Miss

Incident Detail			
Date	06.02.2016		
Organization	Mine		
Division	Fragmentation-Loading/ Support		
Potential Risk	3	2	6
	Consequence	Likelihood	Potential Risk
Brief Description	Layne Drilling Contractors were left inside the 1500ft blast zone for the shots.

1. Conduct a thorough risk assessment, to include line of fire, prior to starting work.
2. Ensure communication between departments
3. Areas should be double checked when clearing for blasts.

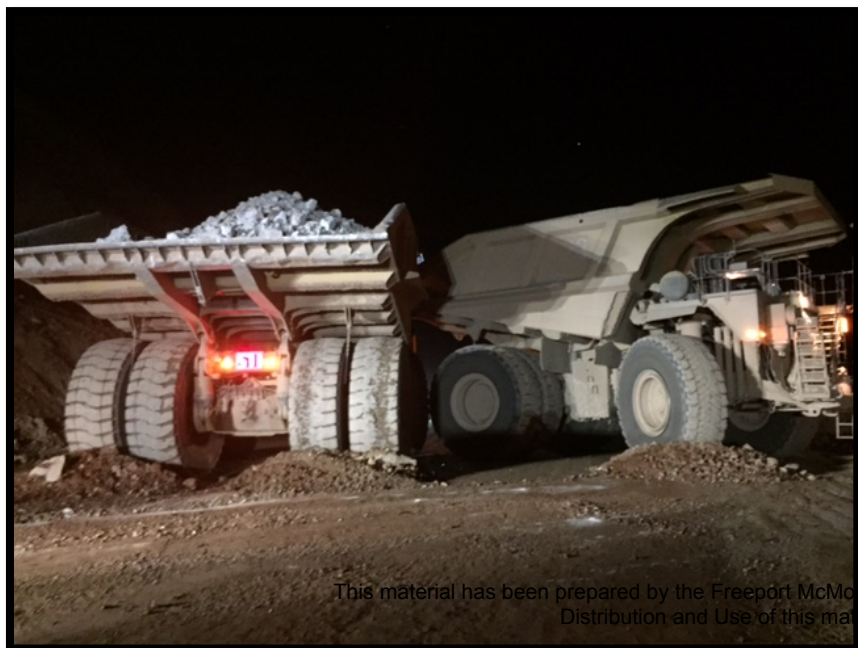
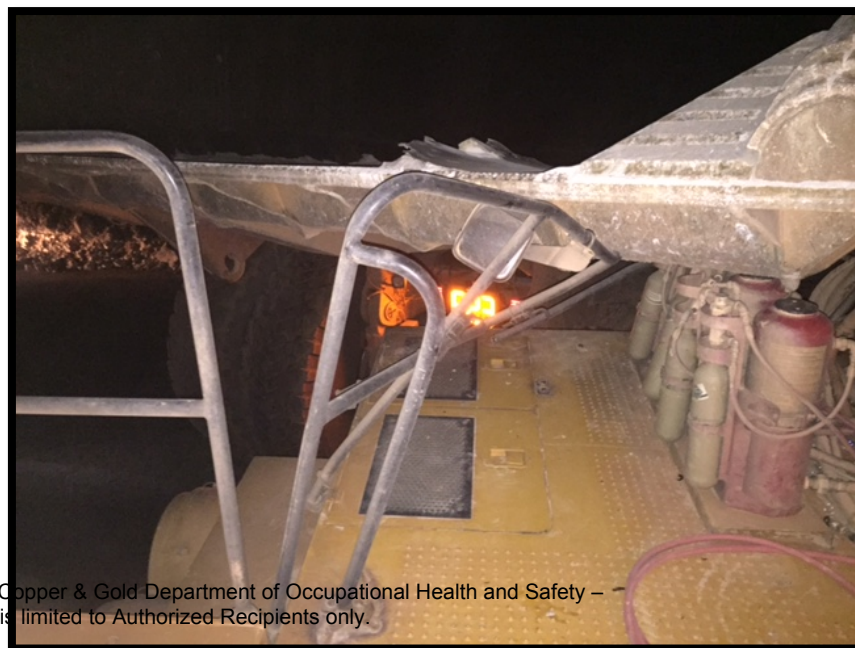
Property Damage

Date	06.06.2016		
Organization	Mine		
Division	Haulage		
Potential Risk	3	2	6
	Consequence	Likelihood	Potential Risk
Brief Description	While traveling down the 801 ramp the 623HT saw the 592HT slowed down in front of it and reduced speed causing it to go into a slide. The 623HT was going approximately 18MPH when the retarder and service brakes were applied. The 623HT slid 180 ft. and the bed made contact with the non-cab side guard rail of the loaded 571HT that was traveling up the ramp. The 801 ramp was heavily watered.

1. Drive to road conditions
2. Follow roadway watering procedures

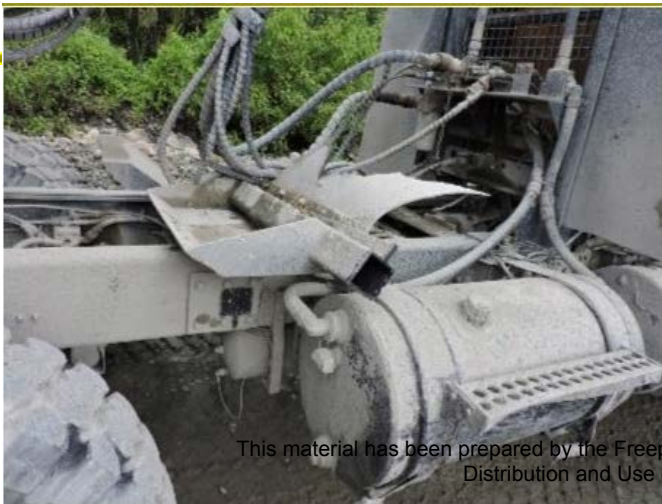
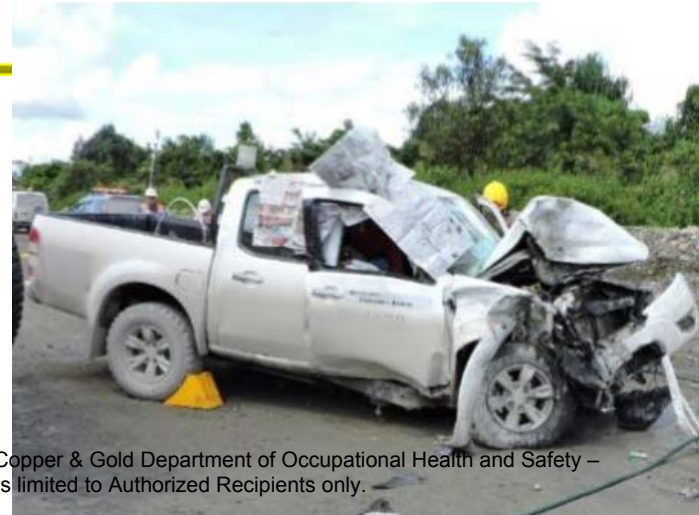
LV-Operator and Passenger

A Light Vehicle (LV) driver and his passenger fell asleep while the vehicle was in motion causing the LV to collide with an oncoming dump truck. The LV driver and his passenger sustained minor injuries.

The LV was southbound on the West Levee when the incident occurred. The oncoming dump truck driver noticed the LV drifting into his path and took evasive action by slowing, flashing his lights and driving onto the side berm of the road in an attempt to miss the LV. The LV collided with the dump truck at the fuel tank and became entangled in the drive wheels of the tractor trailer dump truck. The LV was dragged almost 8 meters while the dump truck came to a stop.

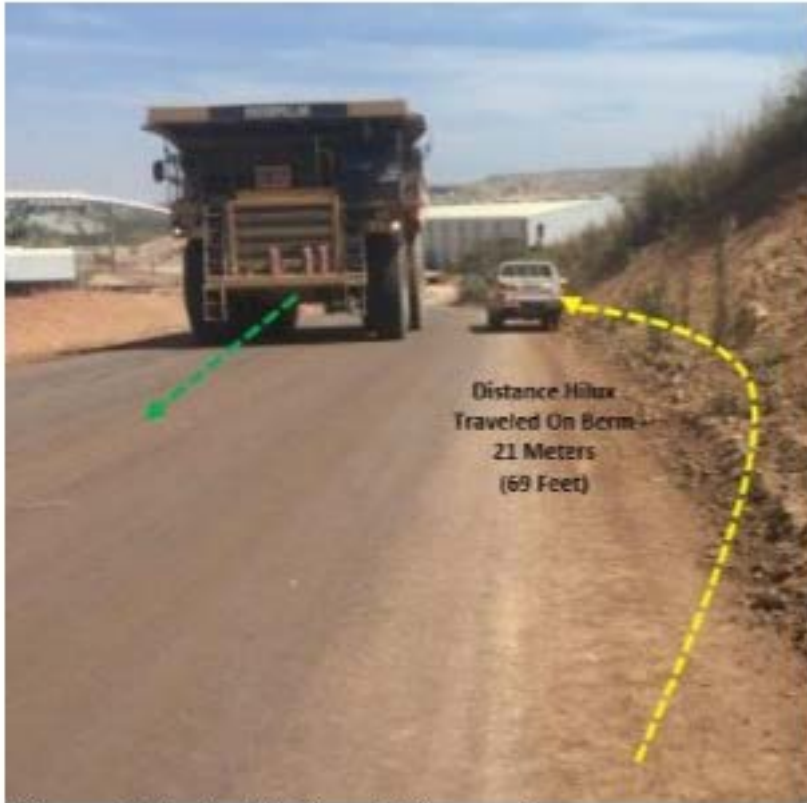
Picture 2: Path of light vehicle travel.

**Pictures 2 and 3 above are a re-enactment of the incident only.*

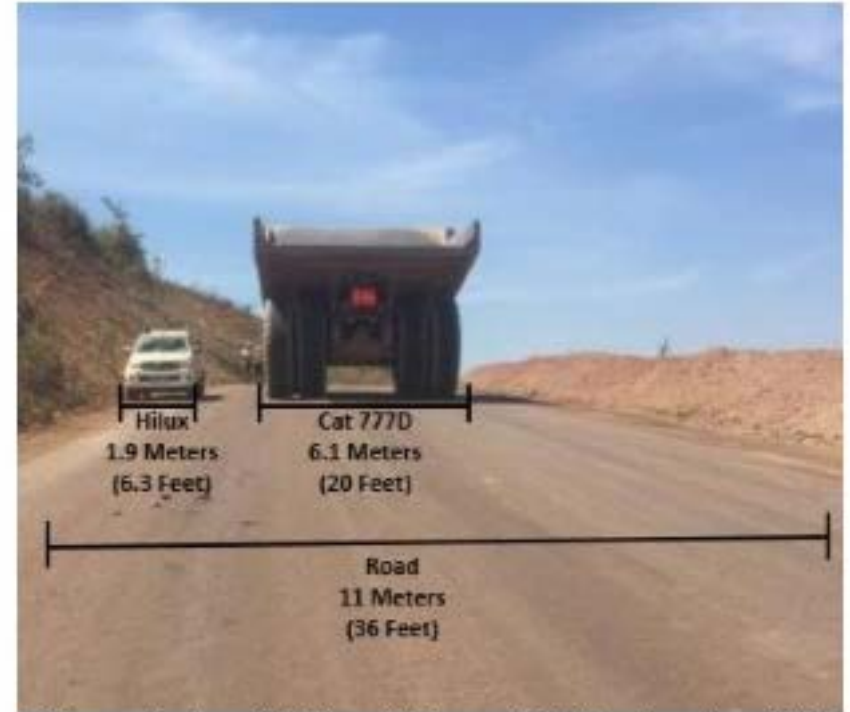
Picture 3: Road, light vehicle and 777 haul truck width.

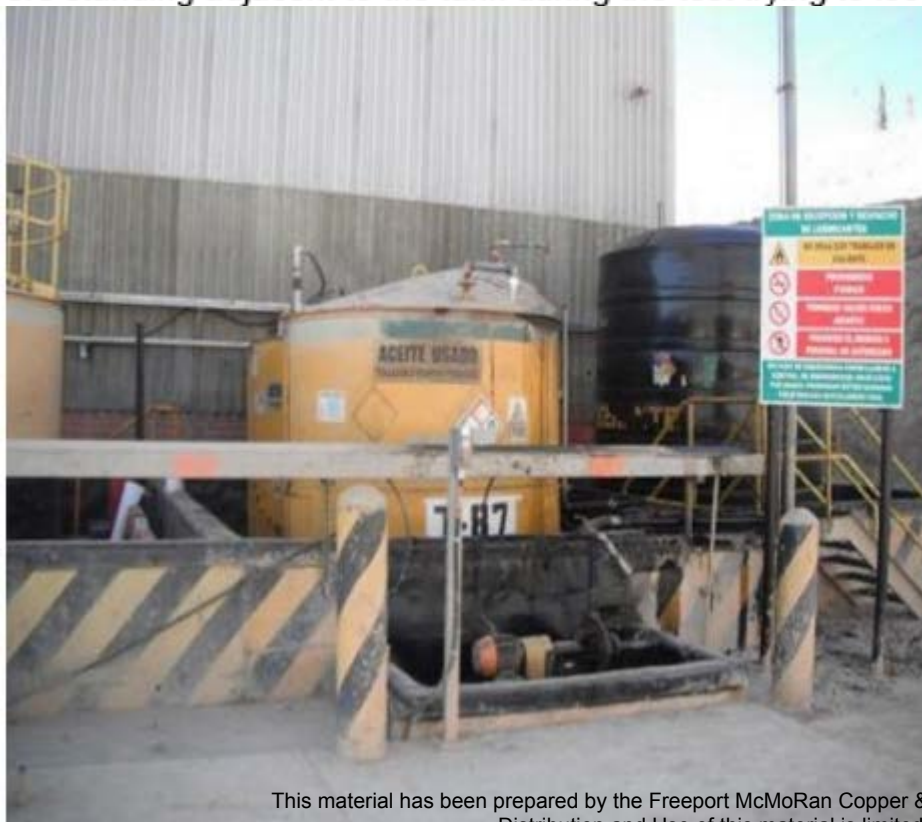
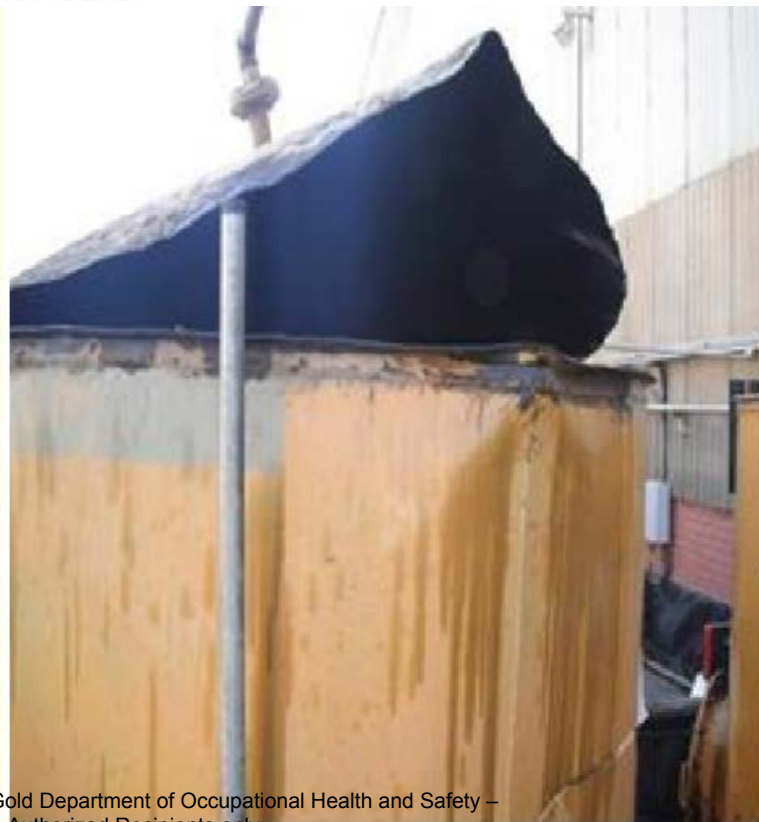
Cerro Verde Pressurized Tank

The lubrication supervisor and a technician decided to perform a pneumatic test on a used oil storage tank #87 in order to search for a leak. After pressurizing the tank for about two minutes with about 12 to 15 psi of compressed air, they heard a cracking noise when the roof of the tank failed. The supervisor and the technician were standing adjacent to the tank during the test trying to look for leaks.

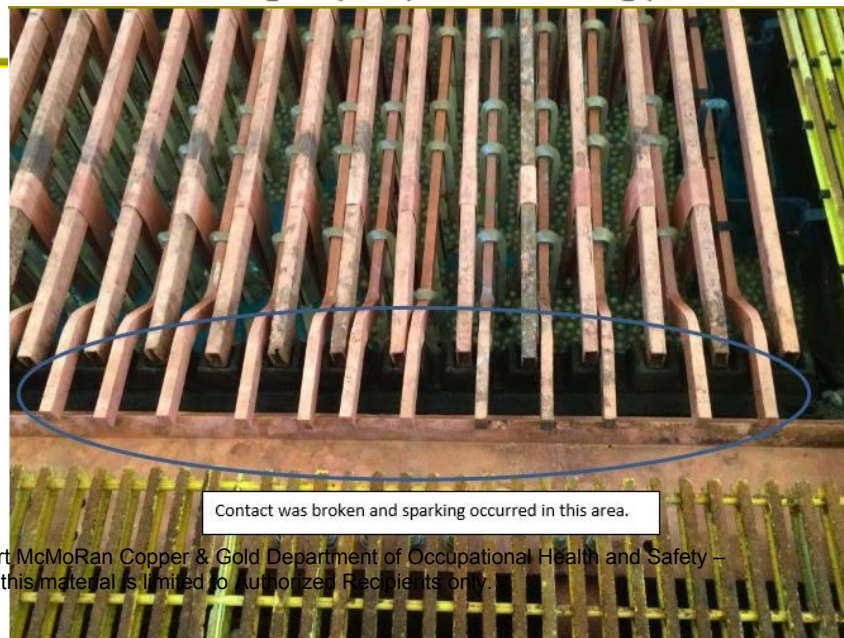
Chino- Cell Line Contact Break

On 05/17/2016 two employees attempted to break anode to bus contact on a cell line while it was still energized at 36,000 amps. The Tankhouse supervisor talked to the west crane operator and asked him to raise all of the west side cell levels to help with electrolyte tank levels. However, the crane operator was wearing a PAPR (full face respirator) and did not clearly understand what the supervisor asked him to do, thinking he was asked to break contact on the cell line instead of raising the cell levels. The crane operator then went to get his crane helper to assist him with the task. The crane operator then relayed the misunderstood information to his crane help and both employees went to cell # 1 and started breaking contact. As the two employees progressed with breaking the contacts in the cell, they got to a point where there were only five contacts remaining when the cell started sparking and getting hot. When the crane operator noticed this, they immediately ran to and activated the closest emergency stop button, killing power to the cell line and stopping the uncontrolled energy event.

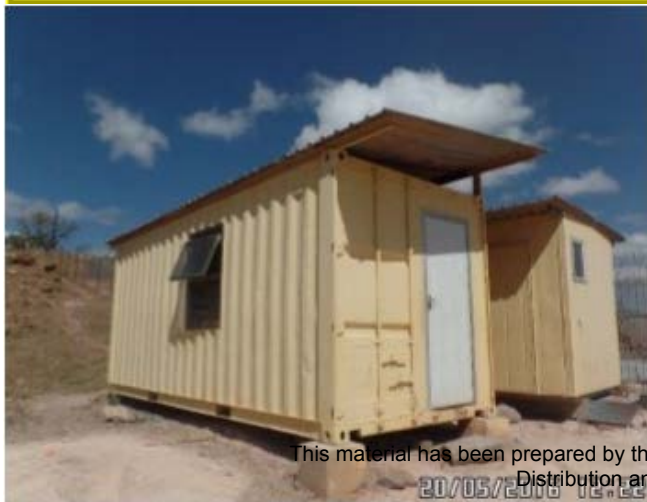
Initial investigation shows that during the night shift the individual became cold and brought a charcoal brazier into the security Connex for heat. Subsequently he was overcome by carbon monoxide (CO) and was asphyxiated in the rear room.

Picture 1: Security Connex

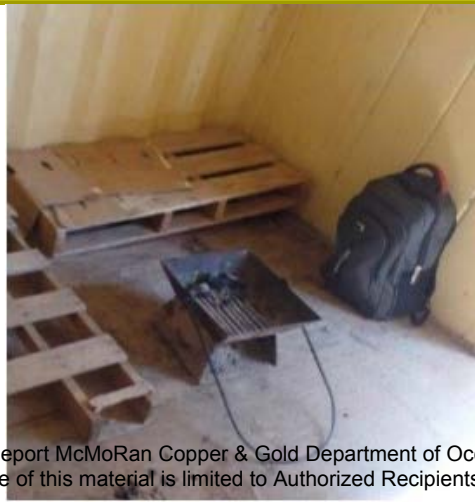
Picture 4: Charcoal brazier brought inside.

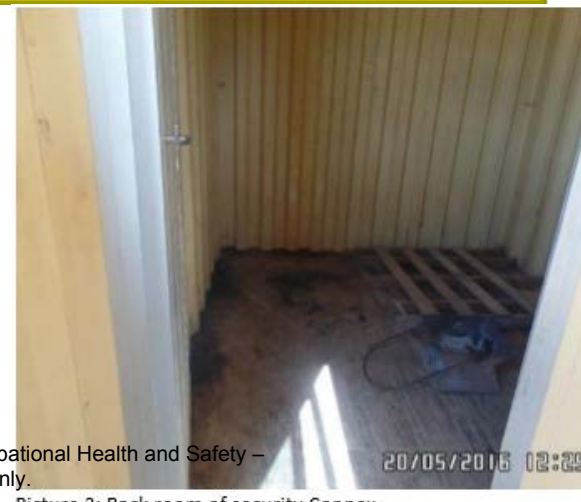
Picture 3: Back room of security Connex.

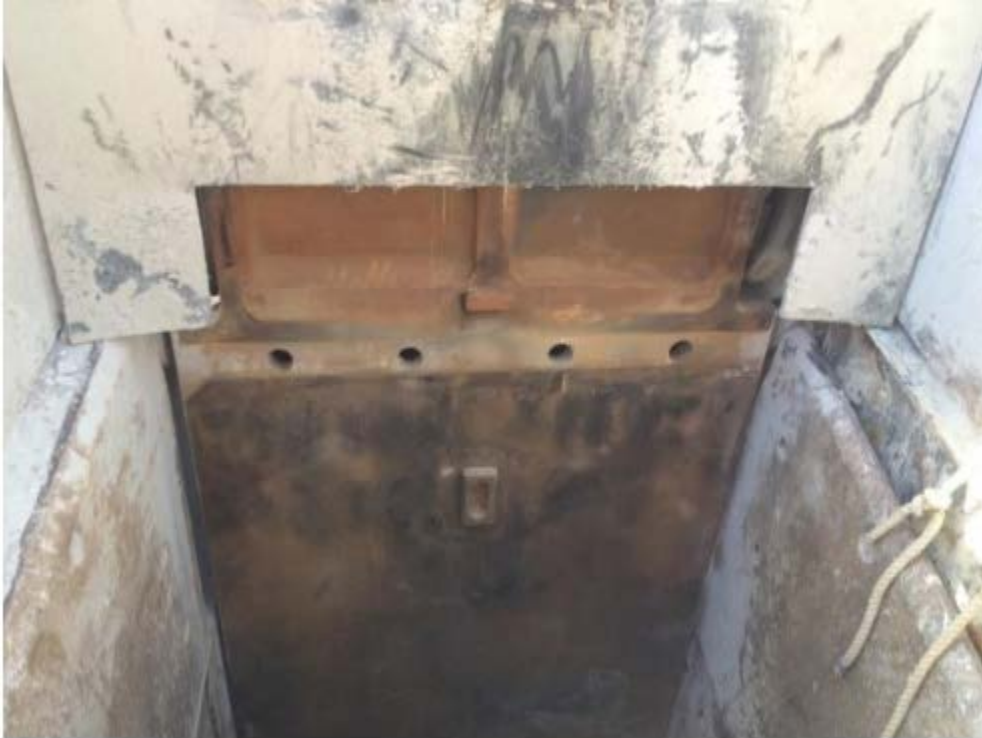
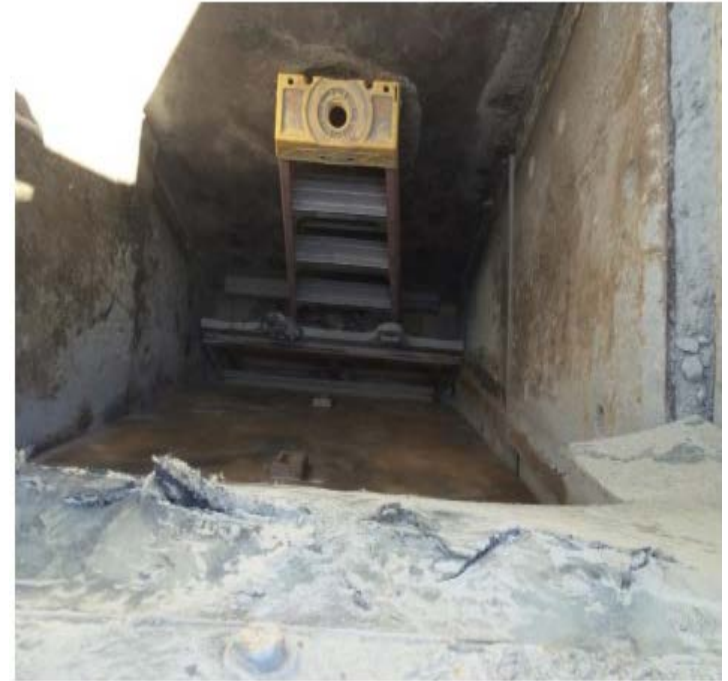
Bagdad Jaw Crusher

On May 21st, three employees were assigned to replace the moving and stationary jaws of the Small Jaw Crusher. The employees removed the stationary and movable plates successfully and broke for lunch. After returning from lunch, the employees began the next step, removing the worn cheek plates. One employee (injured employee) was in the crushing chamber (a confined space), a second employee was above him removing cheek plate bolts, and a third employee (listed as the attendant on the Confined Space Permit) was operating the boom truck. (The employee operating the boom truck should have only been monitoring the confined space work and not operating the boom truck). The employee working in the upper portion of the crusher was removing the Cheek Plate on the right side when the deflector plate dislodged and fell. The deflector plate fell approximately 5 to 6 feet, striking the employee in the crusher on his legs and feet area. (The Deflector Plate weighed 551 pounds according to the service manual.) Rescue efforts began immediately and the injured employee was extracted from the area and taken to the clinic for treatment.

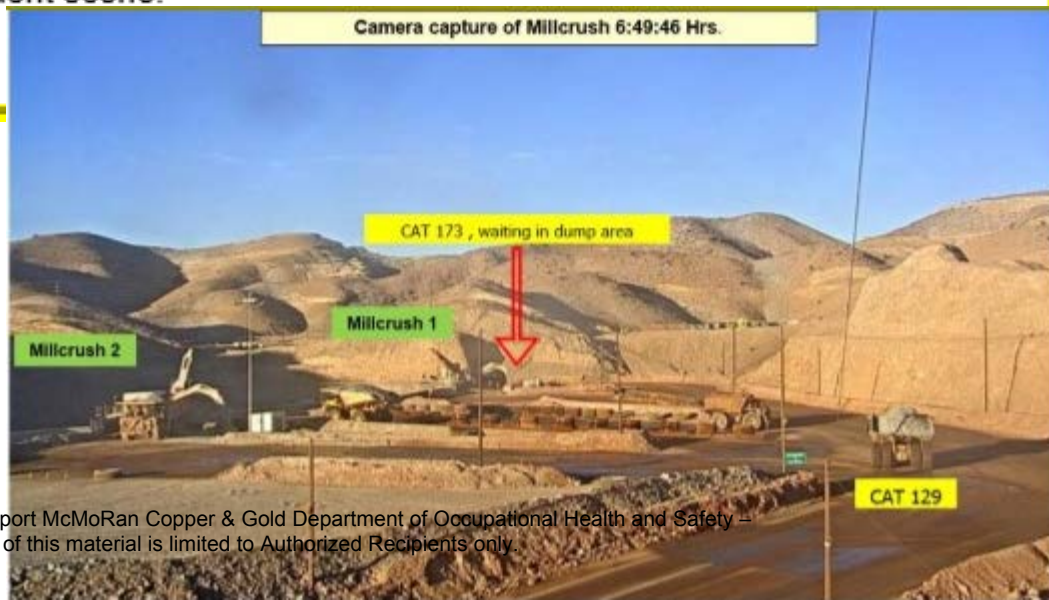
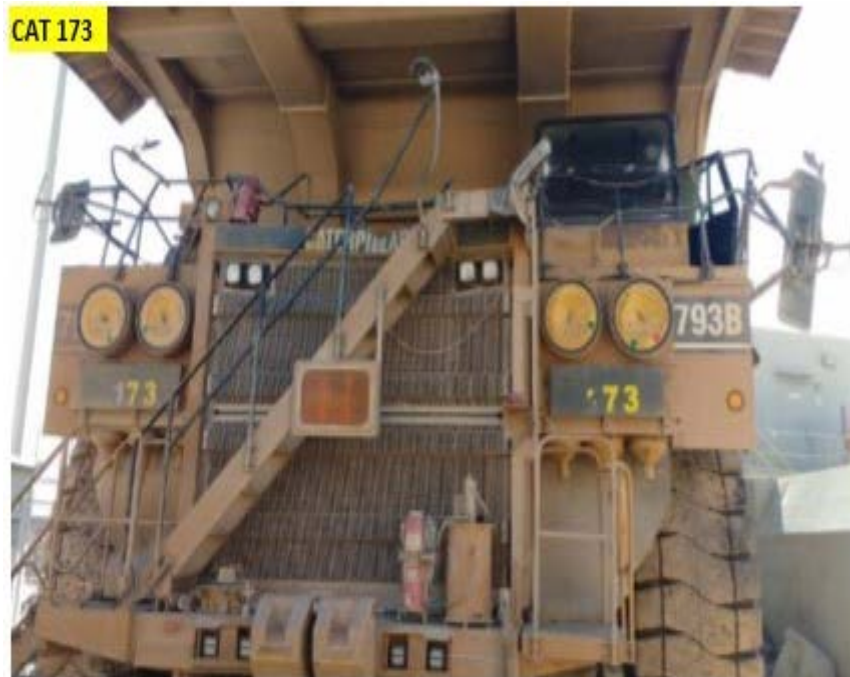
Cerro Verde Haul Truck

At 06:51 a.m. on Sunday June 5th, HT #129 inexplicitly backed into HT #173 while it was dumping ore at the south bay of Millcrush N°1. Despite efforts by the driver of #173 and a nearby water truck to contact HT #129 via radio, including hitting the May Day button, the driver of #129 continued to back up and made contact with HT #173. Just prior to contact, the driver of #173 decided to exit his cab, run across the deck and jump off the right side of his truck. Operator received injuries to his back, hip and ankle. The operator of HT #129 claimed he never saw the other truck (#173) dumping at the crusher pocket.

- Evacuate injured personnel to the clinic.
- Stop the Millcrusher 1 and secure the incident scene.
- Perform investigation
- Communicate event to all oncoming shifts
