Contractor Safety Meeting
September 12, 2023

Morenci Mine

PFE Morenci 769 Lost Steering Wheel

Fatal Risk Deviation on the 6 Thickener

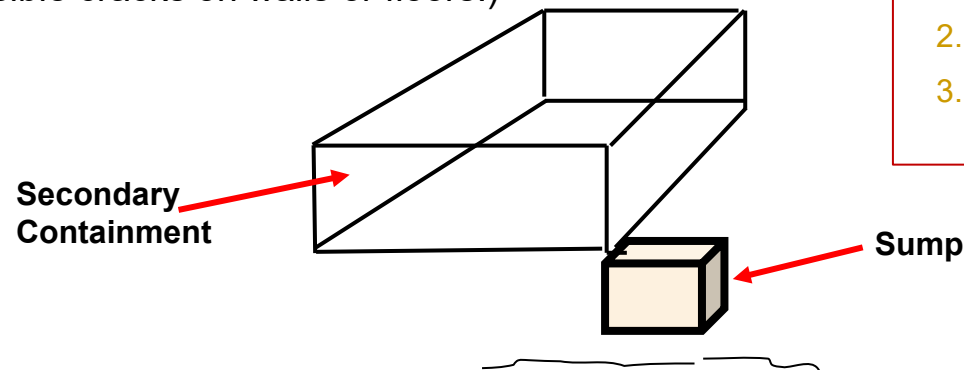
All sumps **must** be operated and maintained (repaired) to ensure that they are in good working condition (no visible cracks on walls or floors.)

Sumps **must** be designed and constructed not to discharge and built on an impermeable barrier that can be visually inspected for leakage.

1. Filling expansion joints with acid resistant caulking
2. Covering water stops in the construction joints
3. Saw cut control joints are filled with acid resistant caulking

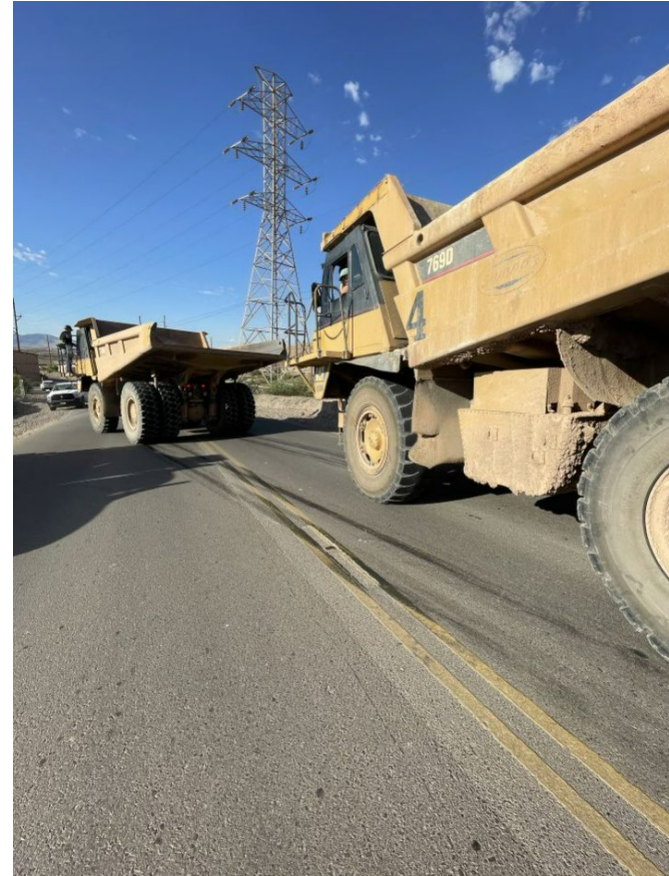
- A contract haul truck operator was traveling downhill in an unloaded CAT 769D when their steering wheel came off.
- The driver's emergency training kicked in and they activated all braking systems as the truck began to drift into the oncoming traffic lane.
- A service truck in that lane drove off the road to evade the sliding haul truck. After getting around the haul truck, the service truck continued and left the scene.
- The haul truck slid to a stop after ~25'.
- A second haul truck following behind the first also had to deploy their brakes and was able to slide to a stop before rear-ending the first truck.

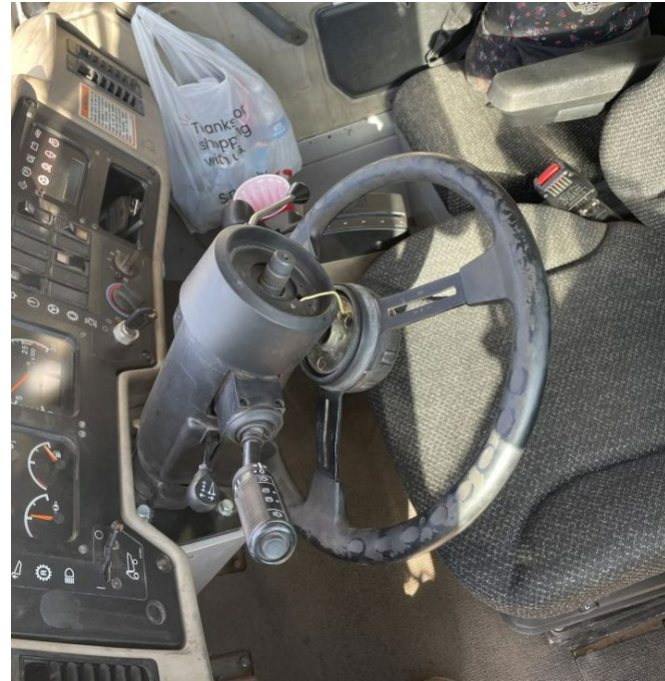
- The truck had been in operation for approximately six shifts since a recent rebuild was completed three weeks prior.
- Initial investigation by a mechanic found that a keeper nut was not tightened.
- Empire representative conducted inspection in the field and shared their standard QA process of marking the head of each nut/bolt/screw with white paint/marker as tightened did not occur for the steering wheel “keeper”.

- The cab was worked on during the powertrain plus rebuild
- The steering column was replaced with a new one
- The old steering wheel was reused
- Torque of the nut was not verified via Empire's "Cover Up" process (Q-C)
- Interviews of every current technician who worked on this machine were conducted
- The technician that installed the steering wheel is no longer employed so an interview was not possible
- A safety stand down was conducted on 9/6/23 in the Tucson facility to discuss the incident and importance of critical fasteners
- A new checklist for cab work in shop has been developed and will be used in both the Tucson and Mesa facilities
- Art McGinty from Empire has inspected the machine in the field. He reinstalled the steering wheel after the incident and reinstalled the nut to proper torque.

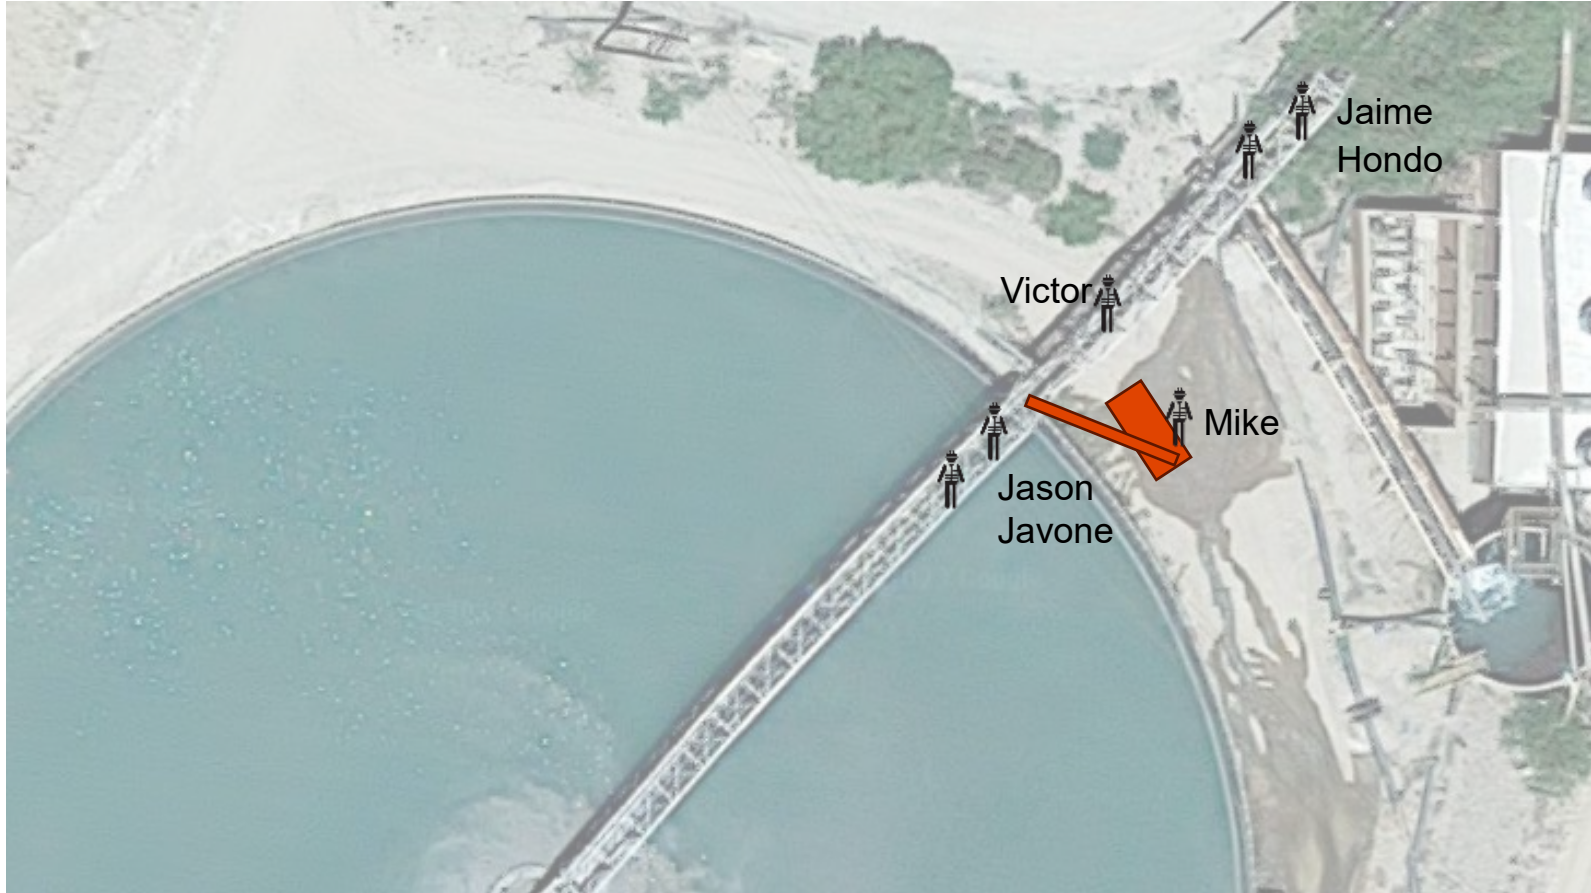
Personnel General Location

- On 8/23/23 a contractor HDPE Crew was working at the #6 Thickener adjacent to a power line near the work area. There was an electrical event from the 47K live line to the cable of the boom truck. After the Boom truck line became energized the boom truck operator moved the boom away from the line. There was not an identifiable point where it could be determined where the current went to ground to determine exact boom location.
- The contractor crew was replacing the 24-inch pipe in the center of the catwalk on the tailings pipe rack. They removed the old pipe in 10 to 15 foot sections. The crew was using a boom truck to help assist to remove the pipe. There was damage done to one of the phases of the 47k line and damage to the boom truck hoist rope.

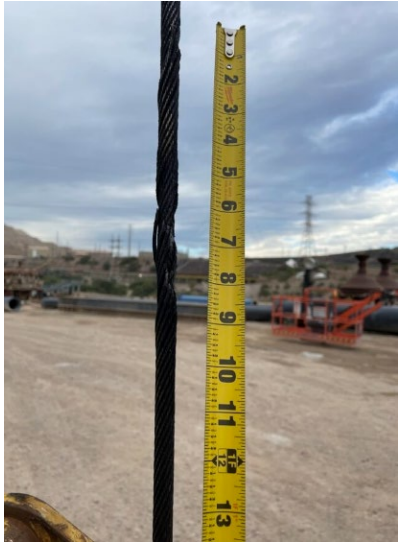
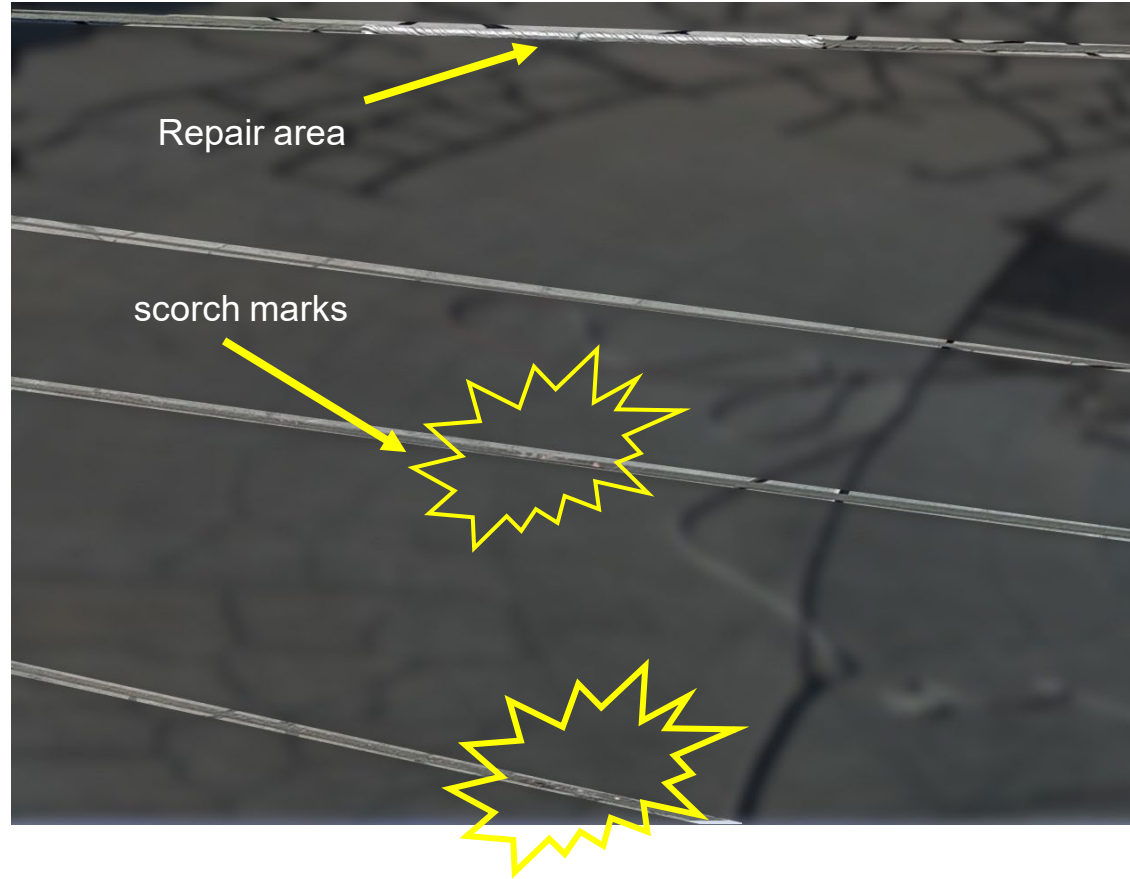
Boom Rope and Powerline damage

- Flagging and barricading for swing radius and demarcation of the 18ft centerline boundary.
- No Isolation of line discussed under 18ft planned work radius known to the crew supervisor.
- Breakdown of planned work communication between crew supervisor, operator and crew.
- Congestion issues not communicated to FMI for correction.
- Pipe pulling equipment and method changed by supervisor and not communicated to Western Industrial nor FMI supervision.

- Create Various Posters and signage to enforce the Safe Production Standards as well as the supplement for the Critical lifting program
 - Ensure that segregation with flagging and barricading is done in the area to isolate

- Additional flagging and barricading as well as any engineering controls from the critical lift permit.
- Engineering :
 - Purchase a proximity electrical warning device for alerting of electrical hazards in the area.

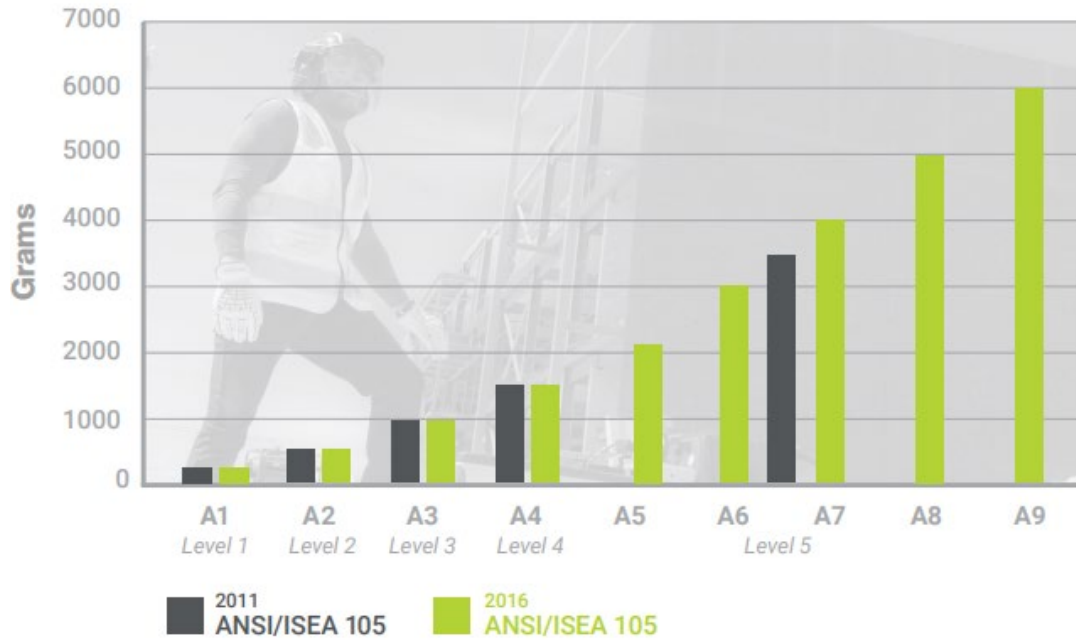
Glove Cut Ratings

Cut resistance rating system: 2011 vs. 2016

Using utility knives or similar: cut resistant sleeves and gloves with cut resistance rating of 5 (ANSI or equivalent) must be used

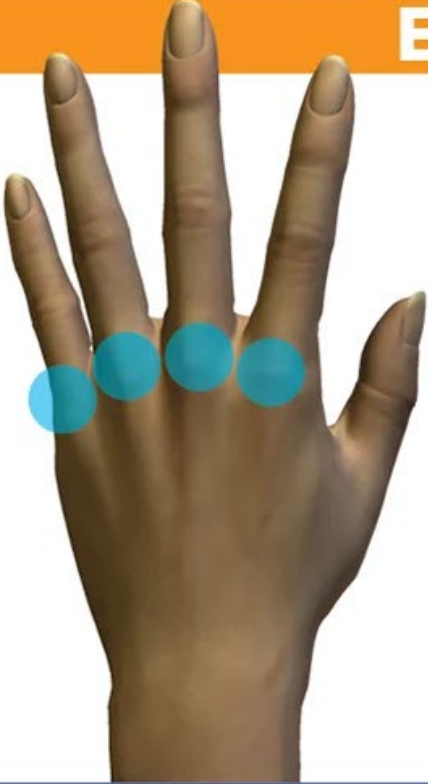
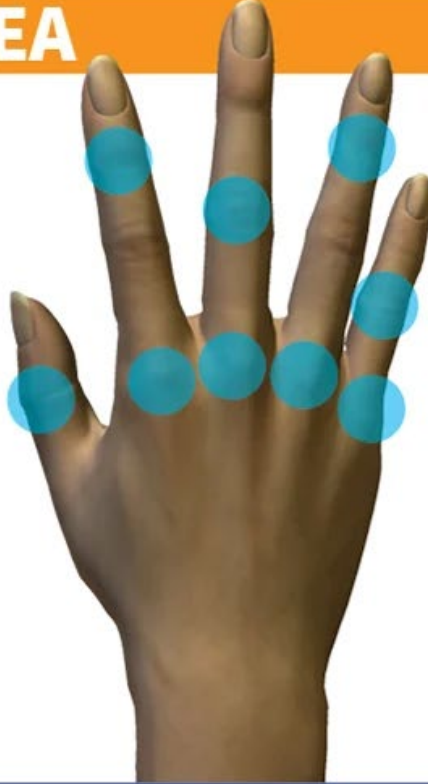
Glove Impact Ratings

<ul style="list-style-type: none"> • 4 Tests • Pass/Fail $\leq 7\text{kN}$ • EN Reference Digit <u>4244XX</u> ↑ 	<ul style="list-style-type: none"> • 18 Tests <div style="display: flex; align-items: center;">

<p>EN 388 Impact Standards : Knuckle Only</p>	<p>ISEA 138 Impact Standards : Knuckle & Fingers</p>
