## SAFETY ALERT NOTIFICATION

OPERATION:	Norwich Operations			Incident:	X
ISSUED BY:	Brian J. DeGrafft			Injury:	
DATE:	March 16, 2015			Property Damage:	
TIME:	0400			Process Loss:	
LOCATION/DEPARTMENT:	Receiving Department				
INCIDENT DESCRIPTION:	An incoming load of cathode was being unloaded from a van-style trailer truck that had been in a hard-braking incident enroute, which resulted in the cathode bundles breaking apart. The GPS tracker unit was buried somewhere among the scattered cathode sheets. While the cathode was being moved by a forklift operator, a sound similar to opening a bottle of soda was heard and flames were observed coming from between the cathode bundles, as the GPS tracker burned. The fire was quickly extinguished. Upon examination of the unit, it was found the Lithium Ion battery in the unit had caught fire, likely from damage from the copper cathode and burned through the protective case.				
DETAILS OF INJURY TYPE:	N/A

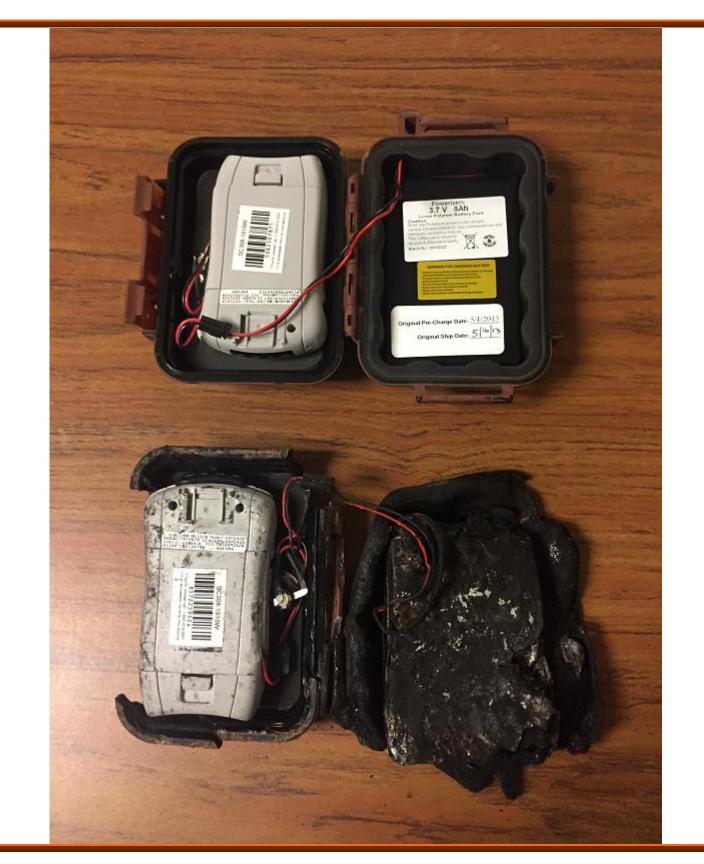
POTENTIAL FOR INJURY:	Fatality	Lost Time	Permanent Disability	Other Potent	ial
				Fire	
PROBABLE DIRECT CAUSES:	Crushing from the cathode may have caused the battery to catch fire.				
IMMEDIATE CORRECTIVE ACTION:	Fire was extinguished and damaged equipment sent to manufacturer for analysis				
REQUIRED ACTIONS:	Mechanical abuse / damage to lithium battery cells can cause shorting between cell electrodes, leading to thermal runaway and fire. Avoid placing batteries or equipment containing batteries where they may be damaged during transport or normal use.
