SAFETY ALERT NOTIFICATION		Safety Alert #	SA – 2017 - 12

<h2>Morenci Light Vehicle/ Haul Truck</h2>	IMS #	78757
		OPERATION:	FMMO
		INCIDENT DATE:	7/20/2017
		TIME:	4:30 PM
		TYPE:	Near Miss
Issued By: Justin White, Morenci Mine Superintendent		Contact For Additional Details: jwhite2@fmi.com

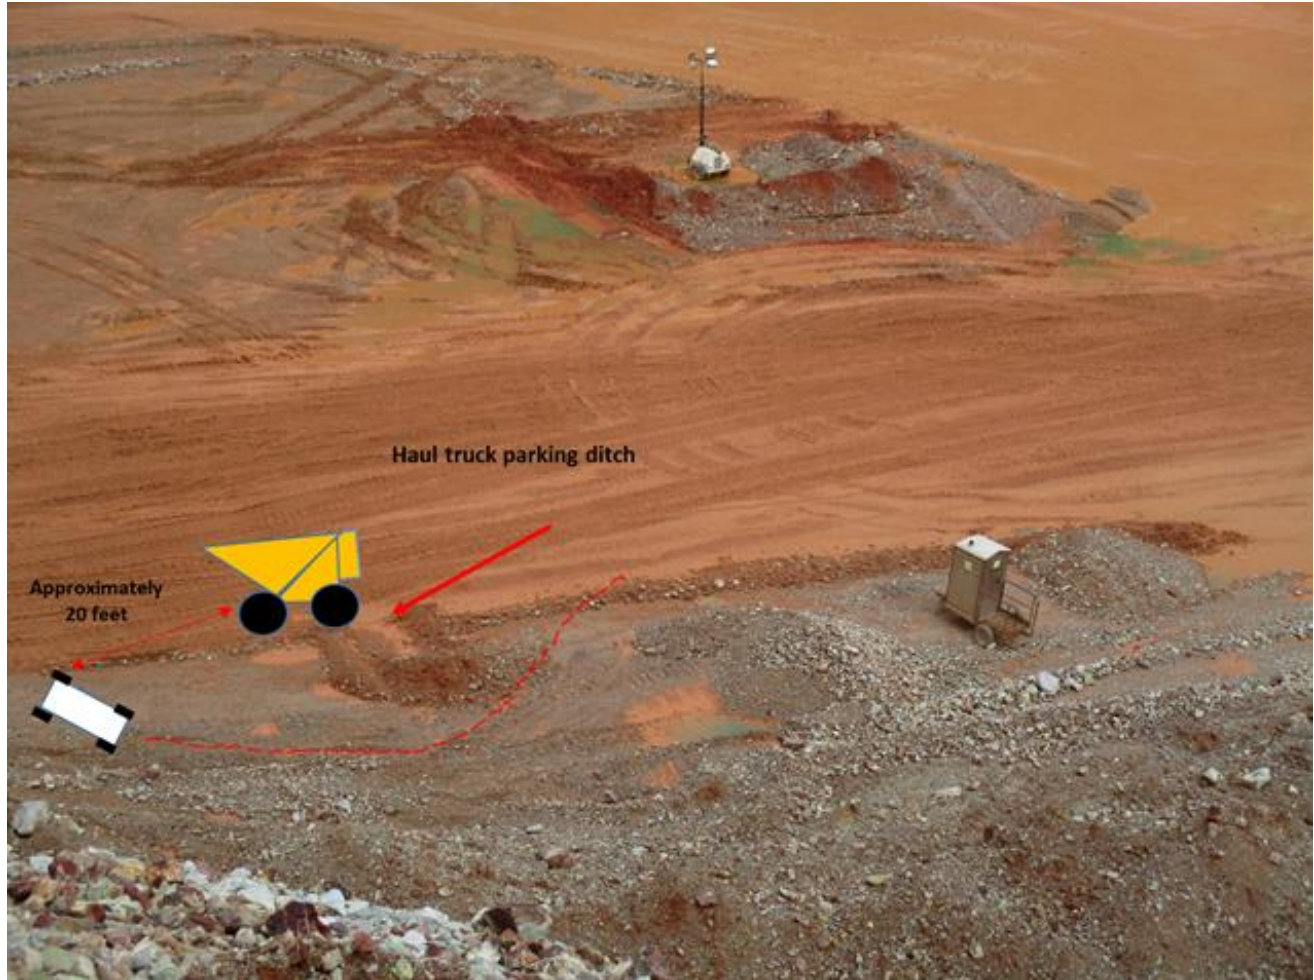
On July 20, 2017, at 4:30 pm, a Ford Transit man van, with 11 employees on board, pulled onto a stockpile to change out the driver of a haul truck with BO air conditioning. As the truck had not yet arrived, the van operator pulled into the porta-john tie-down, located on the stockpile which was separated only by a windrow from the haul road.

At this same time, a different Caterpillar 793D haul truck approached the tie down area to use the restroom. As the driver, a trainee, approached, she noticed that there was a van parked on the her blind side. The trainee had made the decision to leave this area and drive to a different porta-john due to the close proximity of the parked van to her haul truck, which made her uncomfortable. As the haul truck started to pull forward the mentor instructed the trainee to stop.

Observing the haul truck stop, the operator of the van decided to get out of the way by travelling behind the haul truck (without using radio communication). At this very same time the mentor in the haul truck reached over and put the haul truck in reverse (without using the horn signals), telling the operator to just back into the ditch and just stay at this porta john.

The haul truck reversed at 2.8 MPH, unaware that a van had maneuvered behind the truck. Seeing the haul truck in reverse, the passengers in the van then alerted the van driver to hurry and get out of the way.

The haul truck was approximately 20 feet away from the van when it exited the area.

- Van operator contacted supervision to conduct investigation
- Communicated event, proper practices and expectations in division: Fundamentals of communication, parking requirements, approaching porta johns at stockpiles, man van responsibilities

- Review expectations for adherence haul truck operation safety policies: Positive radio communication with haul trucks, cab side approach to a parking area.
- Review mentor and van operator responsibilities.
- Audit operator practices for access and parking at stockpiles
