SAFETY ALERT NOTIFICATION		Safety Alert #	SA – 2017 - 4	
		IMS #	76060	
 	Bagdad Clean Harbors		OPERATION:	Bagdad
			INCIDENT DATE:	3/28/2017
			TIME:	1500
			TYPE:	Near Miss
Issued By: Wally Alsumiri, Health & Safety Specialist		Contact For Additional Details: 928-925-4860

INCIDENT DESCRIPTION

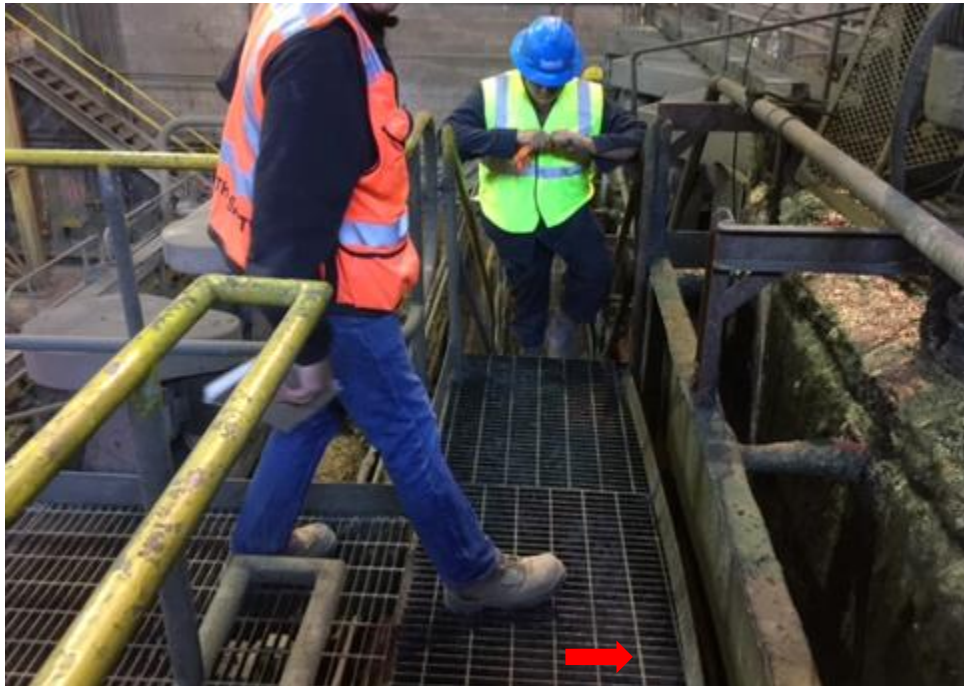
On March 28, 2017, a contractor was performing work in the Bagdad Concentrator that required them to utilize elevated walkways. During the job, the contractor was tasked to ‘shut-off water flow’ and when leaving the work area stepped unknowingly on an unsecured piece of metal walkway grating. When this occurred, it caused the grating to shift and the individual’s right boot dropped approximately 3-5 inches below the grating surface. Fortunately, the contractor was able to catch himself from falling by holding onto the adjacent handrail.

Picture 1: Demonstration photo only. This photo was taken after repairs were completed.

- Stopped work
- Notified Safety
- Grating was tach welded in place

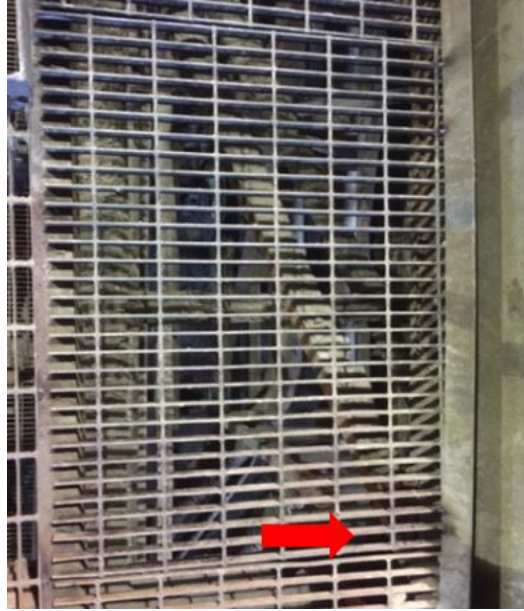
- **30 CFR 56.11001** – Safe access was not maintained in all working places.
 - The grating had not been secured (no welds present) after initial installation.

Picture 2: Red arrow shows the direction the grating shifted. The toe-board in the picture was unsecured at the time of the event. This photo was taken after repairs were completed.

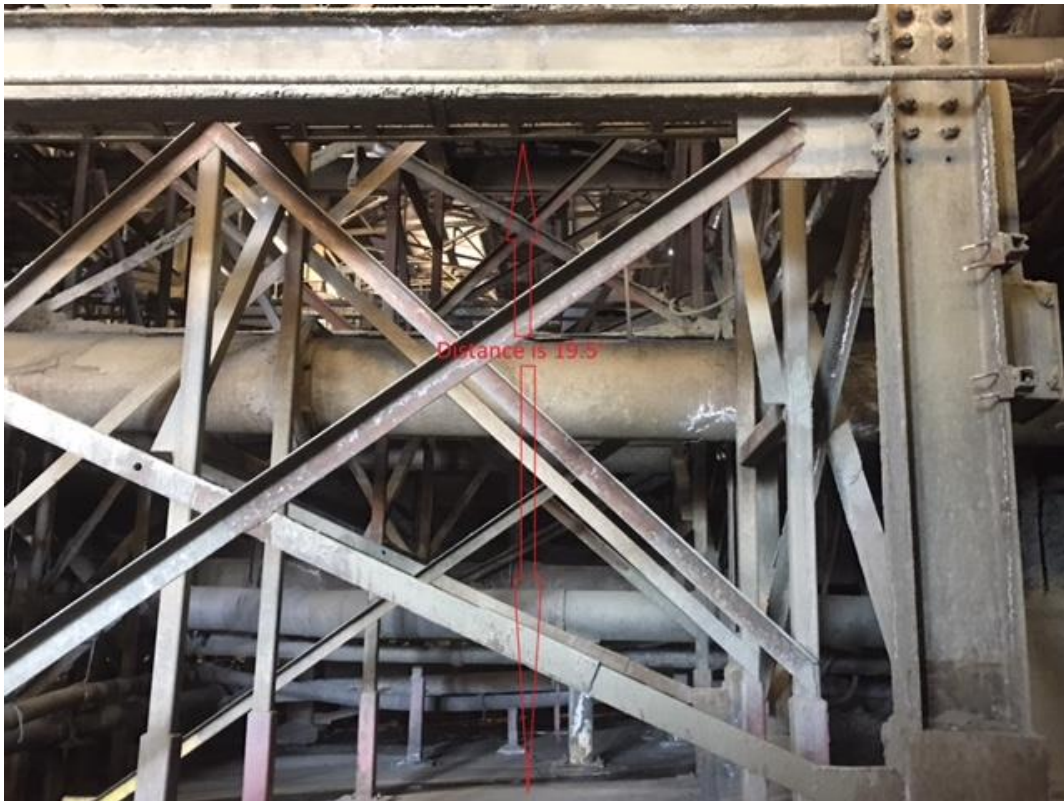
- When the grating shifted it created the potential for exposure to an open hole condition.
- The distance between the walkway and the ground below was measured out to be 19 1/2 feet.

Picture 3: This depicts the distance below the walkway to ground level below.
