Freeport Safety Updates

April 2024

(Incidents and Communications from March 2024)

Freeport Safety Incidents, Successes, & Alerts

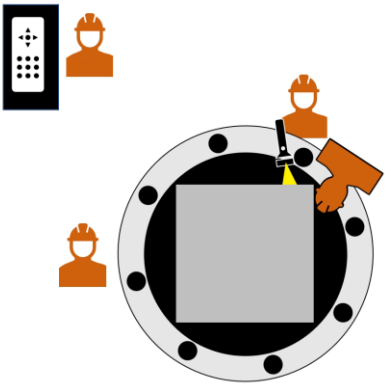
Preliminary Incident Details	
Operation	Morenci
Date / Time	March 22, 2024 / 9:20 p.m.
Event Type	Injury – First Aid
Summary	While attempting to clean out material in a 2B shorthead, an employee’s head became stuck between the mill locking post and discharge chute. When the employee realized they were stuck, they tapped a supervisor’s shoulder. The equipment was backed off, and the employee was released.
Risk Category	Actionable – Significant (3) Likely (3)
Findings / Missing Controls	Control of Hazardous Energy
Applicable Policies / Procedures	FCX HS04 Control of Hazardous Energy
Employee Condition	Employee was treated by first aid
Contact	Jacob Sweet, Manager-Health & Safety Jason Bartlett, Manager-Mill

Pinch Point – Hydraulic ram and feeder

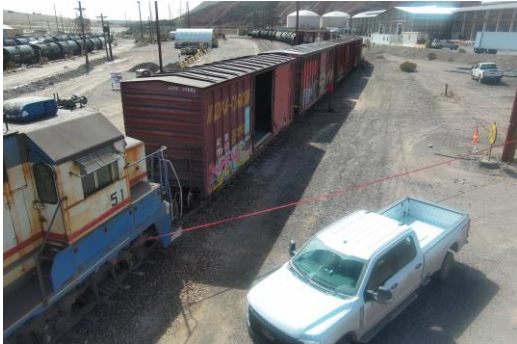
Morenci, March 5, 2024

The Industrial Railroad crew was switching out boxcars at the south side of a copper dock. The locomotive operator and a trainee were standing on the engine stairs and leaned out facing away from the direction of travel. While doing so, the operator's body struck a rail switch guard sign. The operator flipped over the handrail, landing face down on the ground. The operator's right arm landed on the track and was run over. A Mayday was called, and emergency services were dispatched to the area.

- Be aware of the Industrial Rail Policy
- Do not ride on train stairs
- Complete site assessment to determine alternate means to minimize or eliminate the need for train ground crews to mount/dismount a train in motion
- Train crew may only ride on the platform of the leading end of railcars, if necessary to perform duties
- Switch personnel may only ride on leading end of railcars for spotting during pushing/shoving operations
- Do not work on or around rail or trains unless trained to do so
