# FCX Monthly Safety Content

## FCX Safety Updates

December 2023

(Incidents and Communications from November 2023)

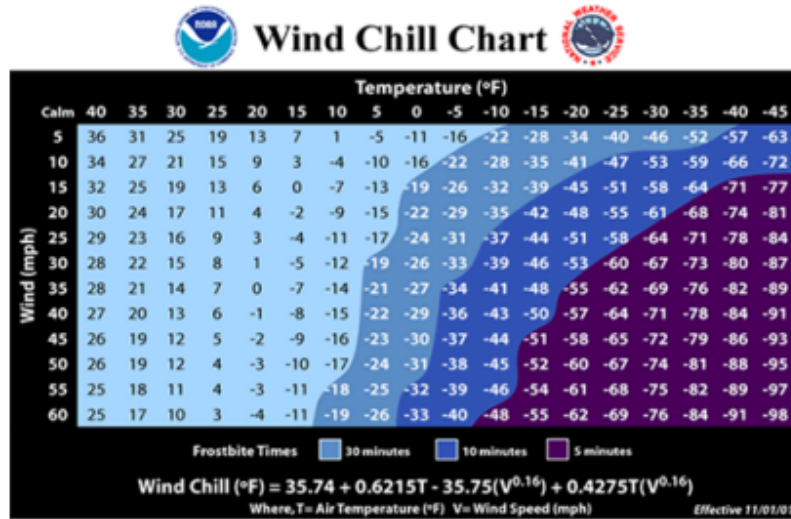
Cold weather can cause cold stress, which can lead to hypothermia, frostbite, and other severe injuries, and illnesses.

In addition, some portable heaters can emit deadly carbon monoxide (CO). CO is odorless and colorless and can accumulate in confined spaces and enclosed areas such as the cabs of vehicles, work trailers, and unventilated areas. Exposure to 200 parts per million of CO for 15 minutes can cause disorientation, unconsciousness and eventual death.

- Monitor your physical condition and that of your coworkers.
- Wear appropriate clothing.
- Wear clothing that allows a full range of motion necessary for the tasks of the work.
- Move into warm locations during breaks.
- Include chemical hot packs in your first aid kit.
- Avoid touching cold metal surfaces with bare skin.

- Maintenance of fuel-burning equipment and vehicles is crucial. Vehicle exhaust systems need to be regularly inspected for leaks or other damage.
- Monitors and audible alarm systems should be in place wherever CO is a potential hazard. Use portable CO detectors as necessary.
- Properly ventilate work areas. The ventilation system should be designed and maintained to remove contaminants from the mine atmosphere.
- Maintain travelways and keep them free of ice and debris.
