FCX Monthly Safety Content

FCX Safety Updates

January 2024

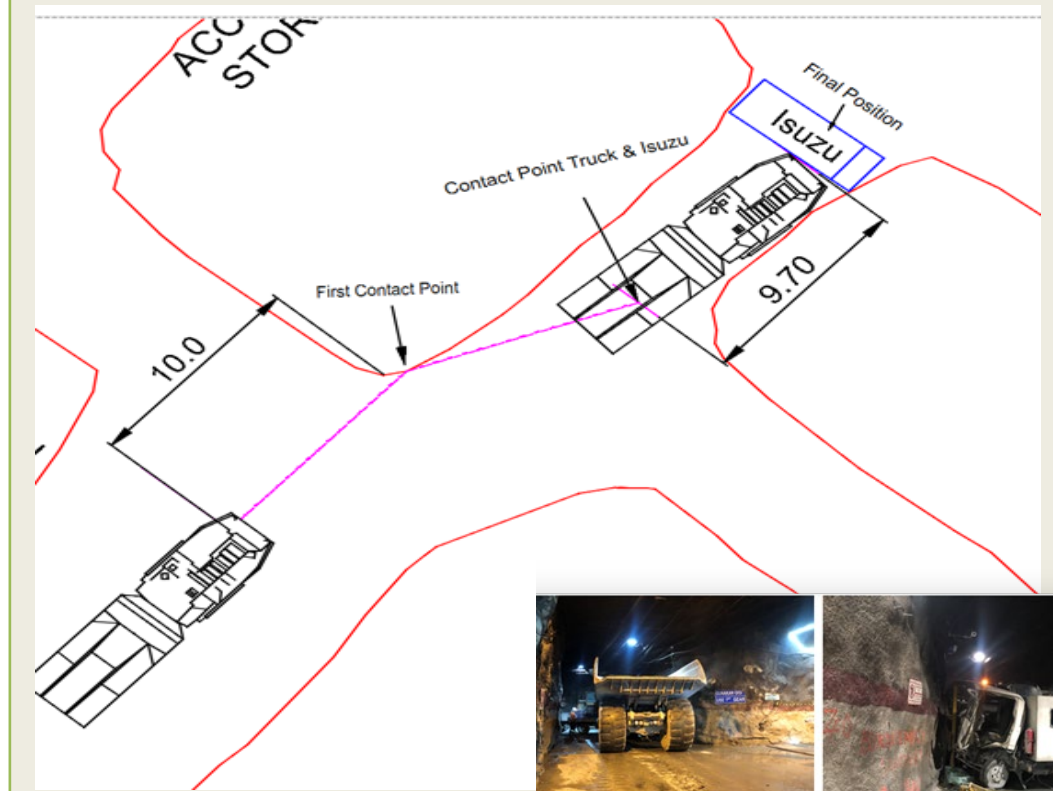
Applicable Policies / Procedures	<ul style="list-style-type: none"> •SOP-6.01-UG-J05 Operating Procedure Truck Elphinstone Series AD30, AD55, AD55B and AD60 •SOP-6.01-UG-J08 Elphinstone AD55, AD55B and AD60 Truck Operating Procedure and Truck Guidance System
Employee Condition	Man haul operator sustained a hand abrasion and shin contusion and was released fit for work after undergoing medical observation at Ridge Camp Clinic.
Contact	Matthew Sullivan, Sr. Vice President-Underground Mine Division

Right: Photos of damage to the man haul
