ACTIONABLE LESSONS LEARNED: Operator Electrical Shock

Exposure to
Electrical Hazards

Chino, March 6, 2024

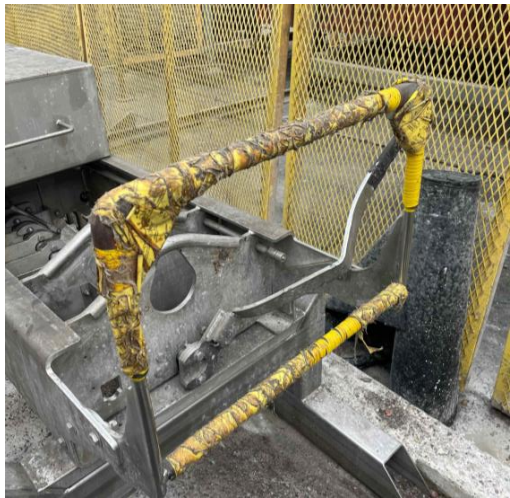
- The integrity of the crane hook insulator was compromised from excessive grease and moisture.
- The crane hook insulators lacked a weekly Megger Meter check for insulator resistance. Megger readings were not documented per Electrowinning/Electrorefining (EW/ER) policy.

A crane operator was harvesting cathodes from cell 8 inside a jumper frame. The employee was removing the second pull when a wet pantleg came into contact with the jumper frame above the boot. The operator sustained a minor shock.

- **Engineering** – Retrofit tank house cranes with non-conductive cables.
- **Substitution** – Replace crane hook grease materials with non-conductive grease. Contractor preventative maintenance reports to be received and reviewed by Freeport site leadership to verify compliance.
- **Administrative** – Create process for crane hook Megger Meter checks at the start of each shift. Meter readings to be conducted by an electrician and reported to leadership. Equipment to be removed from service if insulator fails testing.
- **Administrative** – Corporate Operational Improvement Electrical Subject Matter Expert to inspect tank house and provide recommendations for safety improvements. Will evaluate potential for isolating jumper frame and insulate strongback.
