SAFETY ALERT NOTIFICATION

OPERATION:	Morenci		Incident:	
ISSUED BY:	Robert Chellini, Mgr Mine Planning Engineering		Injury:	
DATE:	5/11/2014		Property Damage:	X
TIME:	6:45PM		Process Loss:	
LOCATION/DEPARTMENT:	Morenci Mine			
INCIDENT DESCRIPTION:	<p>At 6:45PM on 11 May 2014 the Slope Stability Department was notified by the Mine Dispatchers that there was an alarm on the 200_WCP (Western Copper) IDS IBIS radar. This unit is located on the 5550 elevation on the western edge of Northwest Extension. This radar looks to the east and monitors high walls of the Western Copper Pit.</p> <p>Upon inspection it was found that the dust cover over the track, normally held in place by a bracket had come off of the bracket on one end and been pushed out of alignment by the radar unit as it tracked along the rail.</p> <p>It was determined that rubber isolators between the dust cover and accompanying bracket had deteriorated due to weathering causing the dust cover to dislodge. Normal scanning movement resulted in the dust cover becoming wedged against the rail preventing the system from operating.</p>

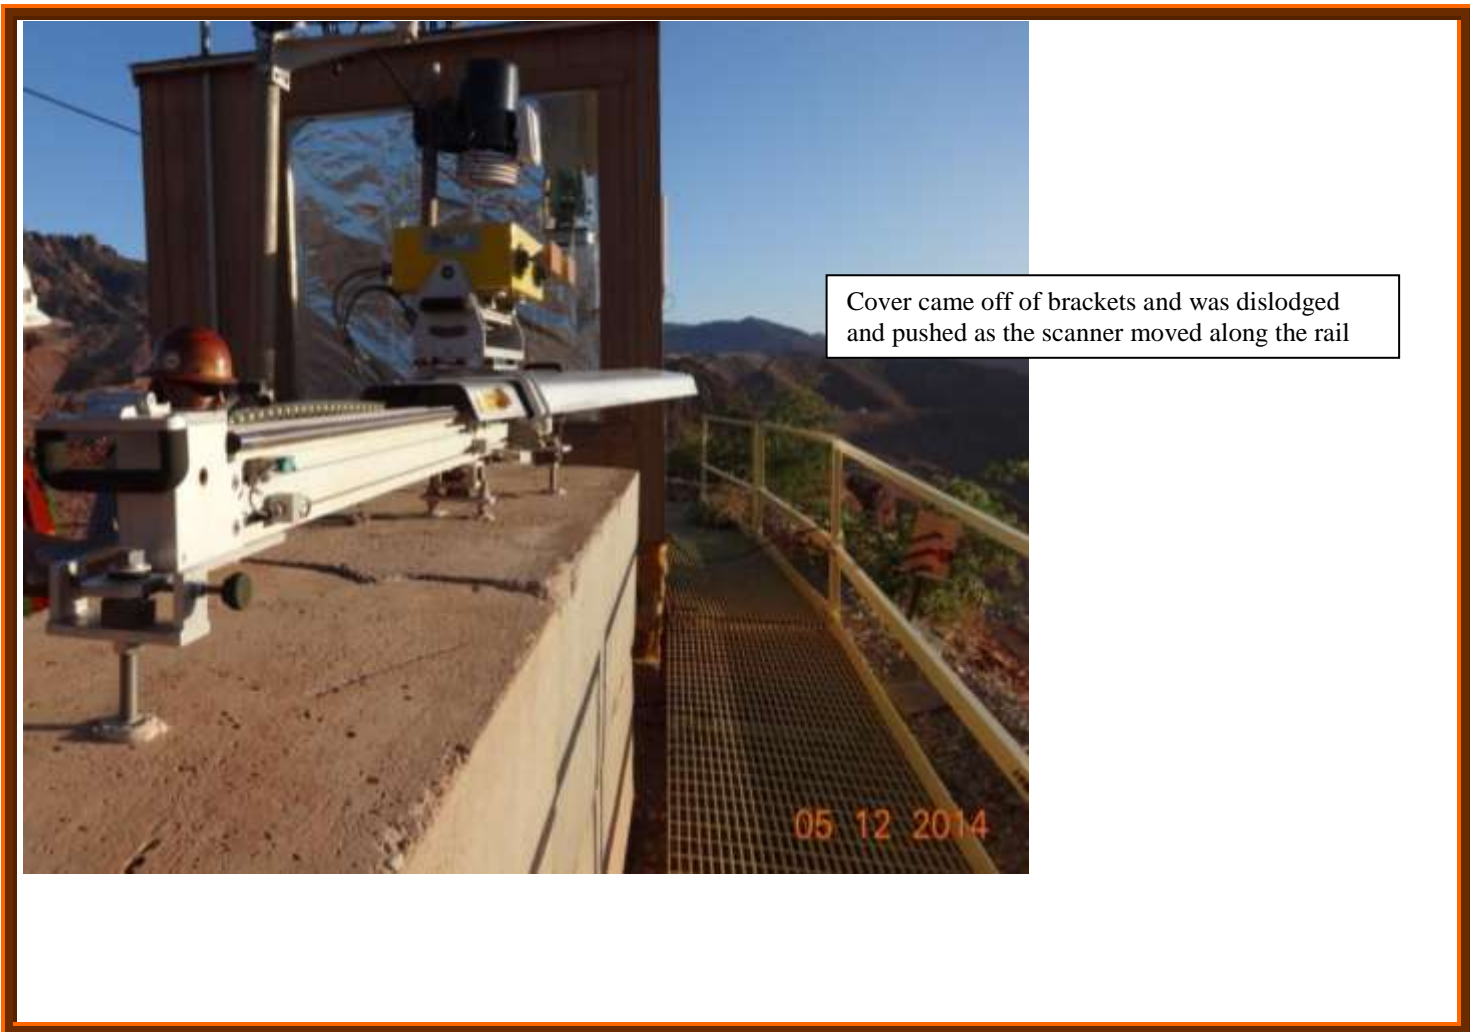
Deteriorated rubber cushion on bracket - Cover normally held in place by brackets, however was dislodged and pushed out of alignment as radar moved along track.

<p>The dust cover was removed and the unit placed back in service.</p> <p>The vendor shipped two brackets and the cover was replaced 14 May 2014.</p> <p>The other two radar units of this type in operation were inspected and it was determined that several brackets were deteriorating and also needed to be replaced.</p> <p>Additional brackets were shipped to site.</p>
<p>REQUIRED ACTIONS:</p>	<p>Checking these brackets has been included to the inspection schedule to make sure this type of incident does not reoccur.</p>
