E FREEPORT- MCMoRAN		
		Safety Alert #	SA – 2016 - 10	
	SAFETY ALERT NOTIFICATION		N/A	
			External	
	Valve Failure (External Company)	INCIDENT DATE:	12/6/2016	
		TIME:		
		TYPE:	Injury	
Issued By: DOHS	Contact For Additional Det	Contact For Additional Details: Mitch Kruger or Steven Richardson

INCIDENT DESCRIPTION

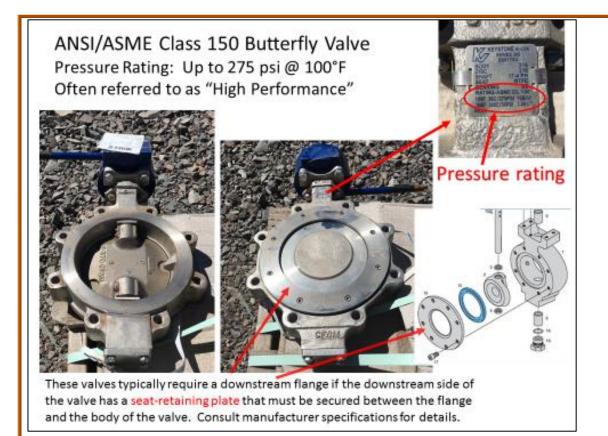
- A key issue was confusion regarding the pressure ratings and naming conventions of butterfly valves. The valve that failed was a rubber-seated butterfly valve with a pressure rating of 150 psi. However, the valve that had been specified was an "ANSI/ASME Class 150" valve, which would have had a pressure rating up to 275 psi. It is often common-place for both of these valves to be generically referred to as "150-pound valves", which can easily lead to confusion regarding the distinction between the two classifications.

- The end-point butterfly valve was a lug-type and was installed without a down-stream flange. While some valve manufacturers allow this type of installation indefinitely without affecting the pressure rating, others stipulate a reduced pressure rating in absence of a downstream flange. The failed valve was a rubber-seated butterfly valve that requires the installation of a downstream flange. Without the downstream flange to secure the seal, the rubber seat material failed and broke free from the valve body, leaving a gap between the metal valve body and the butterfly disk.

Figure 1 Las Bambas valve involved in the incident. The rubber seat material failed and broke free, leaving a gap between the metal valve body and the butterfly disk.

Most rubber-seated butterfly valves must have flanges secured on both the upstream and downstream side in order for the pressure rating to be valid.
