Monthly Contractor Safety Meeting

April 9, 2019

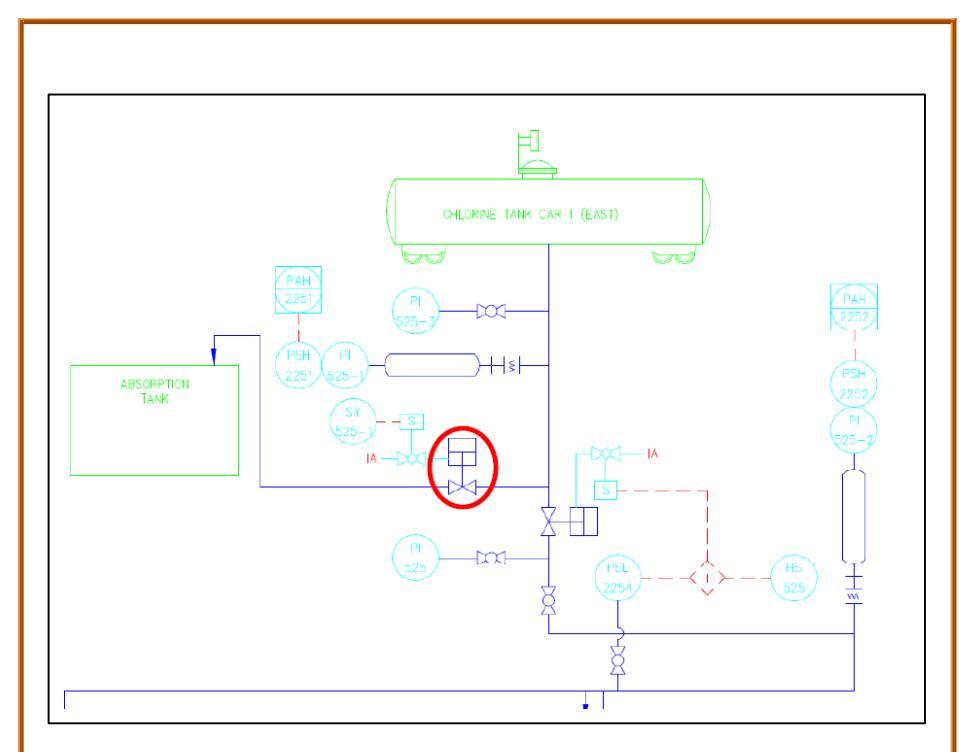
PROBABLE DIRECT CAUSES

Material incompatibility – the titanium dump valve was designed for wet chlorine use and reacted violently to the dry chlorine (<1000 ppm water) used at site. Historically, lined cast-iron dump valves were used that required frequent replacement. To extend equipment life and reduce the risk of employee exposure to chlorine, valve vendor IPT Valves, Pumps and Services recommended switching to Titanium-body Flowserve Durco TSG4 valves.

Damage to titanium dump valve.

- Implement practice to keep building roll-up doors closed with the exception of during rail car movements. Review incident with vendor who recommended the titanium valve. Change existing labels to read dry chlorine instead of chlorine. Review and update the Chlorine Emergency Response Plan. Complete and implement RCA actions. •
- •
- ٠
- •
- •
