Freeport Safety Updates

May 2024

(Incidents and Communications from April 2024)

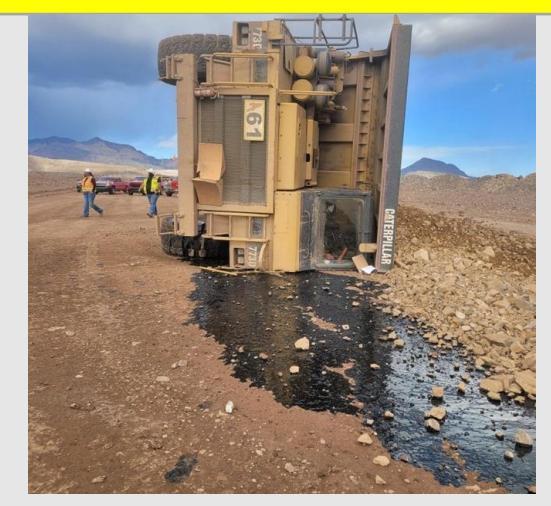
| | Preliminary Incident Details |
|---|---|
| Summary | A 773D haul truck operator was traveling on the west side of a leach pad, hauling the final load of the day, when the truck slid approximately 146 feet and tipped on its side. |
| Findings / Missing Controls | Truck speed was estimated as higher than allowed. 773 trucks were not initially planned to be used for leach pad operations. The trucks are not governed for speed like the 777 fleet. |

Skid marks and roadway.

- Engineering 773D haul trucks, specific to the Safford leach pad construction project, have been governed to limit speeds to the appropriate level.
- Administrative Contractor to present documented process to Freeport project managers regarding expectations of contractor supervision. Process to universally enforce and hold operators accountable when actions violate safety standards and policies.
- **Administrative** Freeport project managers to approve contractor accountability process. Contractor to share/communicate how this will be applied and enforced going forward.

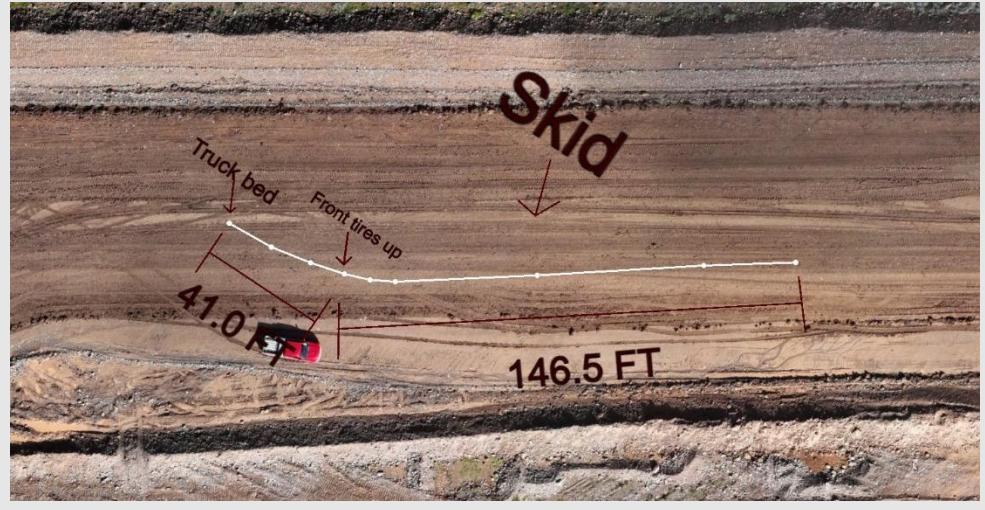
Front of truck

A haul truck was travelling approximately 40 mph down a 3-4% grade, fully loaded. The operator aggressively applied the retarder brake, causing the haul truck to skid, fishtail and flip.

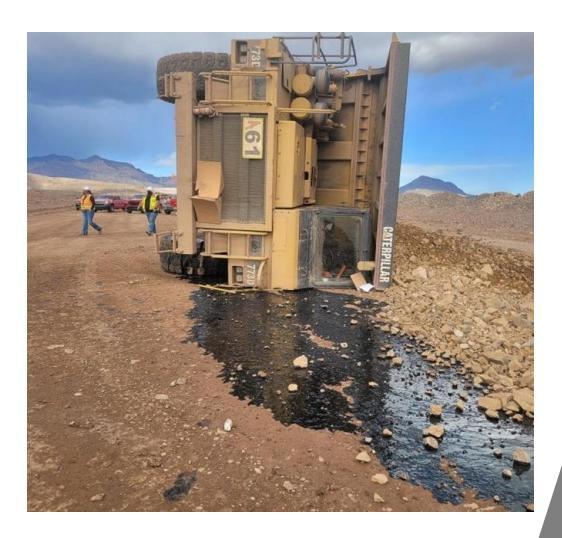
Truck slide and tip over area.

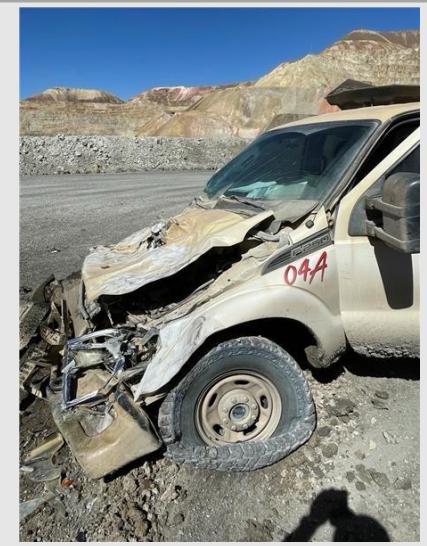
| | Preliminary Incident Details |
|---|---|
| Summary | A pickup truck, travelling from Estrella Pit towards the Crusher, entered an intersection at the same time as a haul truck travelling down a ramp from the South Dump to the Estrella Pit. The pickup did not see the haul truck and proceeded into the intersection, running into the front tire of the haul truck as it was making a right turn. The rear dual tires of the haul truck ran over the hood of the pickup truck. |
| Findings / Missing Controls | Poor road design Failure to yield to traffic Poor vehicle cleanliness obstructed the pickup driver's view |

Pickup truck following incident

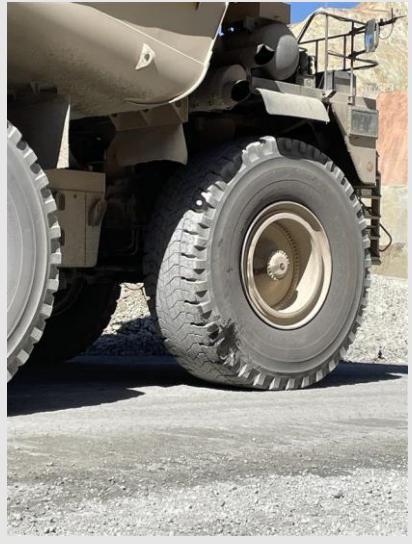
Damage to haul truck from impact.

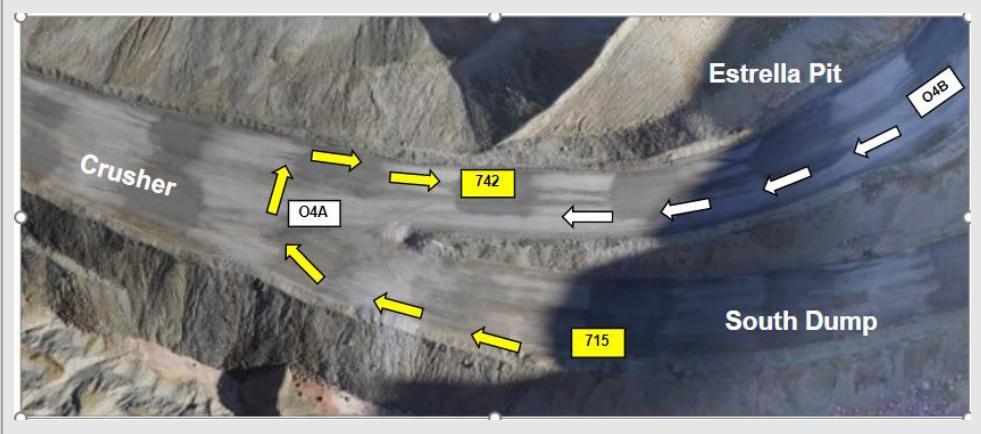
Intersection of incident. Yellow arrows – haul truck. White arrows – pickup truck.

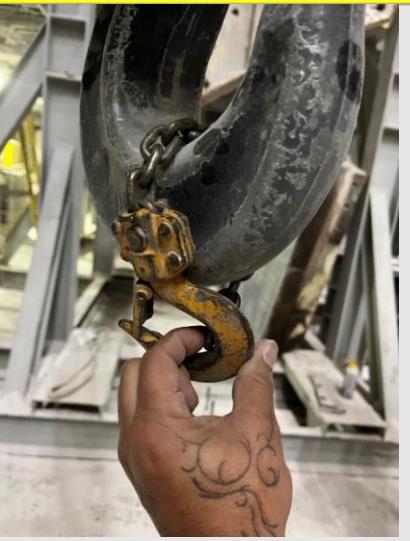
| Preliminary Incident Details | |
|---|---|
| Summary | A mechanic was lowering guides with a crane. A come-along was attached to the crane and the guide to stabilize and balance the load. The mechanic observed signs of over-tension and tried to loosen the come-along. While adjusting, the chain broke, causing a component to strike the employee's hard hat. |
| Findings / Missing Controls | Lifting execution – improper use of equipment |

Come-along secured to the crane hook.

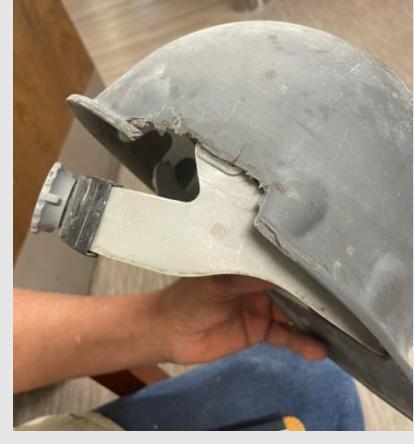
| Preliminary Incident Details | |
|---|---|
| Employee Condition | Employee sustained two lacerations and was treated with multiple staples. |

Employee's hard hat after impact.

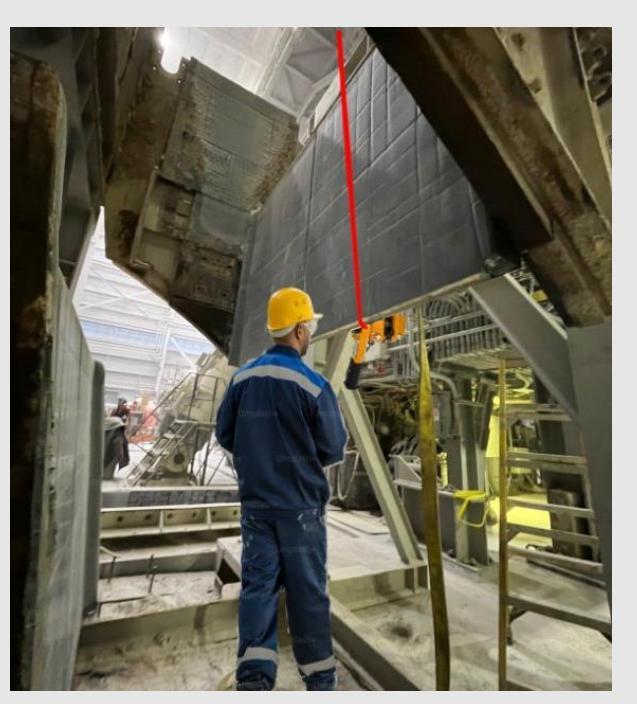
Reenactment of employee's position and chain location (red line).

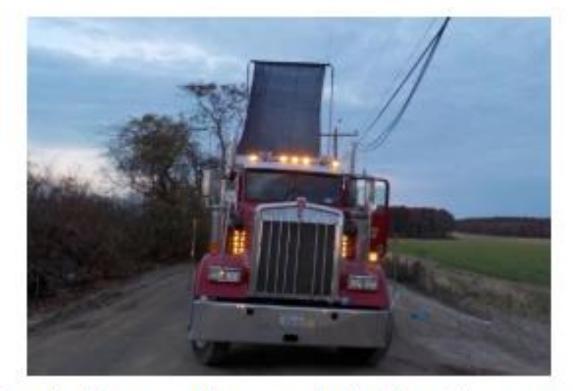
A truck driver was electrocuted when he tried to re-enter the truck's cab while the trailer's tarping mechanism was in contact with an energized overhead high-voltage power line.

- Provide site-specific hazard awareness training to customers, including commercial over-the-road truck drivers.
- Alert customer truck drivers to changes in traffic procedures, patterns, or road conditions.
- Provide fall protection or safe means of access to customers who need to gain access to containers or tankers on their vehicles if there is danger of falling.
- Provide and maintain a safe location for drivers to tarp their loads.
- Ensure customers follow proper loading and dumping procedures.

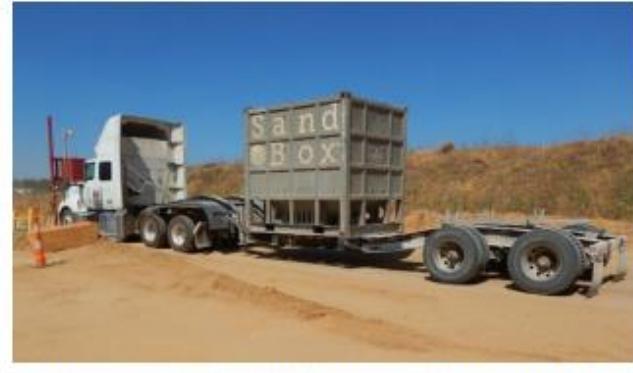
A truck driver died from injuries he sustained after he fell from a large container mounted on the trailer of his truck.

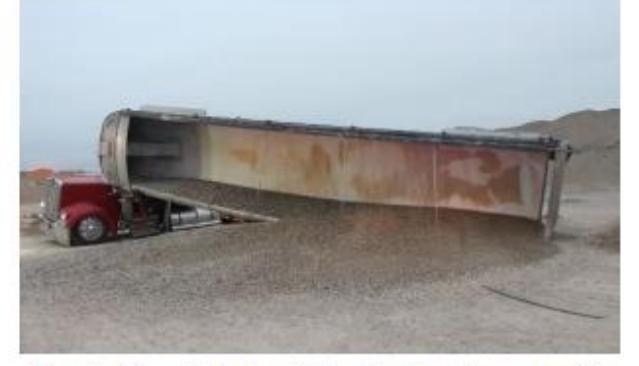
A truck driver died when his trailer tipped over onto the cab of the tractor. The driver was dumping part of the load of gravel from the trailer.

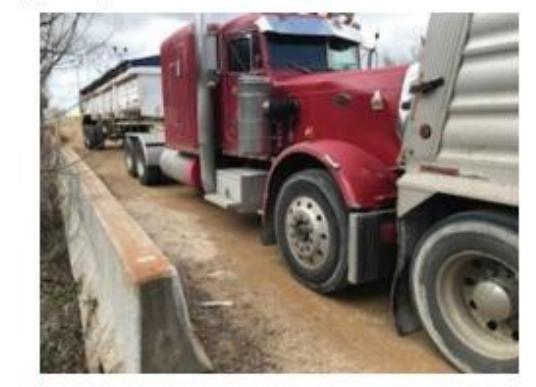
A truck driver died after he was pinned between his truck and the back of the other driver's truck.

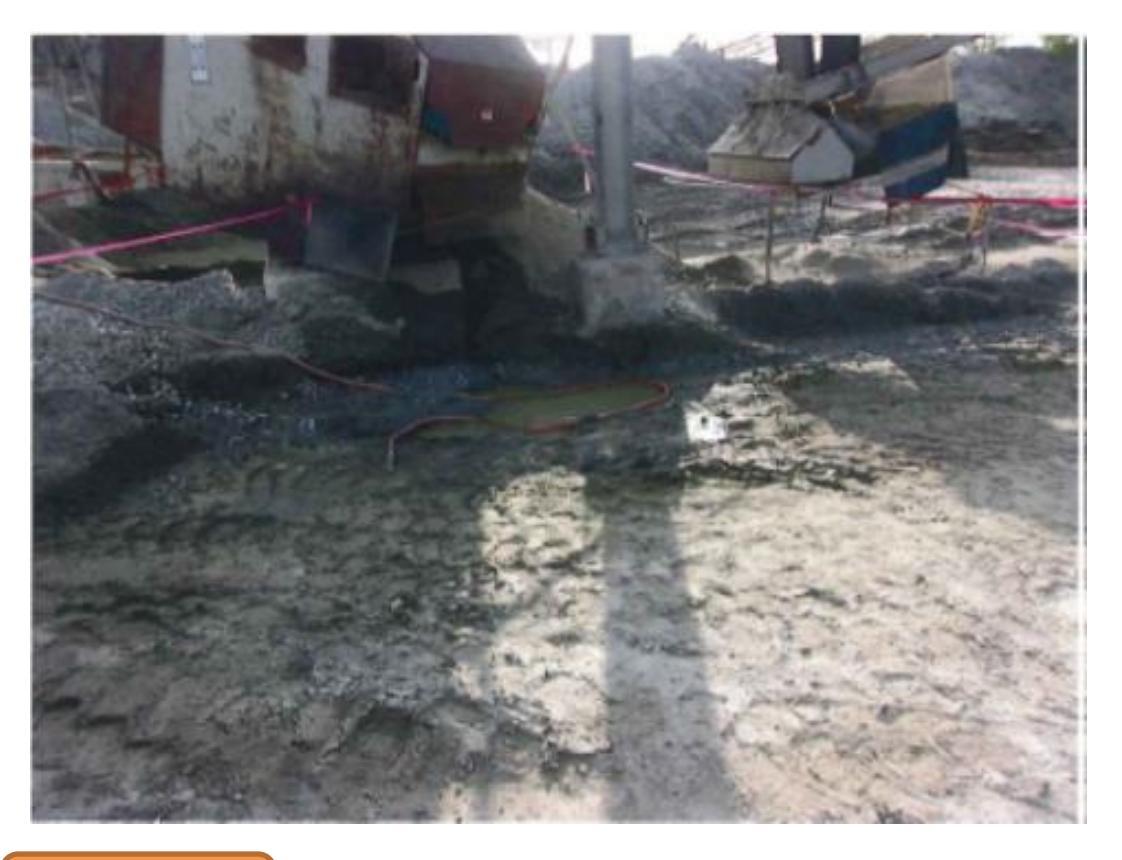
MINE FATALITY – On April 25, 2022, co-workers found a maintenance worker lying face down in a pool of water. The maintenance worker was using a water hose to wash out fine material that had gathered under a tail pulley.

- Maintain workplaces in a clean and dry condition when possible.
- Where wet processes are used, maintain drainage platforms, mats, or other dry standing places.
- Ensure that miners have communication systems available when assigned to work alone.
- Routinely check in on miners working alone.
- Conduct workplace examinations before work begins in an area
