ACTIONABLE LESSONS LEARNED: Employee Falls From Crossover

Fall from Heights

Bagdad, July 29, 2024

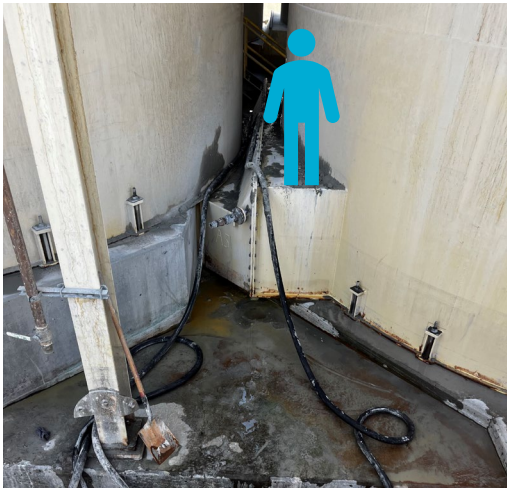
A mill employee was standing on top of a rougher flotation crossover approximately four feet from the floor. The employee fell backwards, hit their ribs on a pipe and fell to the floor.

- A hose was pulled between float cells to clean the walkways, causing it to get stuck. The employee then climbed on the crossover to free the hose. Instead, the hose should have been walked around the cells.
- Employee climbed onto a connection area that was 4 feet 3 inches high. Anything above 4 feet is a fall hazard risk.

- Guarding/railing to prevent access to areas between float cells.
- A high-pressure pump for cleanup.
- A crossover at the east end of the roughers.
- Temporary scaffolding for the crossover.

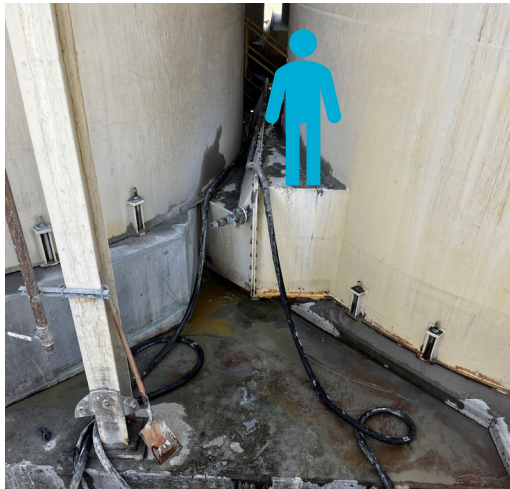
A mill employee was standing on top of a rougher flotation crossover approximately four feet from the floor. The employee fell backwards, hit their ribs on a pipe and fell to the floor.

- Do not climb onto surfaces or equipment that are not intended for standing. Especially if it exposes you to a fall hazard (anything above 4 feet).
- Work safely. Taking shortcuts creates hazards and increased risk.
- If working conditions do not meet the requirements of the task, raise concerns and solutions with your supervisor.
