ACTIONABLE LESSONS LEARNED: Miami Smelter – Slag Launder

Contact With Molten Metal

Incident Overview

January 14, 2024

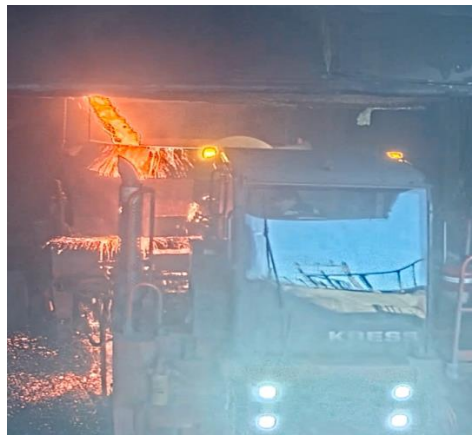
Smelter Operator Trainee gave clearance to the slag hauler operator to set the pot in place to receive slag from the east slag launder. Without confirming that the pot was in place, the operator opened the tap hole while the slag hauler was maneuvering the pot into position. The slag spilled on the ground and slag hauler. The slag hauler operator quickly moved the hauler and pot away from the pouring slag. No damage to the hauler was reported.

- Skimmer opened the west side tap hole without verifying the pot was positioned correctly.
- Skimmer and slag hauler operator were not in communication during task.

• **Engineering** – Miami engineering department will evaluate a proximity system that can detect haulers and pot positioning in the working area. If the system detects a hauler has entered the area, or a pot is lacking under the chute, tapping equipment will be shut off and the skimmer will not be able to open the slag tap.

• **Engineering** – Closed circuit television monitors will be added in slag skimming area. Skimmer will have visual of movement underneath slag deck.

• **Engineering** – Slag skimming area redesign (scheduled 2025) will improve slag hauler approach to picking pots. Tapping machine will be operated by skimmer via remote control.

• **Administrative** – Employees will be retrained on existing slag skimming and slag hauling controls.
-

• **Administrative** – Proper use of communications and tools must be identified and expectations reinforced. Consequences will be applied when protocol is not followed.

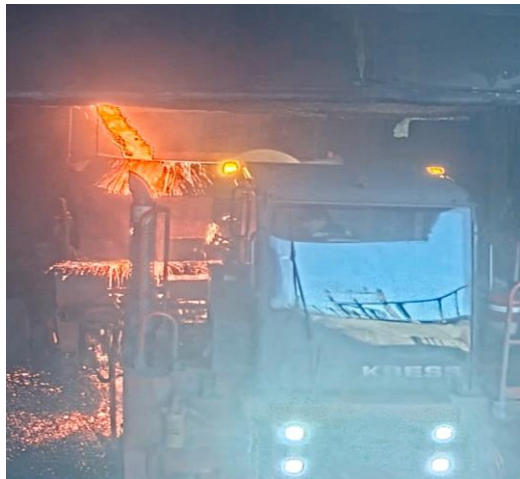
Smelter Operator Trainee gave clearance to the slag hauler operator to set the pot in place to receive slag from the east slag launder. Without confirming that the pot was in place, the operator opened the tap hole while the slag hauler was maneuvering the pot into position. The slag spilled on the ground and slag hauler. The slag hauler operator quickly moved the hauler and pot away from the pouring slag. No damage to the hauler was reported.

- Maintain positive communication with slag hauler operator to verify pot positioning.
- Identify tasks that require positive communication. Validate you are communicating as required.
- Report fit for duty.
- Perform Fatal Risk Management (FRM) verification to confirm all critical controls are in place.

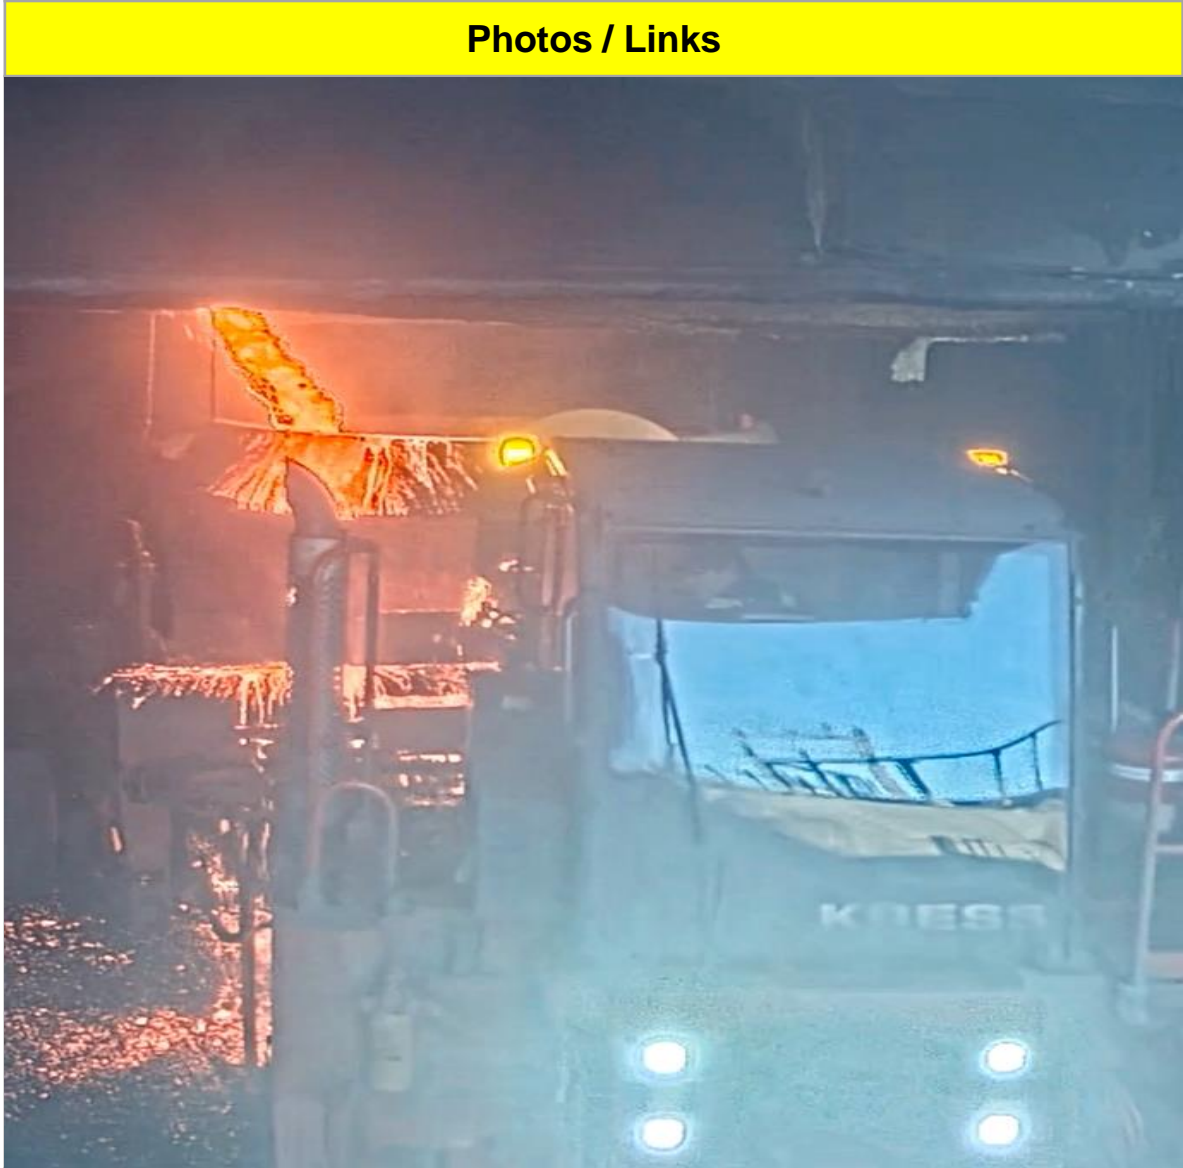
Preliminary Incident Details	
Operation	Miami Smelter
Date / Time	January 14, 2024 / 12:43 p.m
Event Type	Near Miss
Summary	Smelter Operator Trainee gave clearance to the slag hauler operator to set the pot in place to receive slag from the east slag launder. Without confirming that the pot was in place, the operator opened the tap hole while the slag hauler was maneuvering the pot into position. The slag spilled on the ground and slag hauler. The slag hauler operator quickly moved the hauler and pot away from the pouring slag. No damage to the hauler was reported.
Risk Category	Actionable – Significant (3) Likely (3)
Findings / Missing Controls	<ul style="list-style-type: none"> • Communication between slag skimmer and hauler operator • Visual verification
Applicable Policies / Procedures	<ul style="list-style-type: none"> • Slag skimming standard operating procedure • Communication expectations
