ACTIONABLE LESSONS LEARNED: Water Truck Hits Berm

Vehicle Collision

Morenci, March 10, 2024

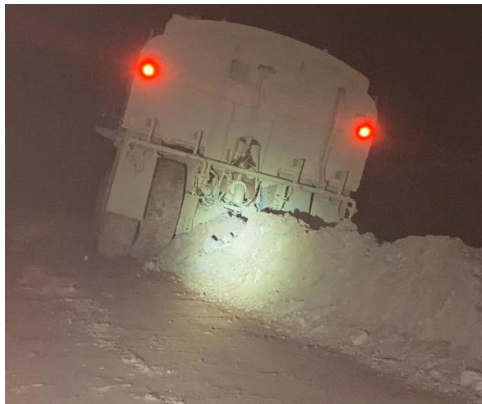
During a second run to water drills, a water truck was travelling on a ramp with approximately 10,000 gallons of water in the tank. At the top of the ramp, the operator identified the area was no longer adequate to safely turn around without running over drill holes. The operator decided to back down the ramp to exit the work area. While backing down, the truck drove through a berm and was high centered at a 45-degree angle. On the other side of the berm was an approximate 180-foot drop.

- Water truck operator was not informed that drill hole airbags are intended to maintain the integrity of the drill holes so they can be driven over.
- Water truck operator did not request a spotter while maneuvering out of a congested work area.

- **Administrative control** – Backing down ramps will no longer be permitted for water trucks and lube trucks. If an operator is in a situation where they need to back down a ramp, a supervisor will determine the best course of action (dozer to widen ramp/road, provide spotter, etc.).

- **Administrative control** – Update heavy equipment training (water trucks, 777s, lube trucks, etc.) and In-Pit Driving training to include:
 - No backing down ramps
 - Purpose of drill hole air bags

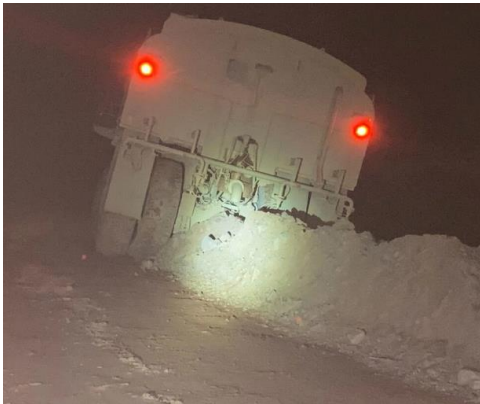
During a second run to water drills, a water truck was travelling on a ramp with approximately 10,000 gallons of water in the tank. At the top of the ramp, the operator identified the area was no longer adequate to safely turn around without running over drill holes. The operator decided to back down the ramp to exit the work area. While backing down, the truck drove through a berm and was high centered at a 45-degree angle. On the other side of the berm was an approximate 180-foot drop.

- When driving any type of equipment, and in tight quarters, request a spotter to assist with backing up.
- Do not back water trucks or lube trucks down ramps.
- If you find yourself in a situation where you need to back down a ramp, stop and ask your supervisor for help. Your supervisor will determine the best course of action (dozer to widen ramp/road, provide spotter, etc.)

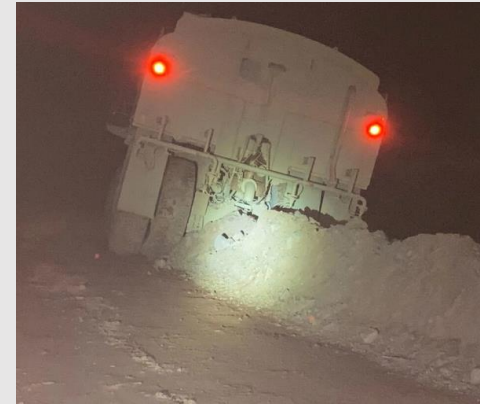
Operation	Morenci
Date / Time	March 10, 2024 / 2:05 a.m.
Event Type	Property Damage
Summary	During a second run to water drills, a water truck was travelling on a ramp with approximately 10,000 gallons of water in the tank. At the top of the ramp, the operator identified the area was no longer adequate to safely turn around without running over drill holes. The operator decided to back down the ramp to exit the work area. While backing down, the truck drove through a berm and was high centered at a 15-degree angle. On the other side of the berm was an approximate 180-foot drop.
Risk Category	Actionable – Significant (3) Likely (3)
Findings / Missing Controls	<ul style="list-style-type: none"> Berms were sufficient height and width Operator failed to follow operating procedure inhibiting reverse travel with water load
Applicable Policies / Procedures	Applicable Morenci SOP
Employee Condition	No injuries

Water truck on berm

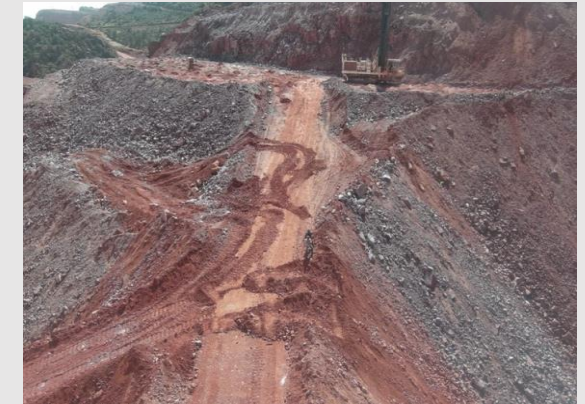
Water truck tire marks on ramp and impacted berm

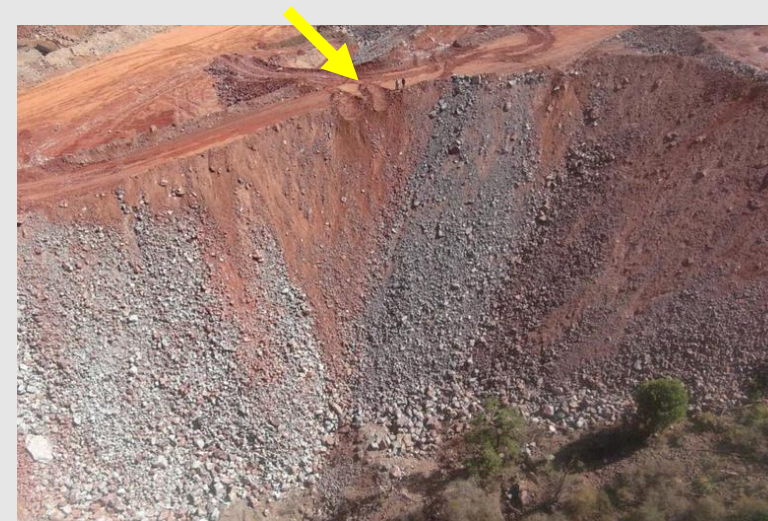
Arrow points to location of water truck on berm
