# Potential Fatal Event: Falling Grating

<b>Operation</b>	Manyar Smelter Project
<b>Date / Time</b>	February 22, 2024 / 8:42 PM
<b>Event Type</b>	Injury- Restricted Duty
<b>Summary</b>	While moving steel, a crane's cable contacted a piece of scaffold grating weighing 20 kilograms. The grating fell 10 meters and struck one of two employees performing structural steel work from a man basket at a height of 15 meters.
<b>Risk Category</b>	Falling Objects – Significant (3) Possible (2)
<b>Findings / Missing Controls</b>	<ul style="list-style-type: none"> <li>• Failure to identify unsecured grating during installation and inspection</li> <li>• Falling objects were identified as a fatal risk on completed FRM verification but did not distinguish grating as potential risk</li> <li>• Failure to prevent crane cable contact with structure</li> </ul>
<b>Applicable Policies / Procedures</b>	<ul style="list-style-type: none"> <li>• Chiyoda Grating Installation Method Statement</li> <li>• Chiyoda Permit to Work Procedure</li> </ul>

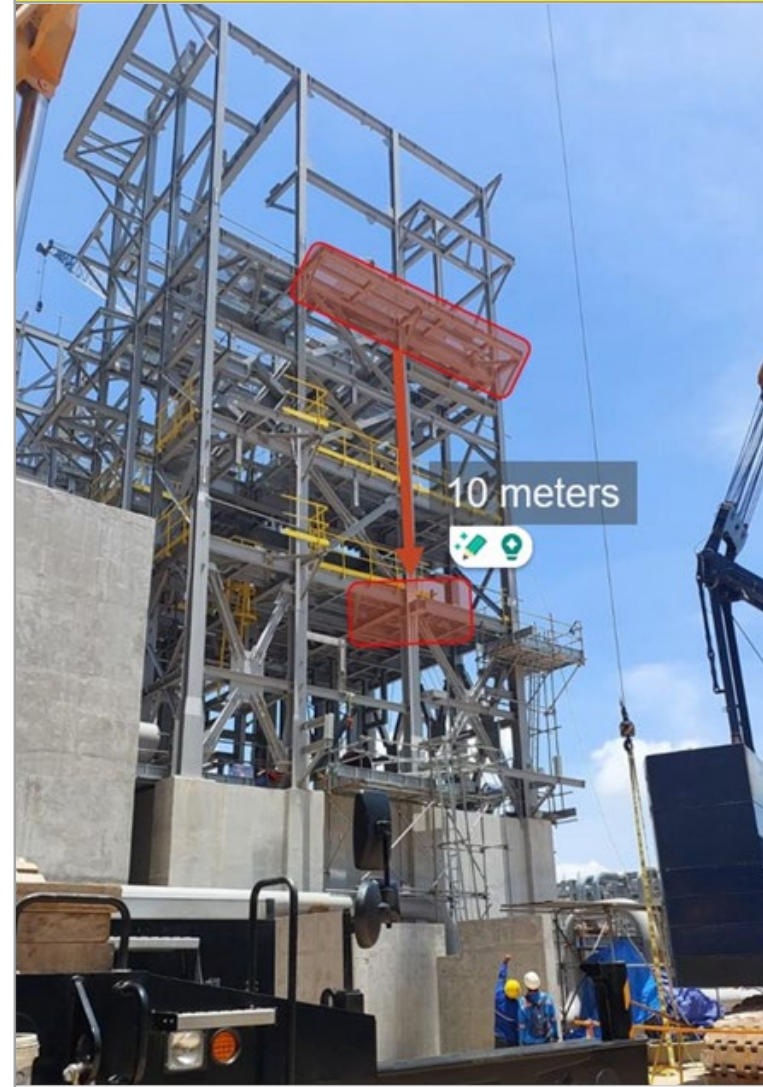
*Scaffold grating weighing 20 kilograms fell 10 meters, striking an employee in a man basket.*
