SAFETY ALERT NOTIFICATION

SITE:	Holstein Spar; GC-644	IMS/RIMS ID:	INR-14-1038
ISSUED BY:	Darren D Hewston CSP, CET	Personnel:	X
DATE/TIME:	November 18, 2014	Equipment:	X
CONTACT INFORMATION FOR ADDITIONAL DETAILS:	Susan Woods, CSP Advisor EH&S 713.579.8052 susan_woods@fmi.com	Property/Process Loss:	
		Health:	
		Other:	
DESCRIPTION:	<p>The attached pictures depict how suspended work platforms were being improperly rigged on an offshore GoM facility.</p> <p>Rigging using the manufacturer's clamps is improper. The first picture shows use of a set of temporary rigging clamps with a shackle. When using the temporary clamps correctly, the work platform cable should be looped through the clamps and free from being pinched between clamps and the beam. The work platform cable is not to be put in a pinch. This type of clamp is for rigging up, "first man up," connection only.</p> <p>The second picture shows how they used one clamp with a hook simply hooked to each side of a beam. This is a homemade and dangerous rigging method.</p> <p>Potential Hazards:</p> <p>Rigging Failure – Shackle being used in rigging is improper and puts Spider cable in a pinch. Potential for cable to rub and wear b

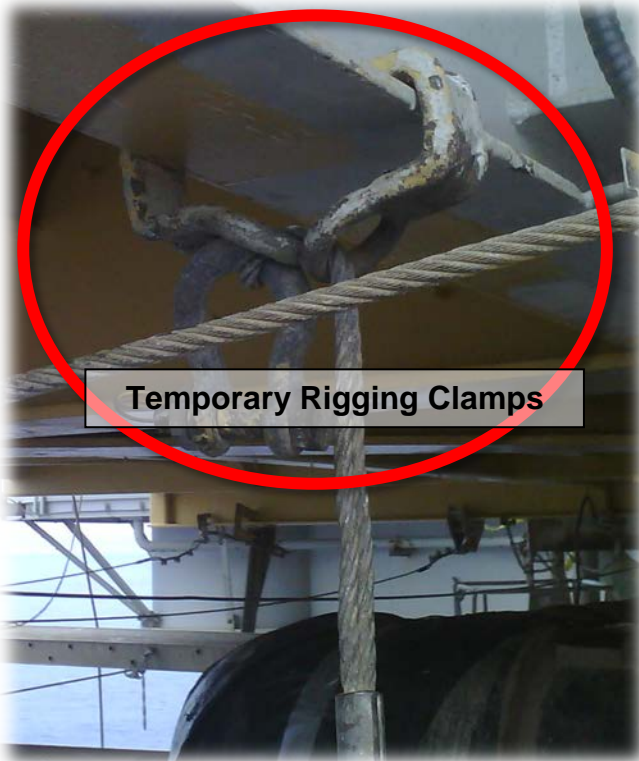
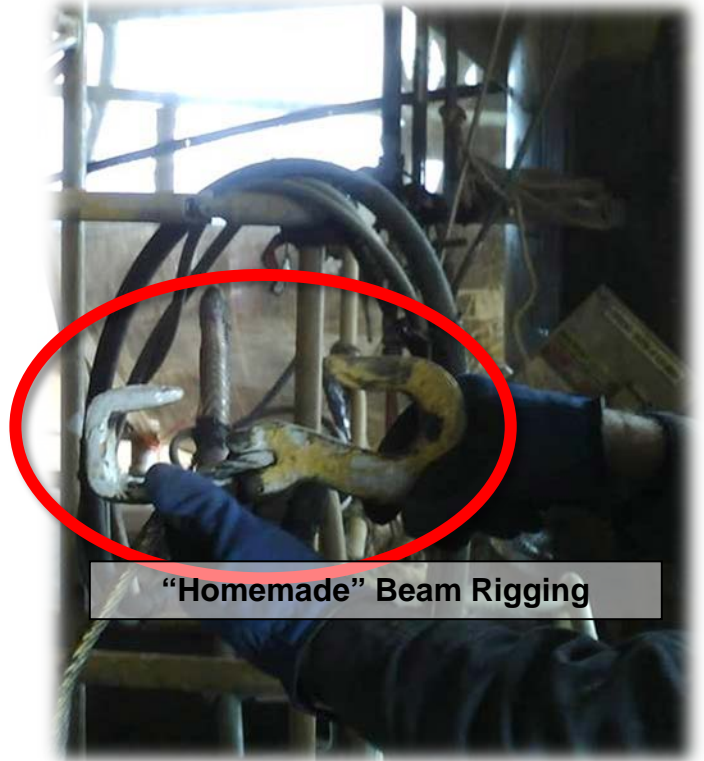
POTENTIAL INJURY TYPE:	Fatality, paralysis, fractures, lacerations		
INJURY:	Actual		Potential
	None		Fatality
IMMEDIATE ACTION:	Stopped work and met with contractor. Discussed rigging issue. Contacted manufacture for recommendation. Discovered onsite contractor personnel were trained to install work platform rigging in this manner by their employer.

- Follow manufacturer's recommendation to use clamps for rigging Spider up and not for long term rigging
- When using clamps for work platform temporary rigging, rig as per manufacturer's recommendation
- Rig with beam clamps per manufacturer. (Example shown below)
- Review rigging of similar devices at all FM O&G locations to ensure safe and proper rigging

Recommend contractor should send key personnel to Competent Person training presented by manufacturer and have manufacturer, or professional engineer knowledgeable in rigging practices, review contractor's rigging plan
