# SAFETY ALERT NOTIFICATION

<b>OPERATION:</b>	Global		<b>Incident:</b>	
<b>ISSUED BY:</b>	Curtis Stacy, Electrical Safety Advisor		<b>Injury:</b>	
<b>DATE:</b>	5/8/15		<b>Property Damage:</b>	
<b>TIME:</b>	N/A		<b>Process Loss:</b>	
<b>LOCATION/DEPARTMENT:</b>	Electrical and Mechanical			
<b>INCIDENT DESCRIPTION:</b>	<p>A potential exists for unintended motion of electrically operated equipment under special circumstances. If electrical equipment is secured under the LOTOTO process known as the "Non-electrical Switching Green Label Guidelines", but is operated by remote equipment such as PLC's operating in automatic mode or some other electrical interlock which could initiate equipment start-up, it is possible for equipment to operate if the following take place:</p> <ul style="list-style-type: none"> <li>The disconnect switch fails to open all energized electrical phases when actuated</li> </ul> <p><b>AND one of the following:</b></p> <ul style="list-style-type: none"> <li>The qualified individual fails to properly try out the equipment by placing the local-remote switch in local mode and actuating the start/jog button</li> <li>The start/jog button has failed and the local-remote

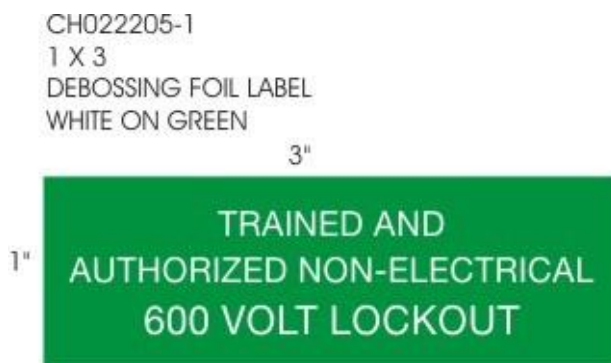
At many of our operations, the green label part number is DBF13LABEL and may be purchased from Hagemeyer. The price of the label is approximately \$0.50 each when purchased in quantities of 500.

The green label will be applied using the following guidelines

- 300 to 600 Volt
- 100 Amperes and below
- Disconnect / Safety Switches only
- Never to be applied to disconnects / safety switches located within a MCC Room, Control Room, Switch Room, etc.
- The integrity of the disconnect / safety switch must be verified prior to placing a green label (door latching mechanisms)
- The disconnect / safety switch must be properly labeled for identification
- Each area will be responsible for identifying the disconnects / safety switches and applying the green labels
- An arc flash evaluation on the disconnect / safety switch is not required for the placement of the green label
