SAFETY ALERT NOTIFICATION	Safety Alert #	SA – 2017 - 8
	IMS #	76616
CERRO VERDE – Domestic water contamination incident	OPERATION:	Cerro Verde
	INCIDENT DATE:	4/1/2017
	TIME:	19:30 Hrs.
	TYPE:	Injury
Issued By: Carlos Castro	Contact For Additional Details: ccastrog@fmi.com

INCIDENT DESCRIPTION

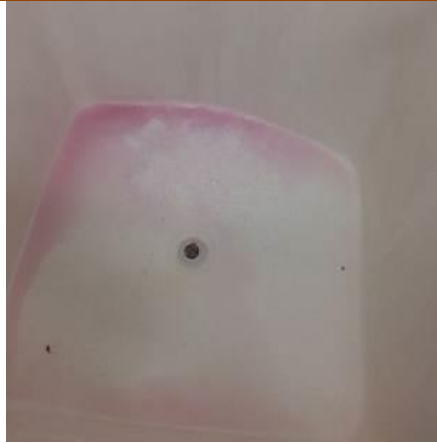
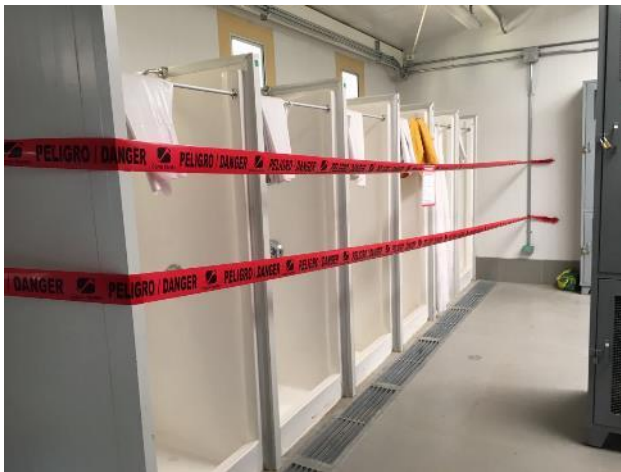
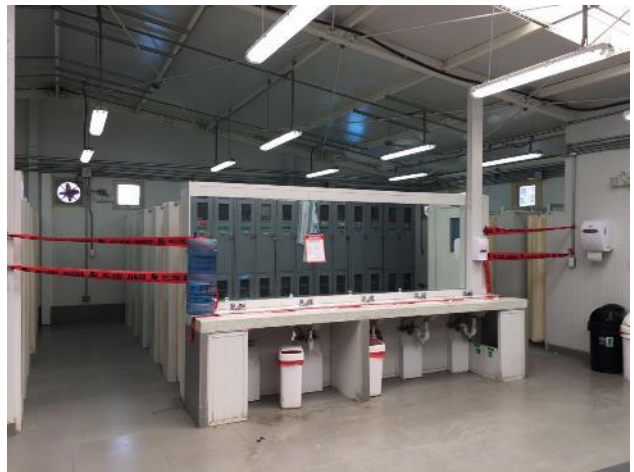
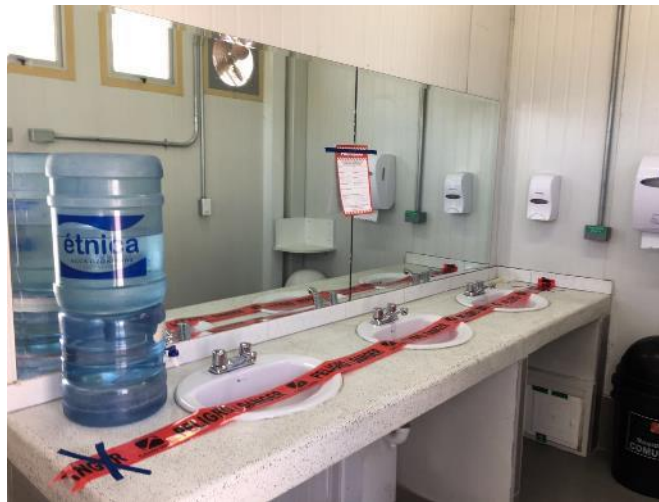
Workers who were at a change room, when using the services for hygiene (showers and washbasins), came into contact with pink colored water, coming from the domestic water system.

Domestic water piping system was connected to the cooling system circuit directly with a check valve and not isolated properly. A failed check valve allowed the refrigeration system chemicals to mix with the domestic water system.

Change rooms and restrooms where the pink water hazard was identified were closed and access restricted to determine causes of the event.
Water samples and plant inspections were taken to determine the source of contamination.

1. Physically isolate domestic water lines and process cooling system lines from HPGR crushers and mills.
2. Perform site wide inspections to verify any additional potential where domestic or potable water systems are connected to process water systems or other contamination sources
3. Develop site policy for Backflow Prevention and Cross Connection controls
4. Coordinate with FCX Engineering to review engineering and construction standards to prevent cross contamination to domestic and potable water systems
5. Review water quality monitoring procedures for domestic and potable water system.
